**REPORT**  
**TO**  
**BMT WBM PTY LTD**  
**ON**  
**GEOTECHNICAL ASSESSMENT**  
**OF**  
**EROSION HAZARD LINES**  
**ALONG THE**  
**WYONG SHORE COUNCIL FORESHORE AREAS**  
**BETWEEN CRACKNECK POINT AND**  
**HARGRAVES BEACH, NSW**

**5 April 2016**  
**Ref: 28424WRrpt**

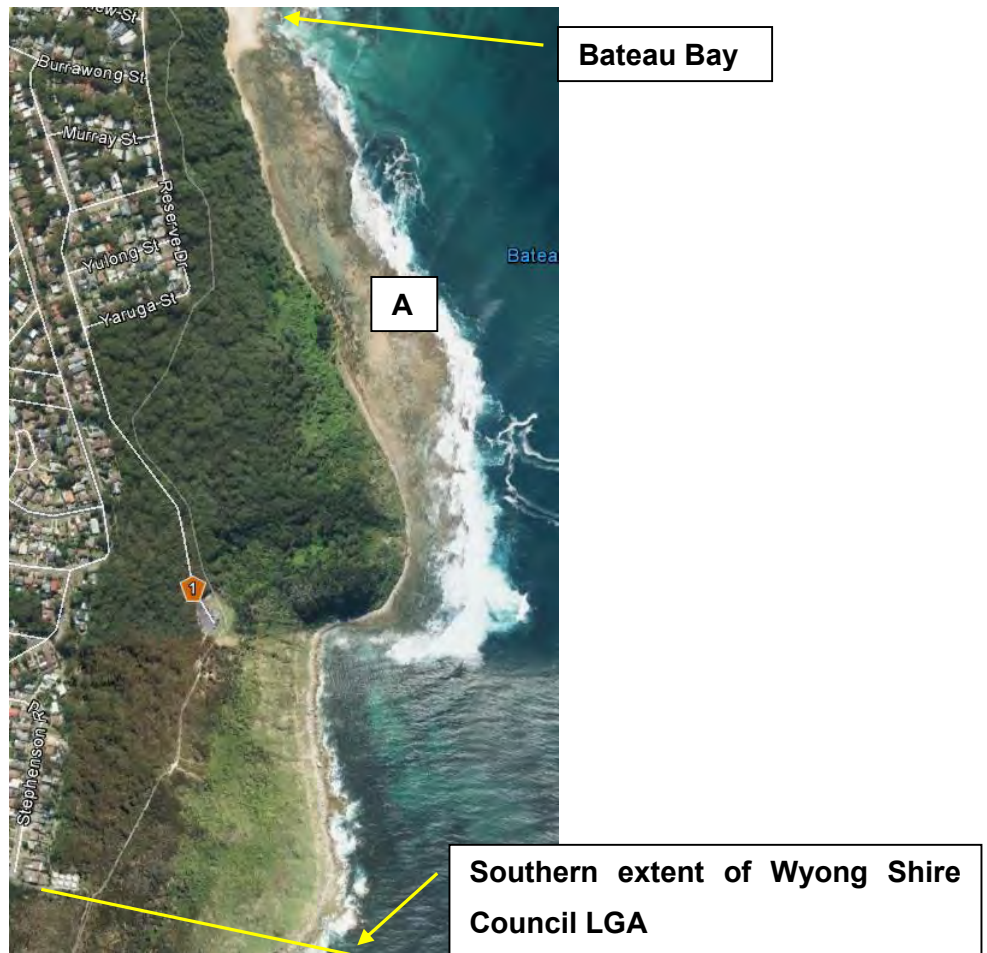
From the southern end of the study area, the cliff line was initially a total maximum height of about 50m, reducing to a maximum of about 25m to 30m height to the north at the southern end of Bateau Bay (see Plate 1).

**Plate 1: Crackneck Point Site Area**

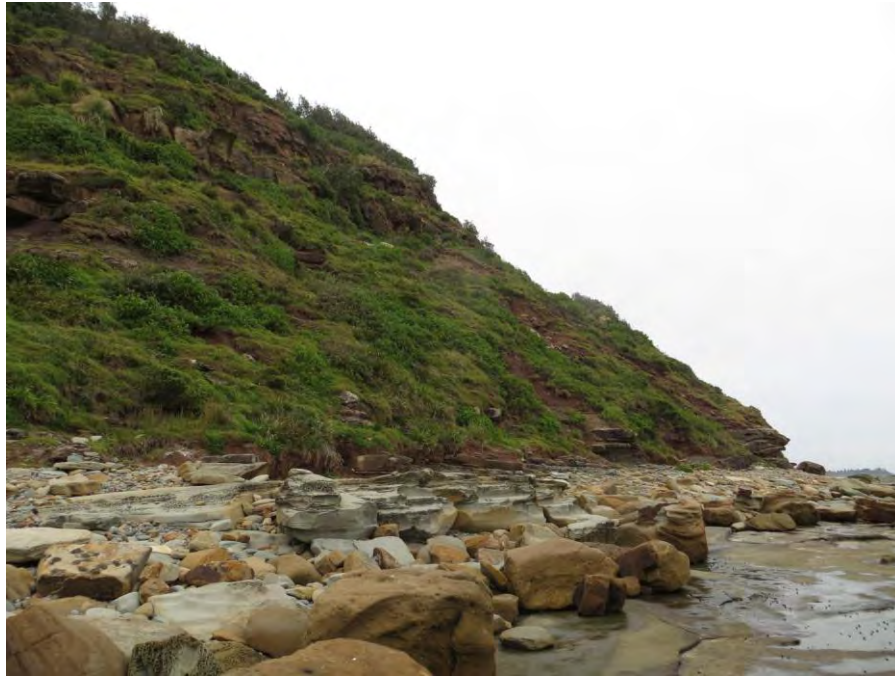
The base of the cliff comprised a sub-vertical rock face ranging from between about 1m to 15m height. The base of the cliff was typically covered with gravel, cobble and boulder sized blocks of sandstone (see Plate 2). A drape of soil with a similar size range of sandstone inclusions was also evident over much of the basal portion of the cliff face (see Plate 2). However, to the north (towards Bateau Bay), the frequency of sandstone blocks significantly reduced.

**Plate 2: Southern Portion of Crackneck Point Cliff Line**

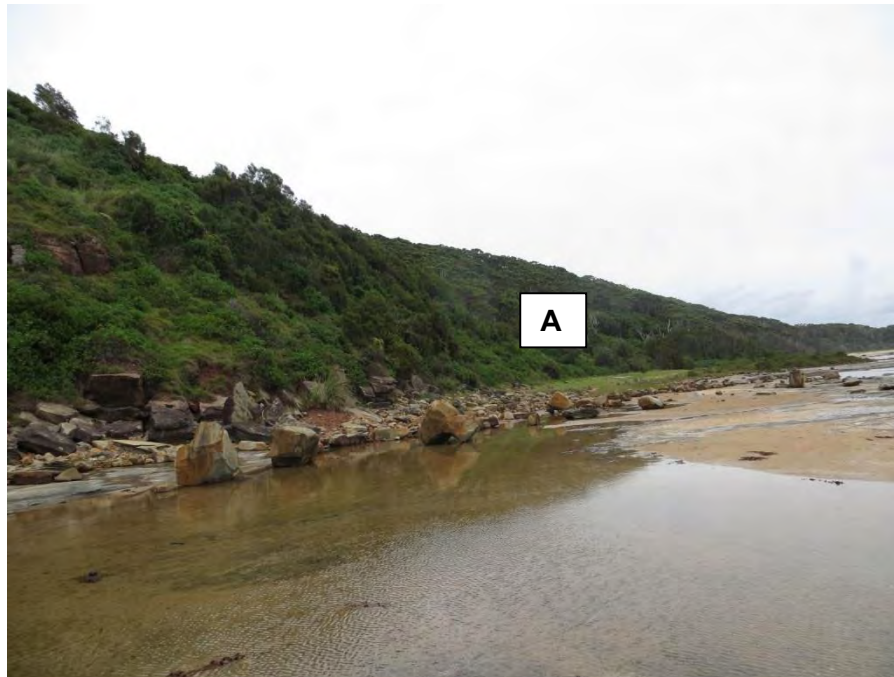
At location 'A' (see Plates 1 and 3) the cliff line was absent at the landward edge of the wave cut platform. This area of the foreshore comprised a low lying, gently sloping vegetated area, with what appeared to be a cliff line set-back at least 50m landward of the toe of the foreshore slope. This portion of the foreshore may well represent an area of previous landslide activity.

**Plate 3: Looking North To Location 'A' (low lying area where cliff face absent)**

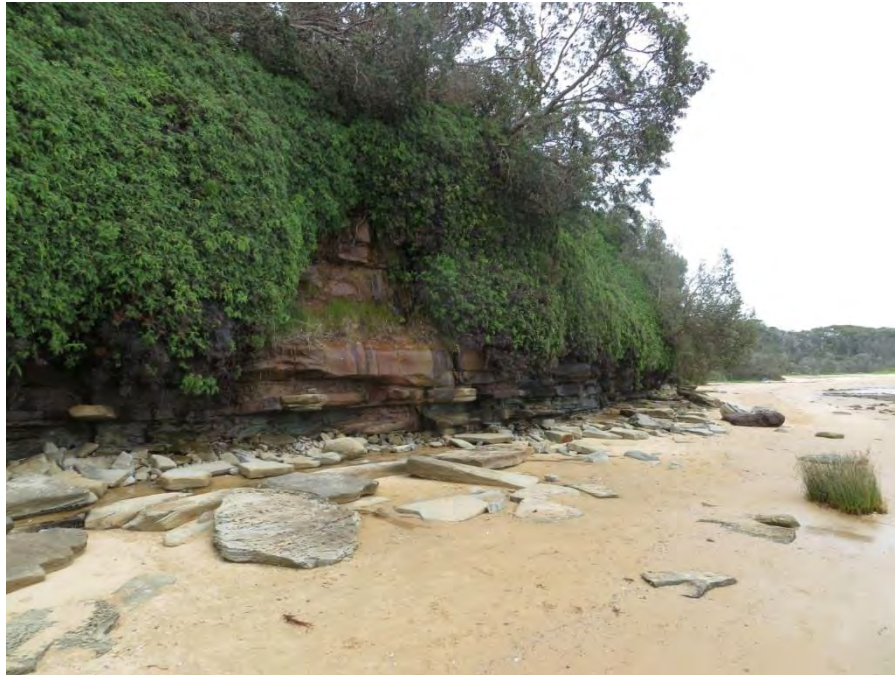
Where exposed, immediately above the wave cut platform, the rock face at the base of the cliff typically comprised a claystone band (at least about 0.5m thick) with sandstone above. The claystone had been eroded and undercut the sandstone above. The overlying sandstone 'roof' had clearly collapsed in places and detached on sub-horizontal bedding planes to form 'platy' cobble and boulder sized sandstone blocks (see Plate 4).

**Plate 4: Claystone Eroding and Undercutting Sandstone Above**

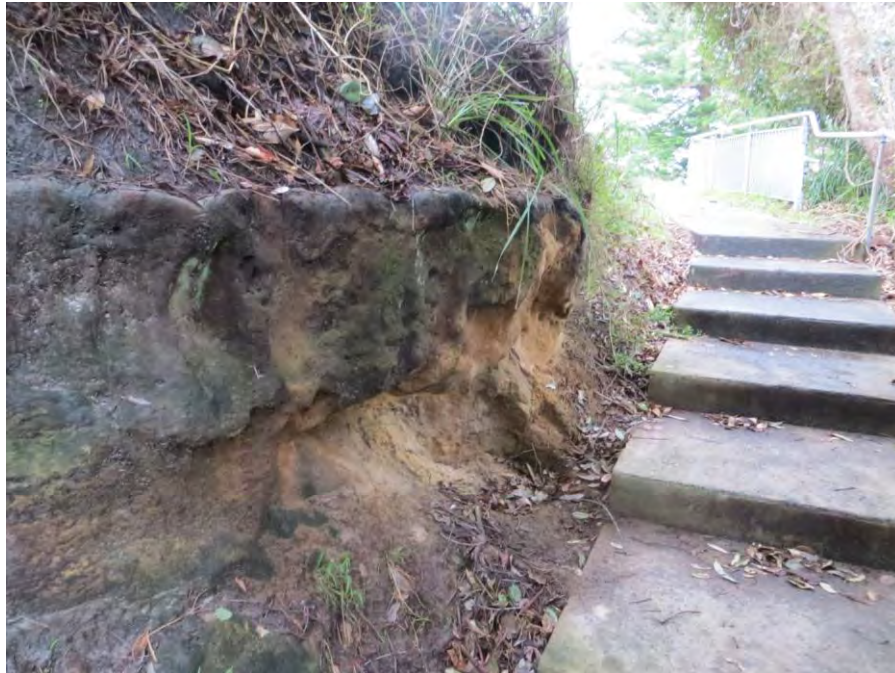
Adjacent to selected walkways down the steep slope, sub-vertical outcrop faces exposed cemented/indurated sand which was generally assessed to be of very low strength (based on striking with a geopick).

**Plate 6: Indurated/Cemented Sand**

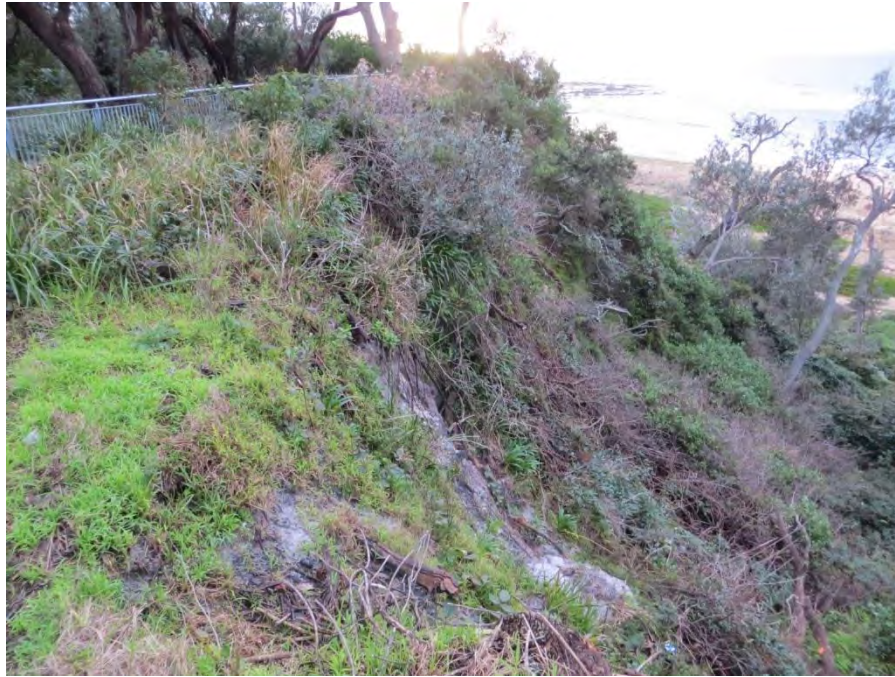
The foreshore slope has been interpreted to represent a landslide area (based on the cross sectional slope profile, the uneven slope surface and downslope lean of trees) which may well comprise several smaller landslides over this site area.

**Plate 7: Upper Steep Section of Slope (Looking North-East)**

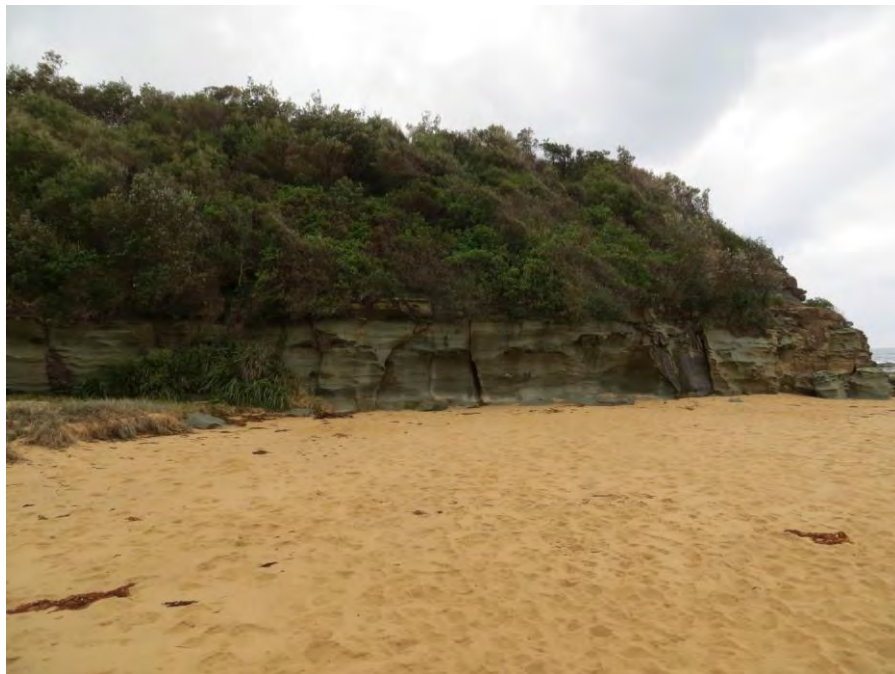
The northern margin of the beach comprised a sub-vertical sandstone cliff face typically about 3m high with a steep (maximum about 45°) vegetated slope above with what appeared to be traces of sub-vertical sandstone outcrop faces (see Plate 8).

**Plate 8: Cliff Face at Northern End of the Beach**

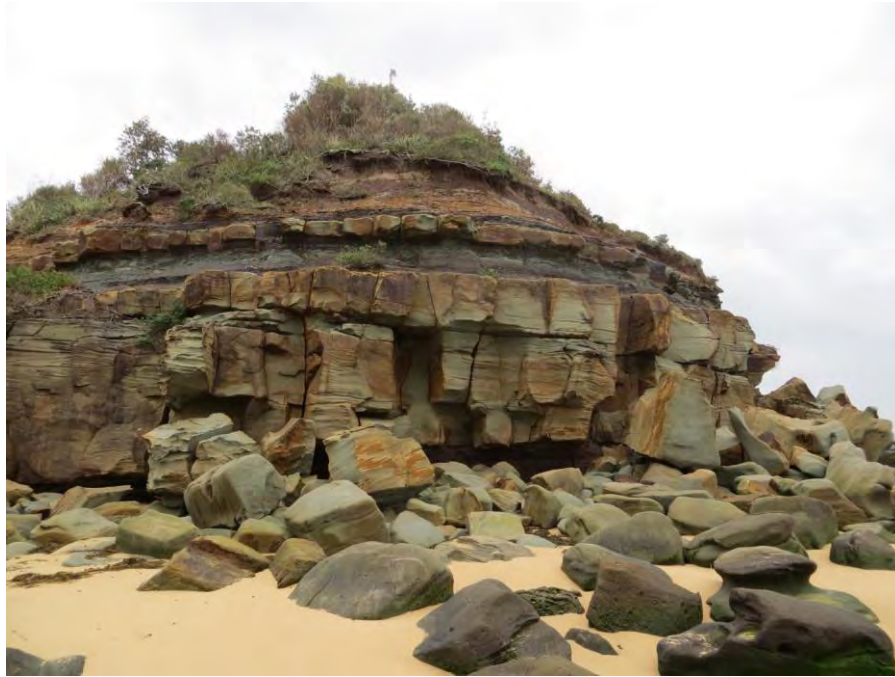
The northern margin of the Bateau Bay beach comprised a sub-vertical sandstone cliff face with claystone interbeds maximum about 5m high with a steep stepped profile (see Plate 10). The claystone had been eroded and was undercutting the sandstone above. The sandstone blocks scattered along the toe of the cliff have been derived from localised collapse of the undercut sandstone beds with the block sizes controlled by the spacing and orientation of the sub-vertical joint planes; typically orientated at approximately 330°, 290° and 040°. The approximately east-west joints typically had a lateral spacing of about 0.5m (see Plate 10).

**Plate 10: Cliff face Southern End of Blue Lagoon**

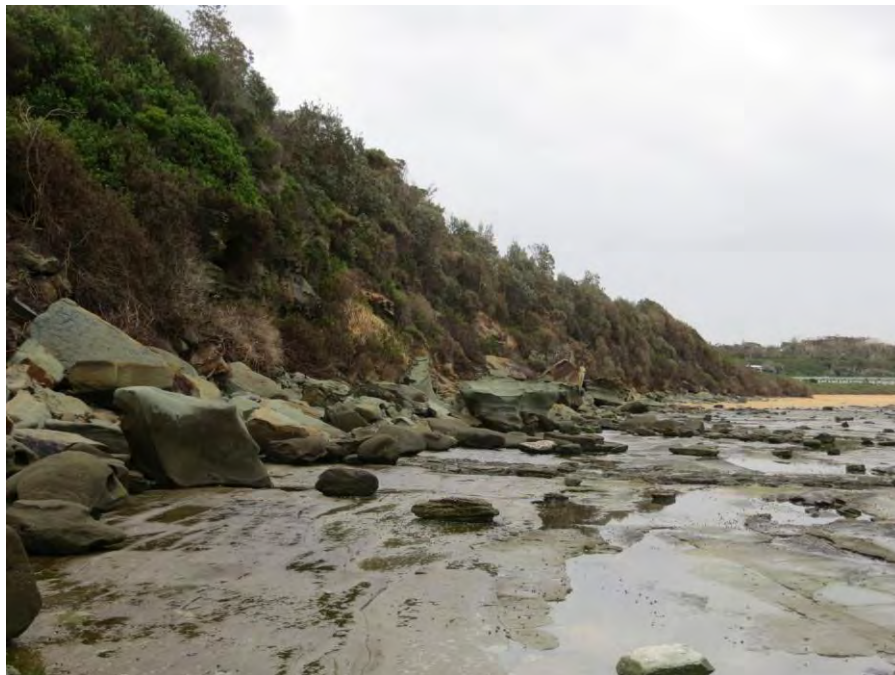
**Plate 11: Sub-Vertical Soil Face North of Location 'B'**

North from the southern end of Blue Lagoon, above the cliff face a steep (maximum about 45°) vegetated slope was present. North from location 'B' (see Plate 9), the cliff face was absent and the vegetated slope extended down to a 1m to 2m sub-vertical face which lined the landward margin of the beach surface. At location 'B' what appeared to be a localised small scale rock fall deposit was observed. North of location 'B', to the southern boundary of the Blue Lagoon Beach Resort, the sub-vertical soil face exposed what appeared to be colluvial or residual clay soils (see Plate

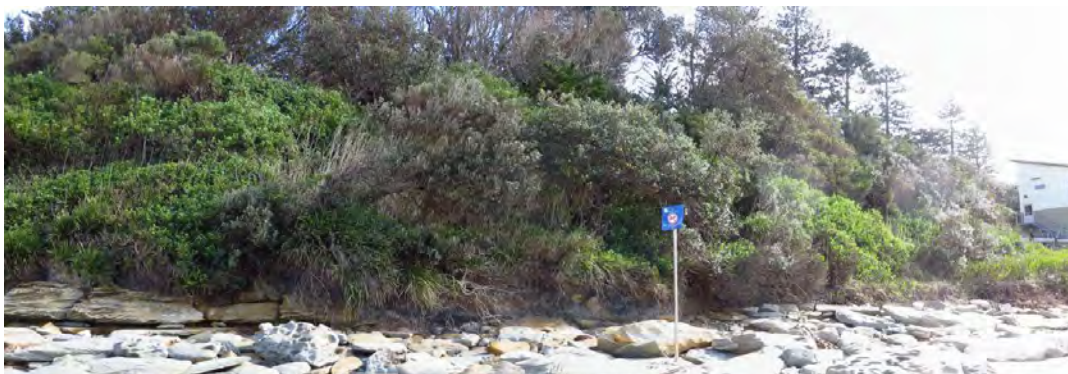
South from the SLSC, the foreshore slope initially comprised a moderately steep ( $25^{\circ}$  to  $30^{\circ}$ ) vegetated colluvial clay soil slope which extended south to a sub-vertical sandstone bedrock face about 2m to 3m maximum height. The vegetated colluvial soil slope extended landward from the crest of the rock face (see Plate 13).

**Plate 13: South of SLSC**

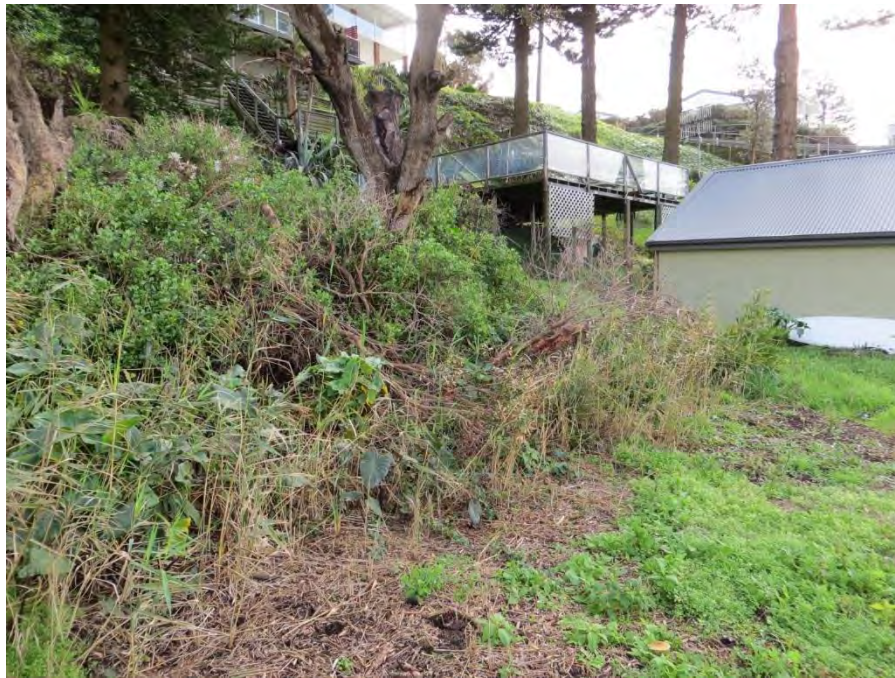
- Location 'D': this sandy foreshore slope was steep and, where observations were possible through the vegetation, the slope surface was typically concave and has been interpreted to represent an area of previous slope instability. This foreshore area corresponded to the area covered by the No. 2 and No. 4 Rolls Avenue DP geotechnical reports provided by Council (see Section 2, above).

**Plate 16: Location 'D' Below Rolls Avenue**

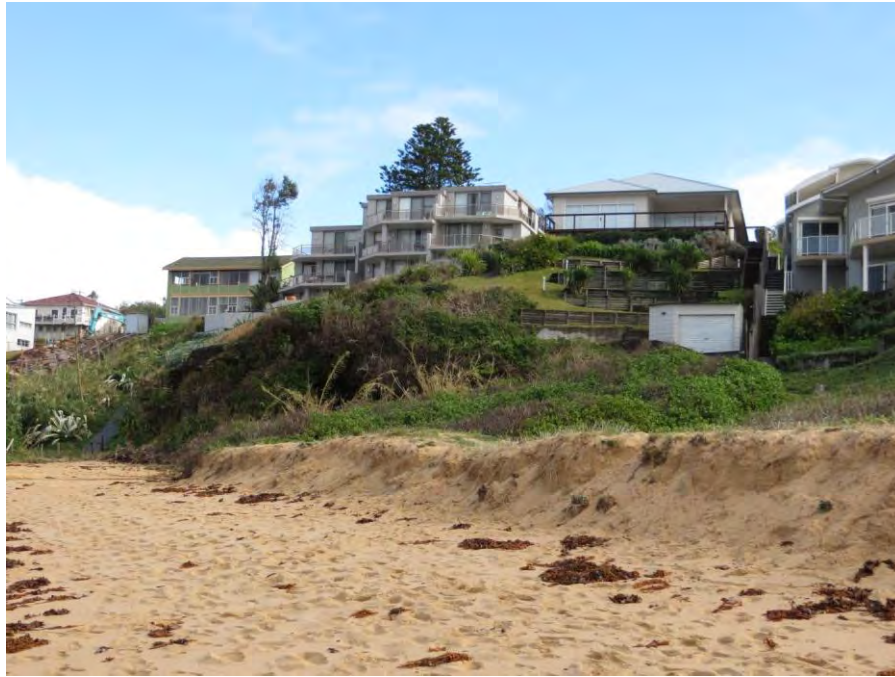
- Location 'E': a short length of sandstone bedrock outcrop (maximum height about 5m) was present at the landward margin of the beach this sandy foreshore slope (see Plate 17). Sub-vertical joint planes orientated at about 040° and 325° were recorded. This foreshore area corresponded to the area covered by the JK and DP geotechnical reports and WP coastal engineering reports along Werrina Parade (60, 62 and 64). Buried cliff lines below the sandy slopes have been interpreted to influence the formation of the small headland feature defining the boundary between Towoon Bay and Blue Bay. In this regard, we note that a bedrock wave cut platform was evident on the aerial photograph for this area (see Plate 15).

**Plate 17: Location 'E' Below Werrina Parade**

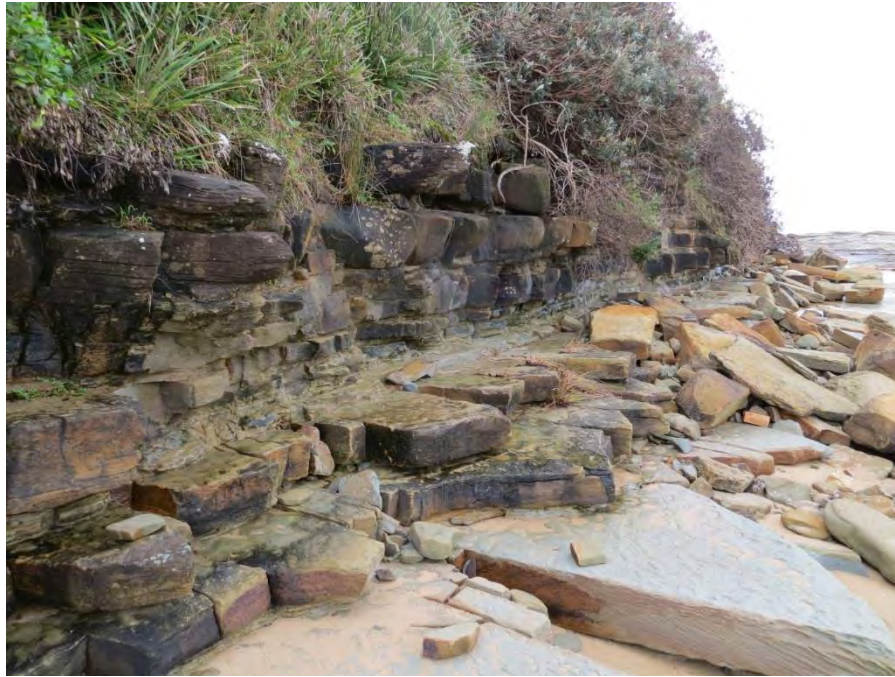
- Location 'F': the northern end of Blue Bay was defined by an approximately east-west trending gully feature. The northern slope of the gully extended east to the south-eastern section of the headland feature. The headland was characterised by a 0.5m to 2m high sub-vertical sandstone bedrock face with claystone interbeds. A steep (maximum 45°) vegetated slope extended landward from the crest of the rock face.
- A stepped bedrock wave cut platform (with a thin sand cover) extended seaward from the toe of the headland rock face. The sandstone blocks scattered along the toe of the rock face were derived from localised collapse of undercut sandstone beds formed due to the preferential erosion of the weaker claystone beds (see Plate 18).

**Plate 18: Blue Bay Headland**

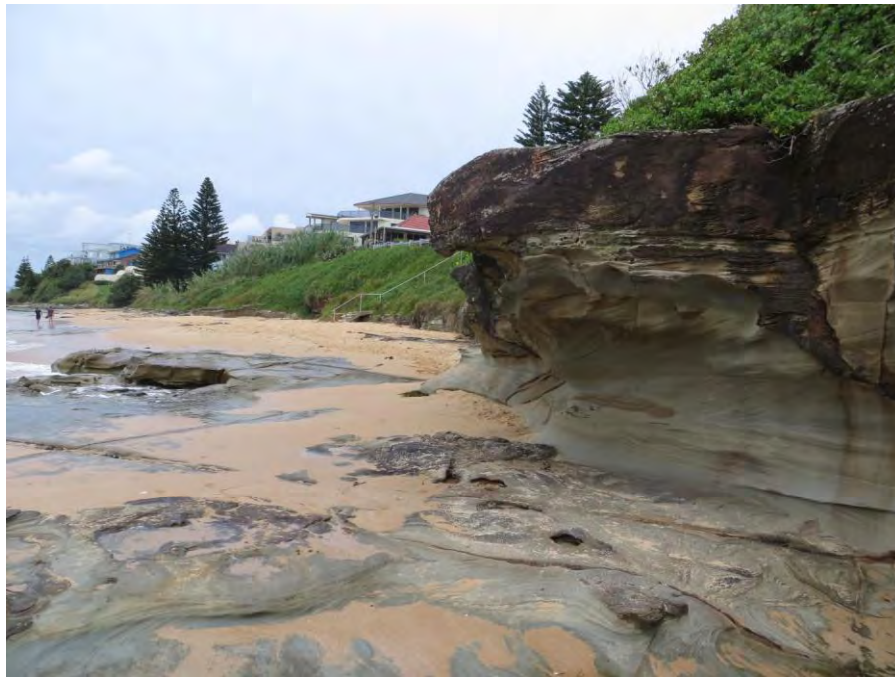
South of the rock pool, the sandstone had been eroded to form an overhang (see Plate 20) and, adjacent to the southern end of the rock pool, was supported by a concrete pillar.

**Plate 20: The Entrance, cliff face south of the rock pool**

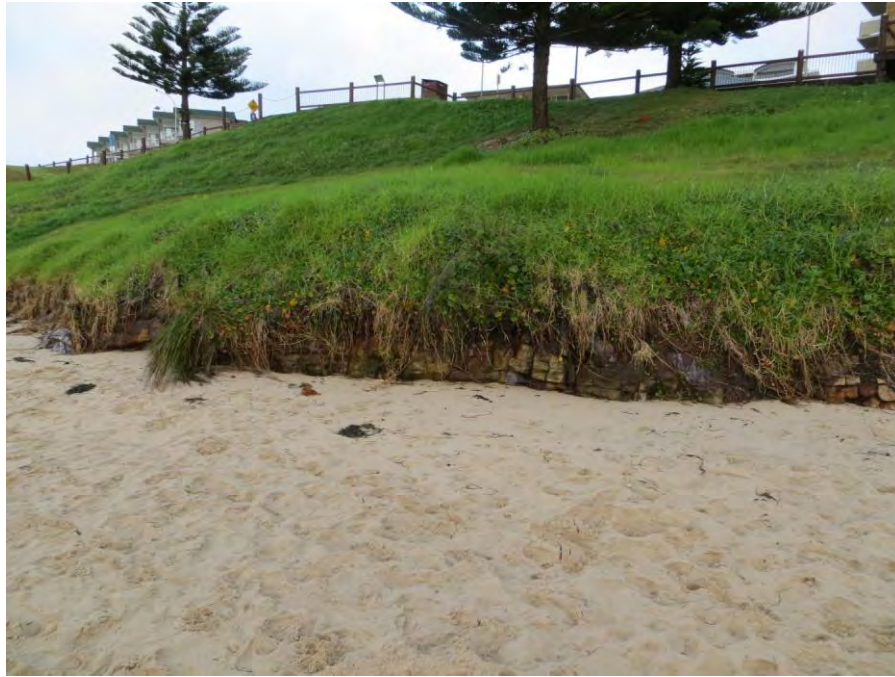
Sand dune slopes extended from the northern end of the SLSC to about location 'G' (see Plate 19) where a maximum 1m high sandstone bedrock face was noted at the toe of the grass surfaced moderately steep concave slope (see Plate 21).

**Plate 21: Slope below the eastern end of Marine Parade**

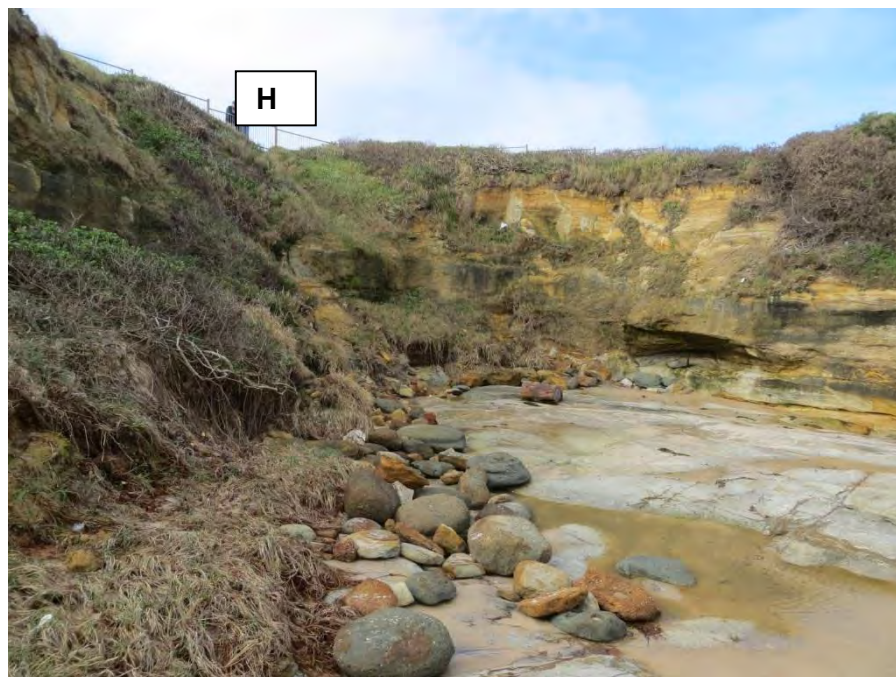
The cliff face and wave cut platform exposed planar sub-vertical joints orientated approximately  $110^{\circ}$  and  $030^{\circ}$ . On the south-western face of the headland, the claystone band had been locally eroded to form an undercut approximately 2m long, 1m high and with a maximum 'depth' of about 1m (see Plate 25).

**Plate 25: Undercut in cliff face and colluvium to the west (Location 'H')**

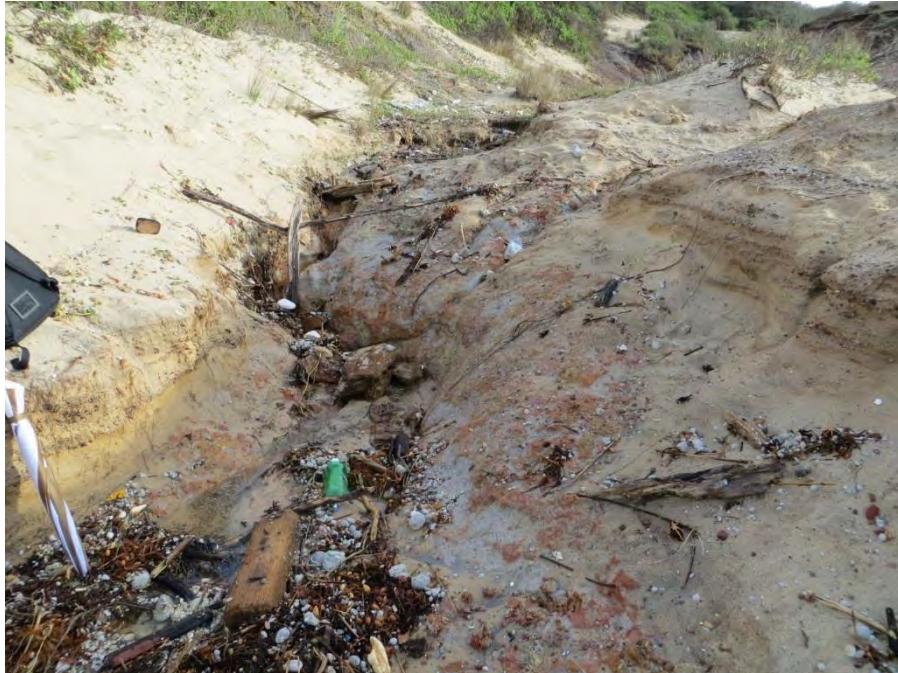
conglomerate which was typically extremely weathered with a thin residual clay cover overlain by the sand dune slope (see Plate 31).

**Plate 31: Creek line at Location 'I' exposing extremely weathered Munmorah Conglomerate**

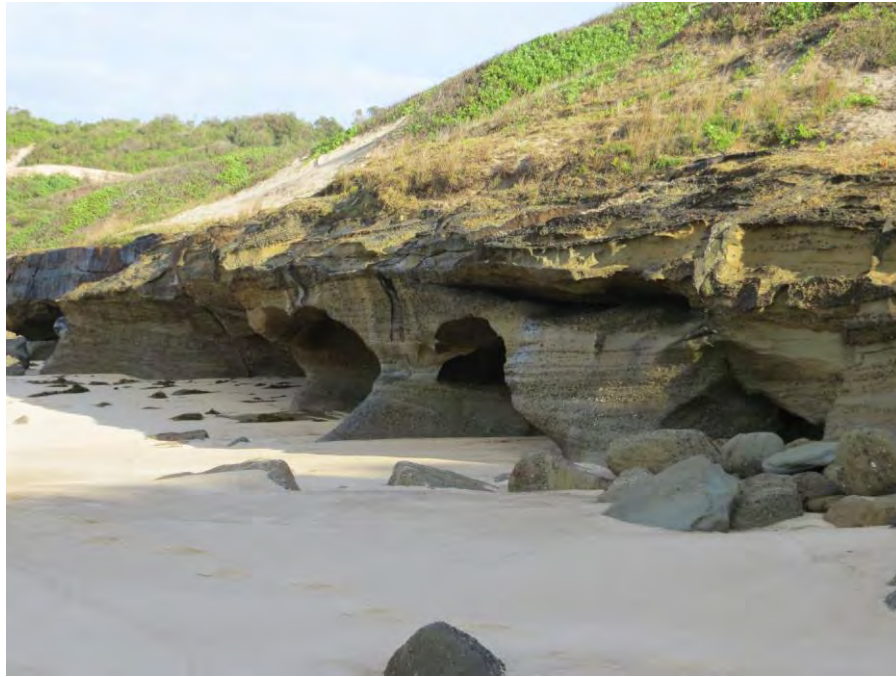
The sandstone beds were preferentially eroding relative to the conglomerate beds and the erosion had formed a series of undercuts (maximum 1.5m height above the beach surface) which extended back a maximum 'depth' of 3m (see Plate 32).

**Plate 32: Erosion of Munmorah Conglomerate at northern end of the beach**

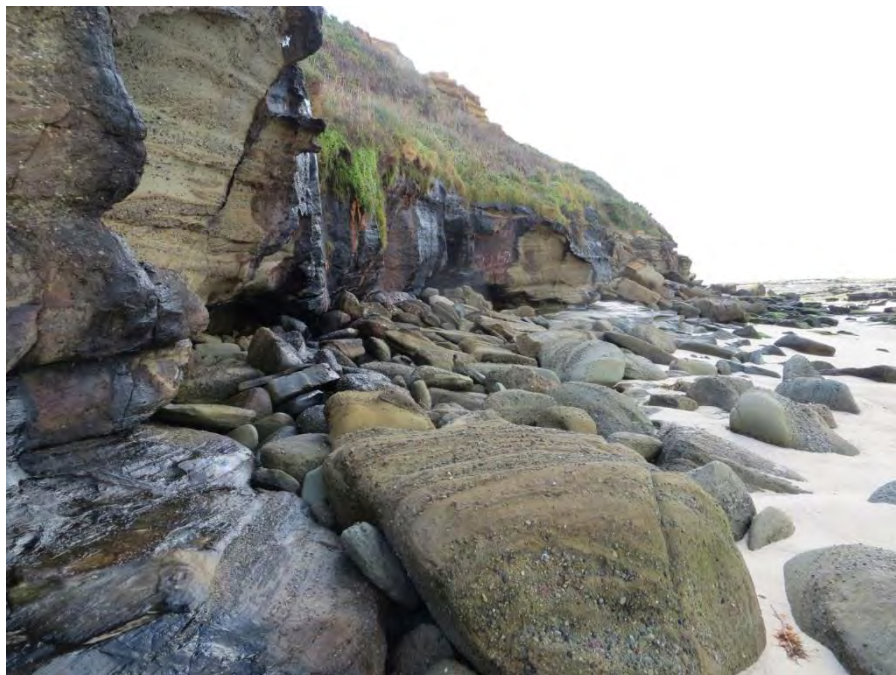
The cliff face extended round to the north and formed the southern margin of the following Norah Head site area (see Section 4.9, below). The sandstone band at the base of the cliff face had preferentially eroded to form an intermittent undercut (maximum height about 1m, maximum 'depth' about 1m). Numerous rounded to angular cobble and boulder sized blocks of sandstone and conglomerate derived from previous rock falls covered the base of the cliff (see Plate 33).

**Plate 33: Blocks covering the base of the cliff and undercuts (looking north)**

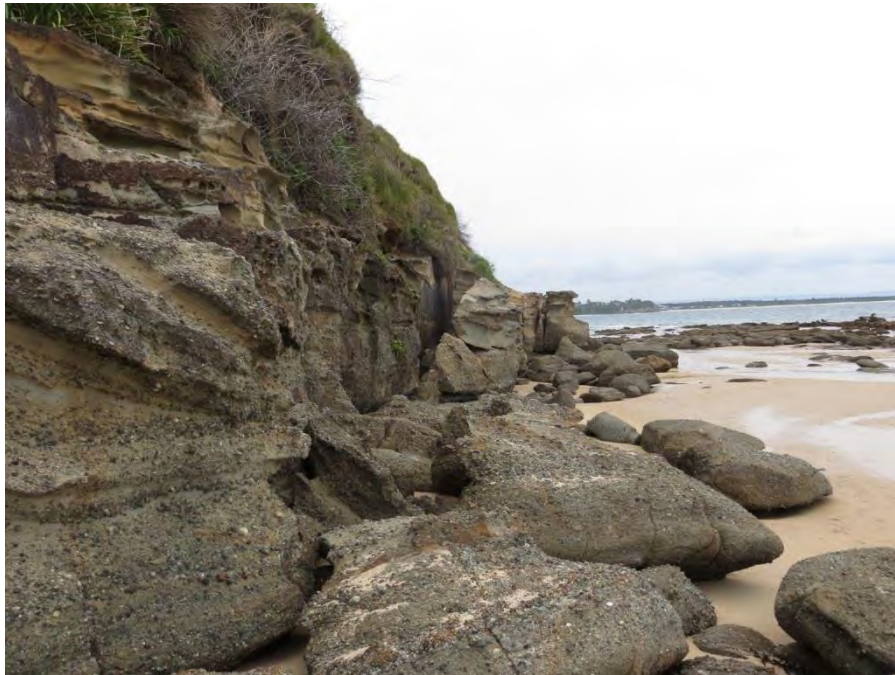
At the north-eastern end of the headland, blocks of conglomerate were observed to be detached from the cliff face along sub-vertical joint planes orientated approximately  $305^{\circ}$  (see Plate 35).

**Plate 35: Conglomerate blocks detached from the cliff face**

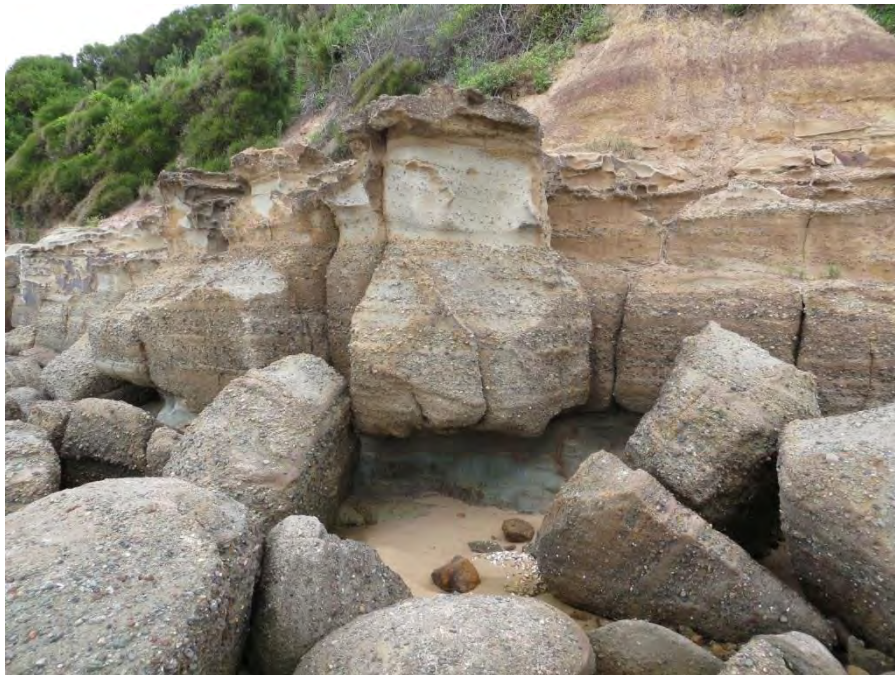
**Plate 36: Undercut conglomerate and blocks covering the base of the cliff**

A claystone band was noted at the base of the blocks and had been eroded to form undercuts (see Plate 36). Numerous cobble and boulder sized angular blocks of conglomerate were evident along the base of the cliff, presumably derived from collapse of previously detached and undercut blocks

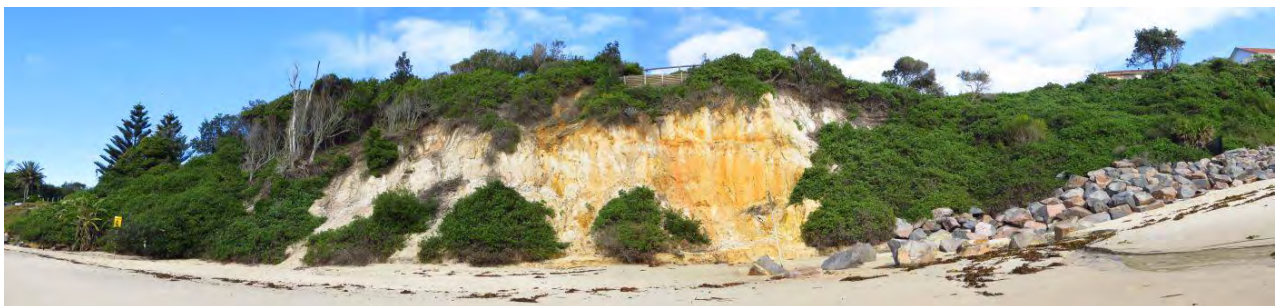
To the west of Location 'J', the foreshore was dominated by a sub-vertical face, approximately 10m high, which exposed silty sand and clayey sand (see Plate 40). The sands were typically moist and wet at the toe of the slope where debris from previous slope instability had collected. Striated and smooth surfaces in the sands sloped down to the north at between about 60° and 80°, and have been interpreted to indicate previous slip planes. A reserve area and car park lined the crest of this section of foreshore.

**Plate 40: Unstable sub-vertical sand face**

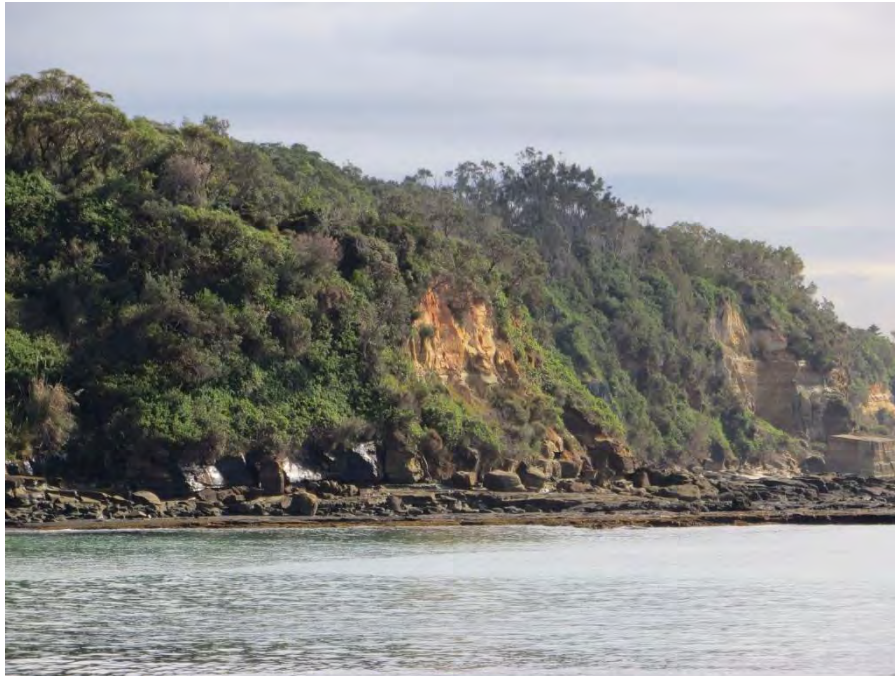
'Blocky' sandstone boulders were evident on the sandstone bedrock wave cut platform at the toe of the cliff face (see Plate 43).

**Plate 43: Cliff Face at the western end of Cabbage Tree Harbour**

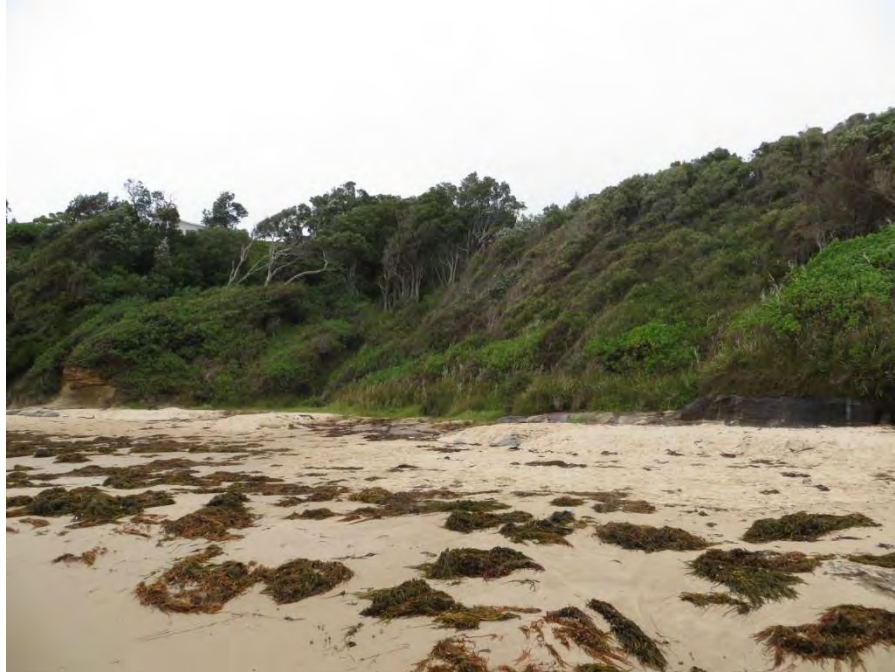
**Plate 46: Area of previous cliff face instability (Location 'K')**

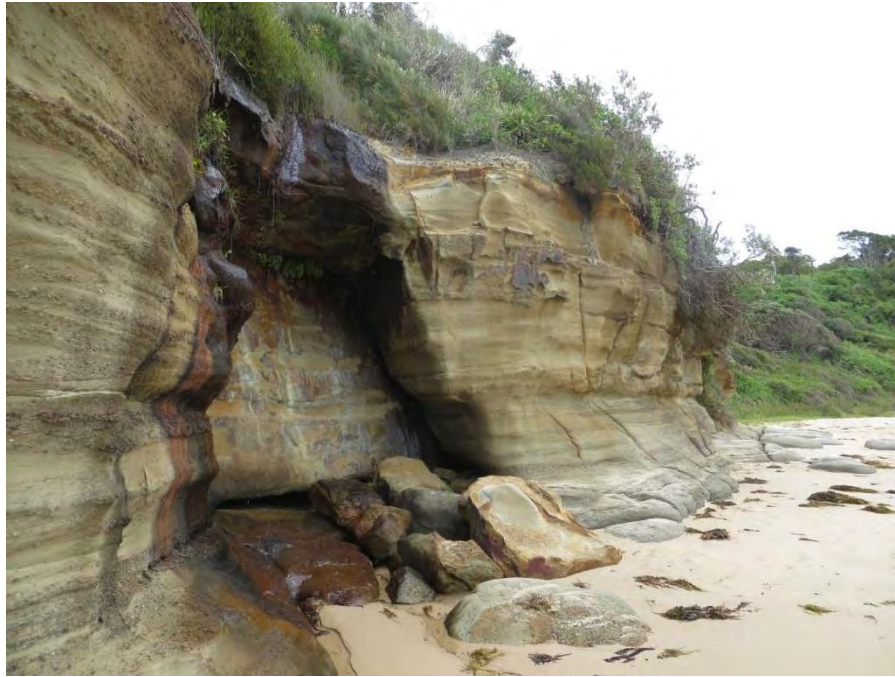
**Plate 47: Area of previous cliff face instability (Location 'K')**
