# The Entrance - Post Storm 13/06/2016

FIGURE 1.1  
Detailed LADS Bathymetric Data

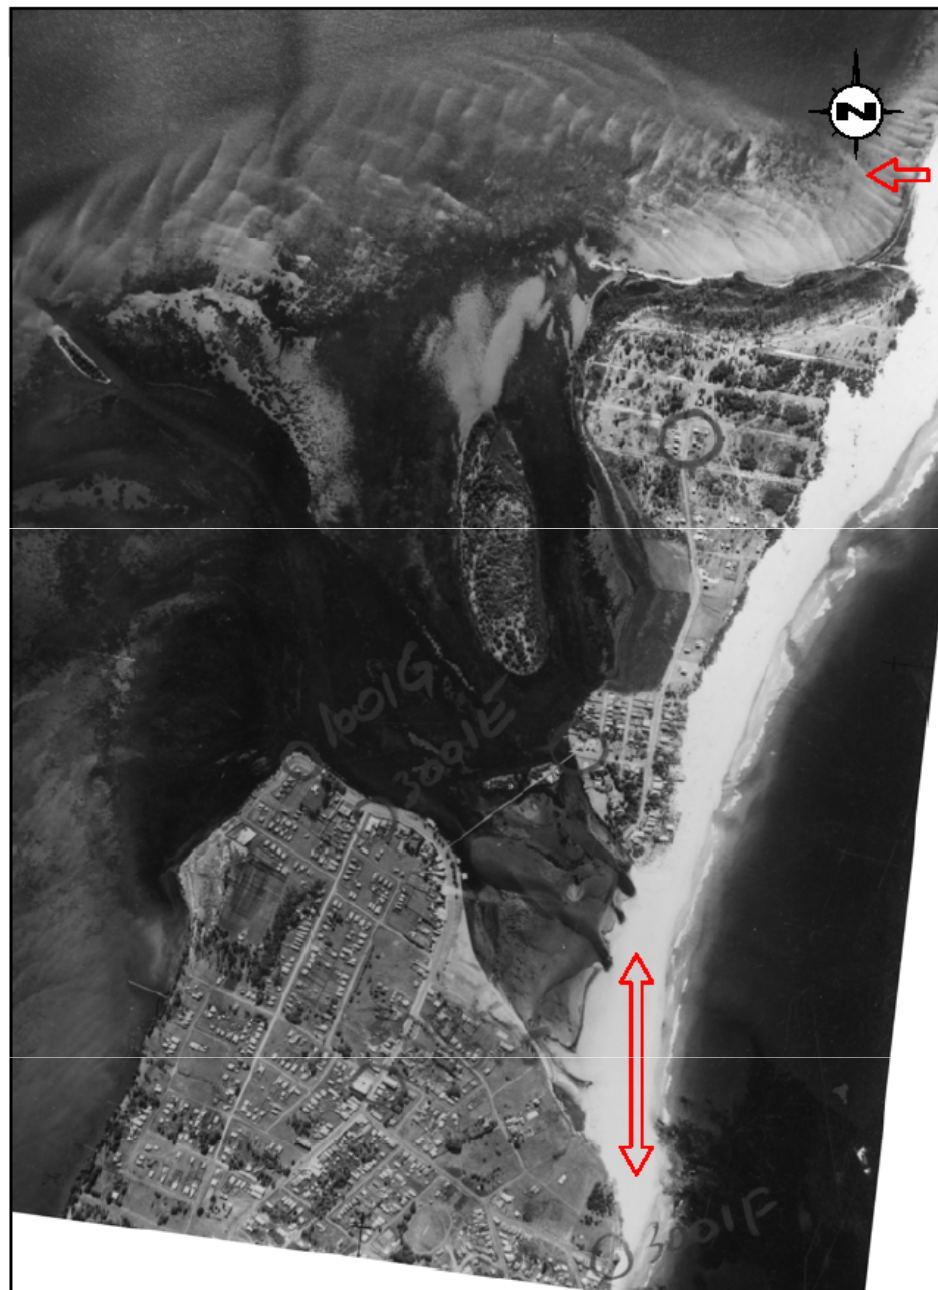
**1941**

- Active blowout transferring sand from North Entrance Beach (Curtis Pde area) across the barrier to outer edge of tidal delta
- Entrance closed. Long shore sediment transport building The Entrance Beach
- Very wide beach at North Entrance

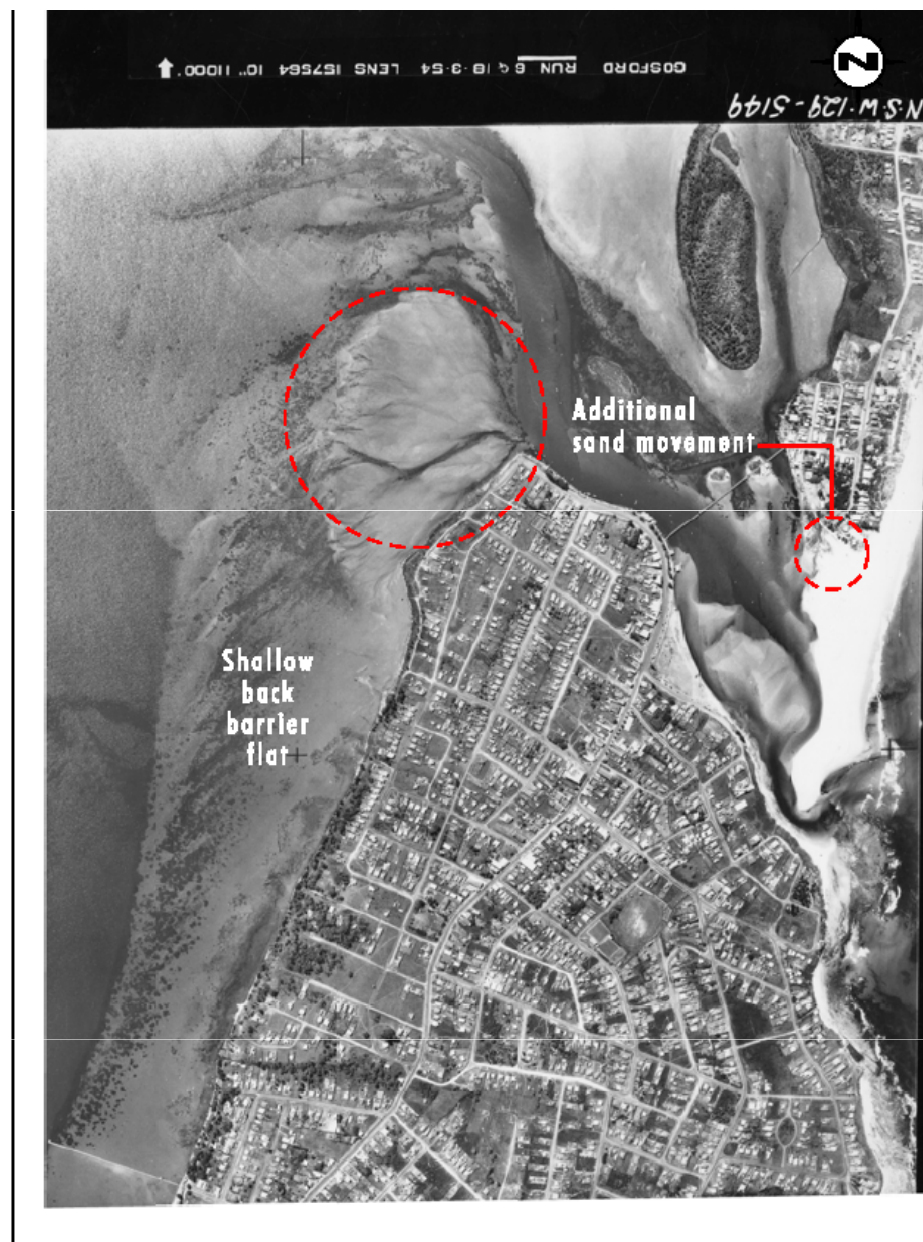
### 1954

- Entrance open on southern side
- Sand stripped from The Entrance Beach and from outer tidal delta
- Extensive tidal flats off main channel on western side of tidal delta
- Limited delta activity to northern side

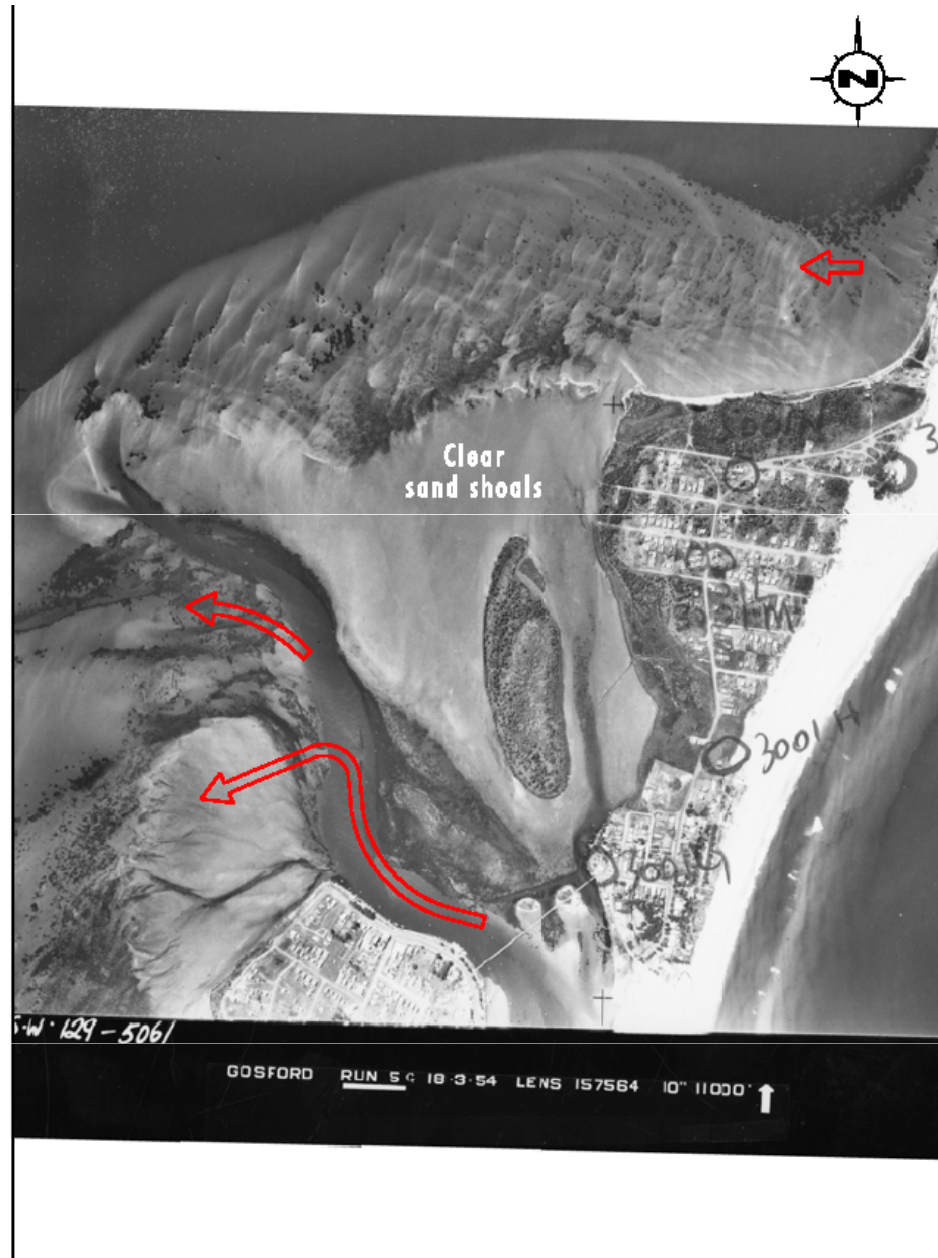
**1954**

- Active blowout continues at North Entrance
- Sand from blowout moving west across outer margin of delta
- Eastern side of delta strongly shoaled
- Wide beach at North Entrance, but low sand volume at The Entrance Beach

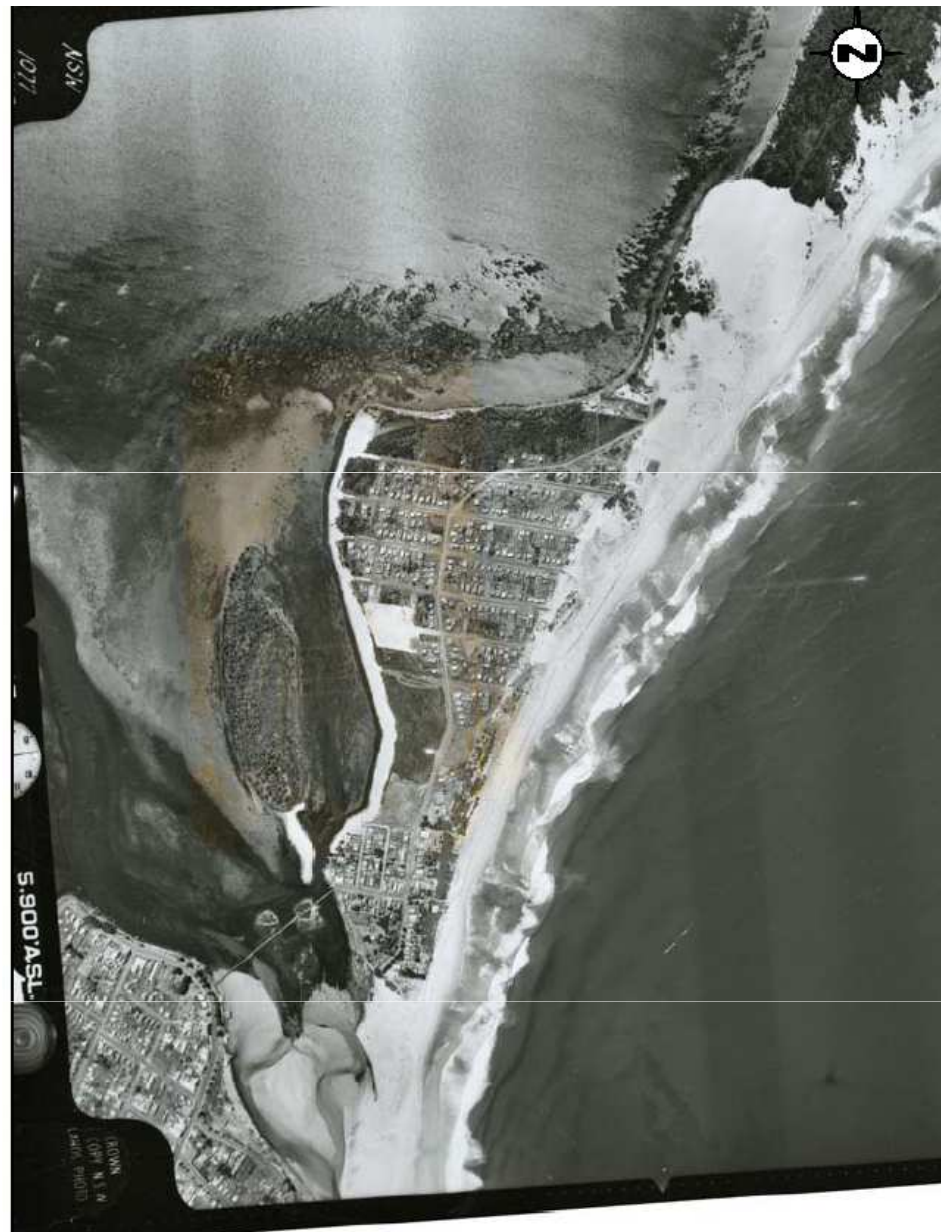
**1961**

- **New alignment of lake shore at North Entrance, with sea wall**
- **large bars in nearshore, storing sand; large rip cells off Hutton Rd and in front of blowout**

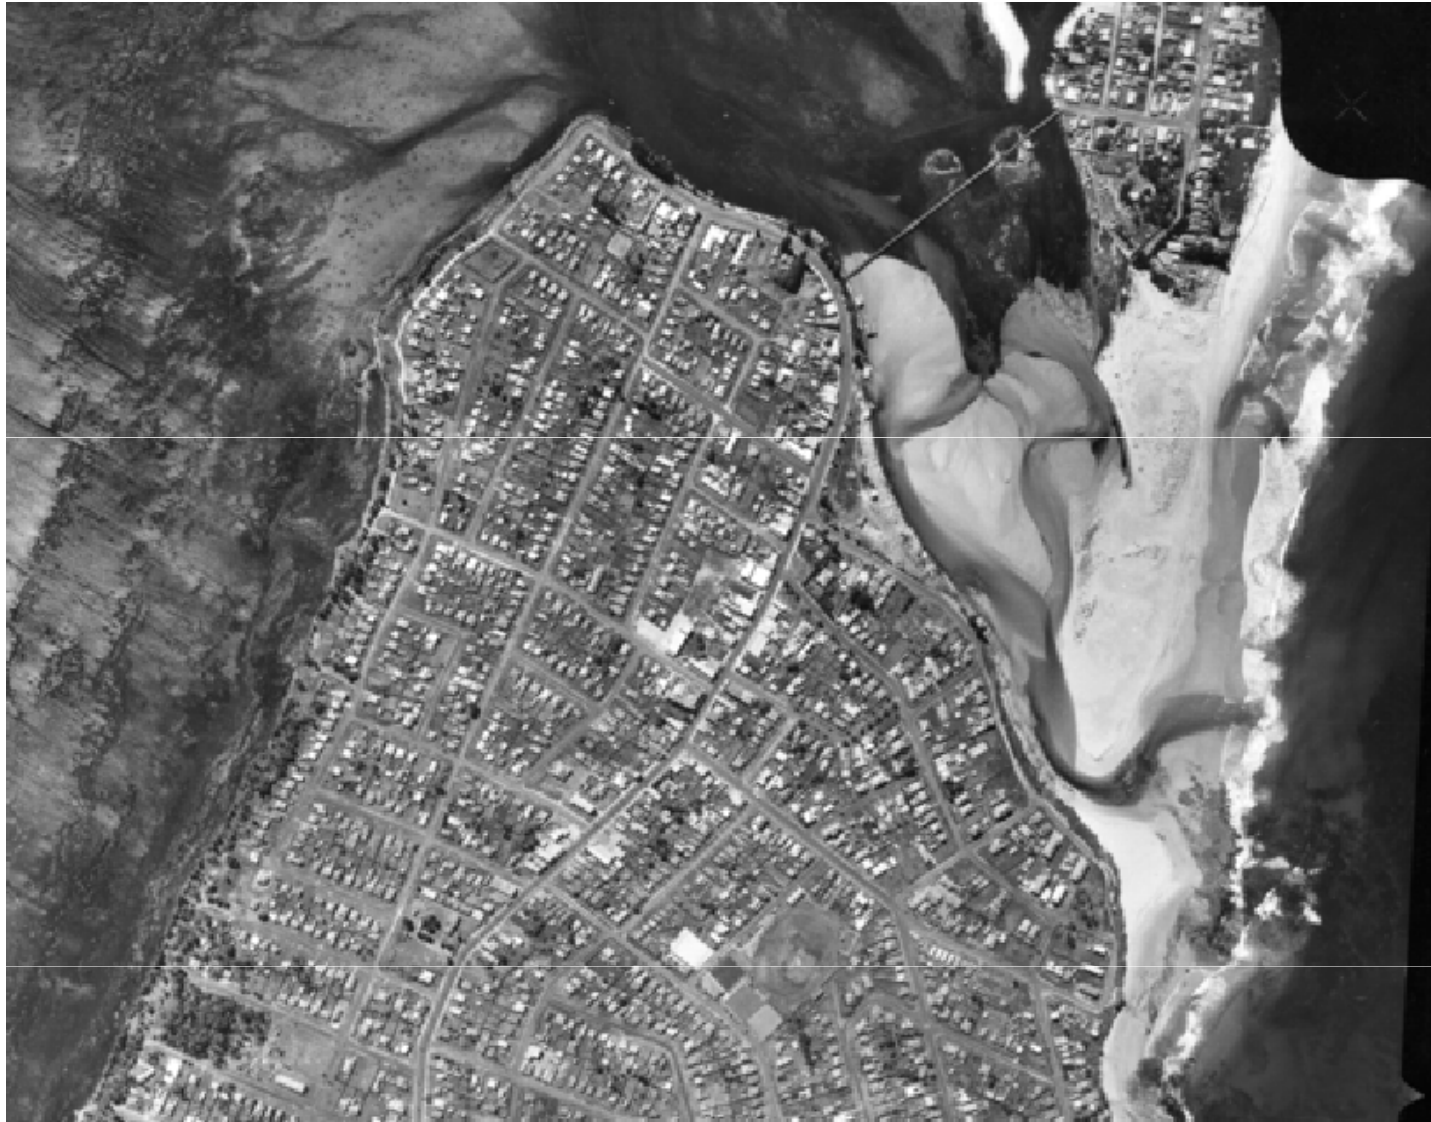
**1961**

- **Limited sand on The Entrance Beach; isolated from North Entrance by entrance channel**
- **Limited stabilisation of the sand spit across The Entrance - spinifex colonisation?**

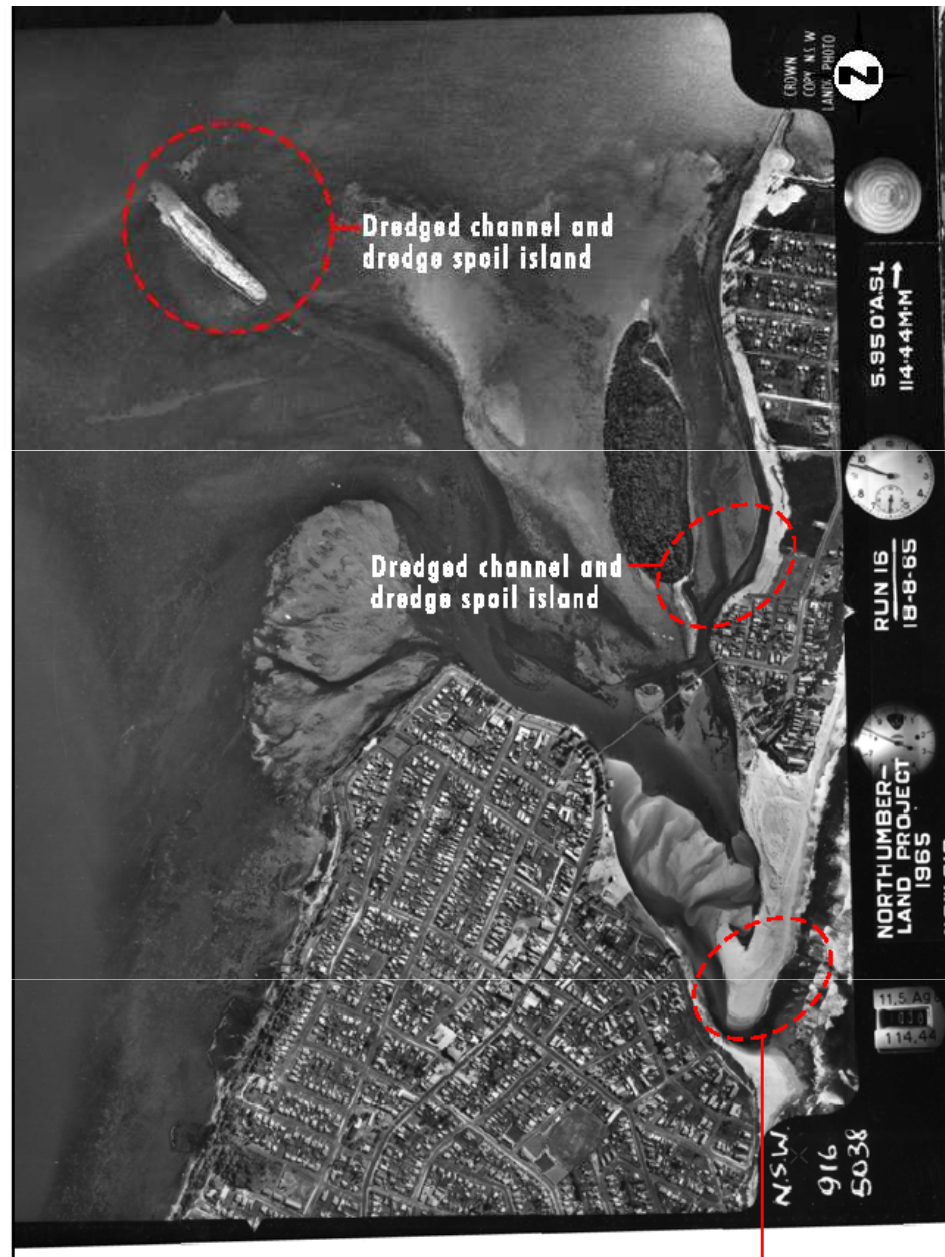
**1965**

- Entrance shoal and spit trimmed by migrating channel
- Many small beach cusps, reduced rip cell circulation

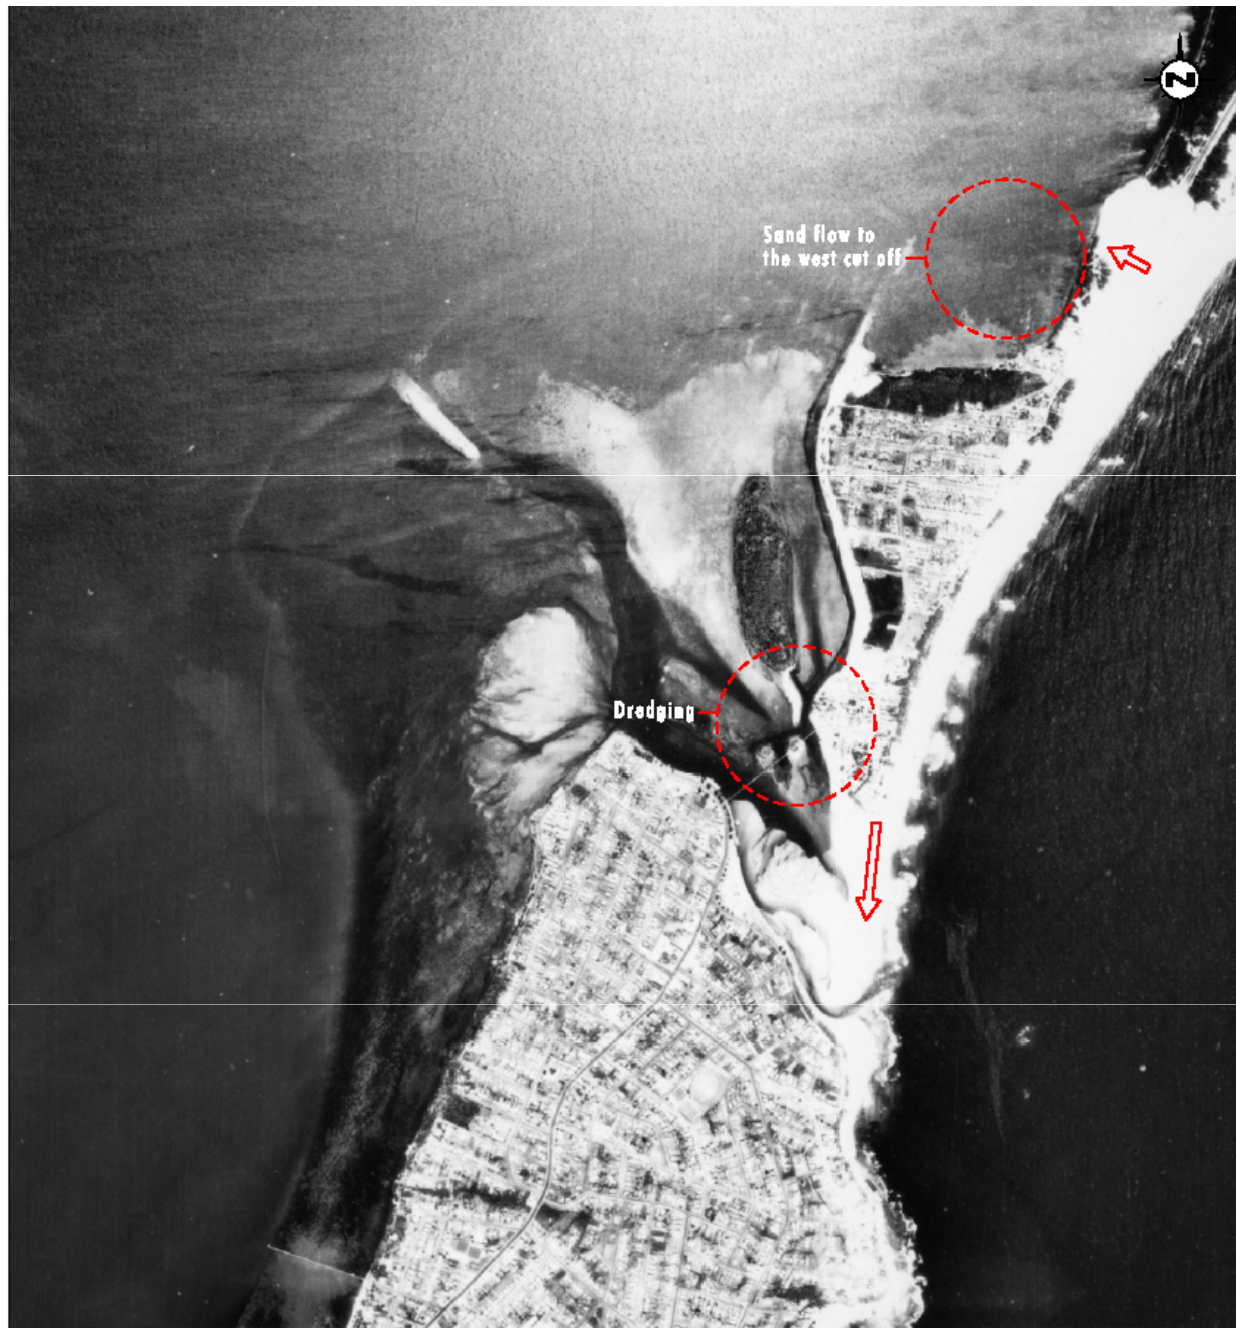
**1966**

- Dune blowout at North Entrance still active, diverting sand from the beach back to the lake shore
- Entrance channel almost closed, sand moving south along the southern part of North Entrance Beach and split, but limited transfer to The Entrance Beach

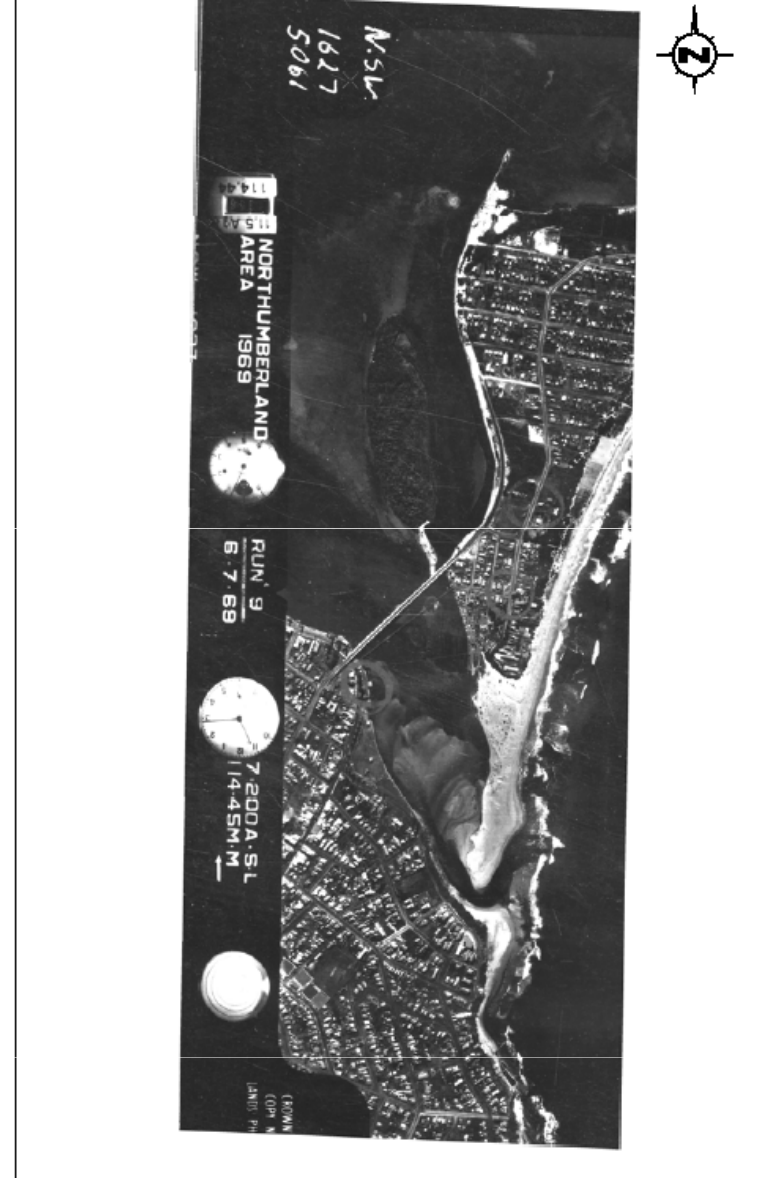
**1969**

- Entrance open with wide channel on southern side
- Erosion of shoals in outer tidal delta
- Reduced sand volume south of entrance channel
- Open channel trimming spit to north
- Closely spaced rip cells on southern part of beach. Many cusps in surf club area

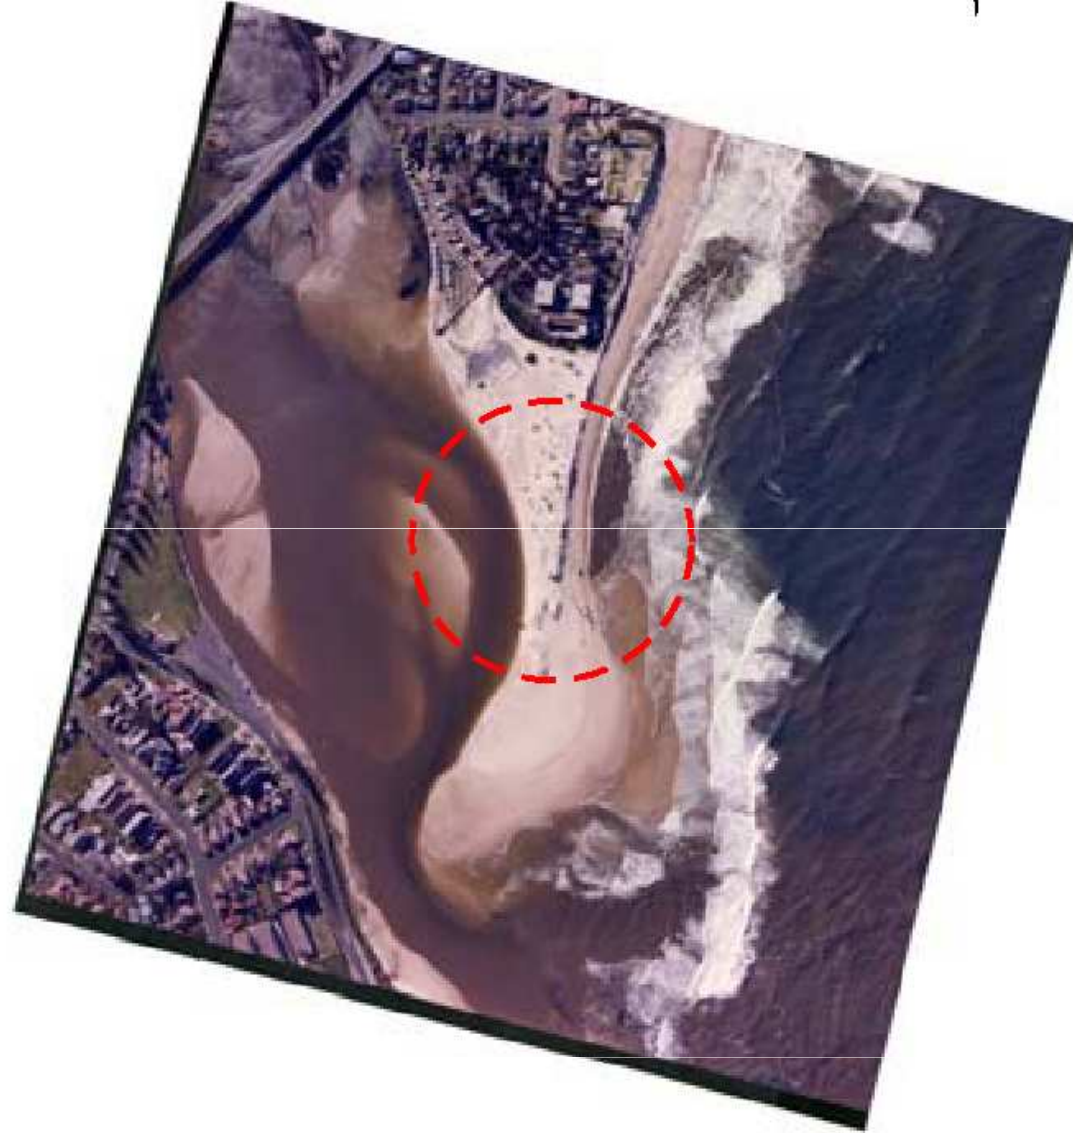
**1978**

- Entrance open with wide channel
- Sand spit severely depleted from entrance channel migration and storm bite into the frontal dune

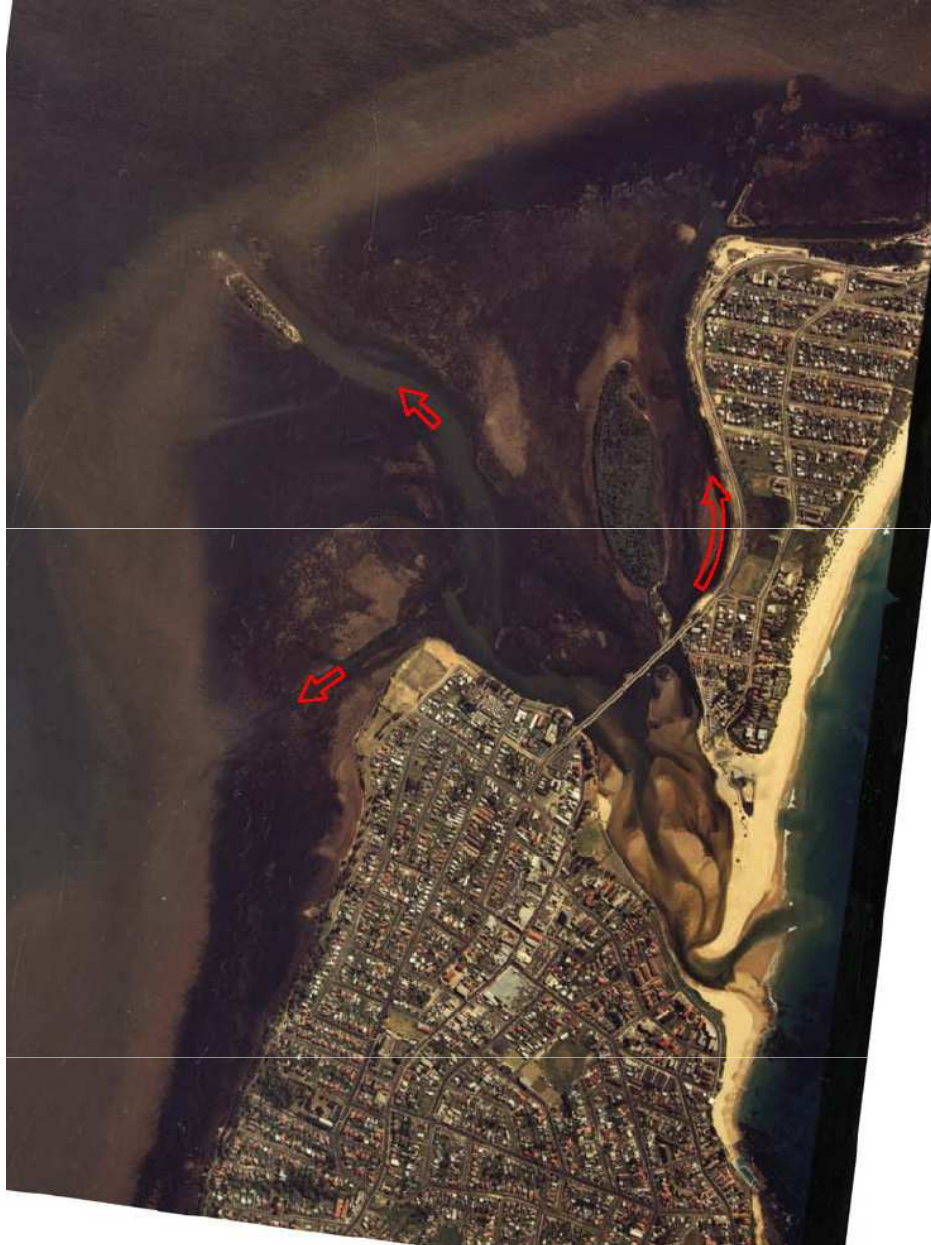
**1982**

- **Multiple dredged channels - outside and inside the bridge**
- **Accretion on ocean side of the entrance spit. Some recovery of shoaling in the entrance outside of the bridge**
- **The Entrance Beach in accreted condition**

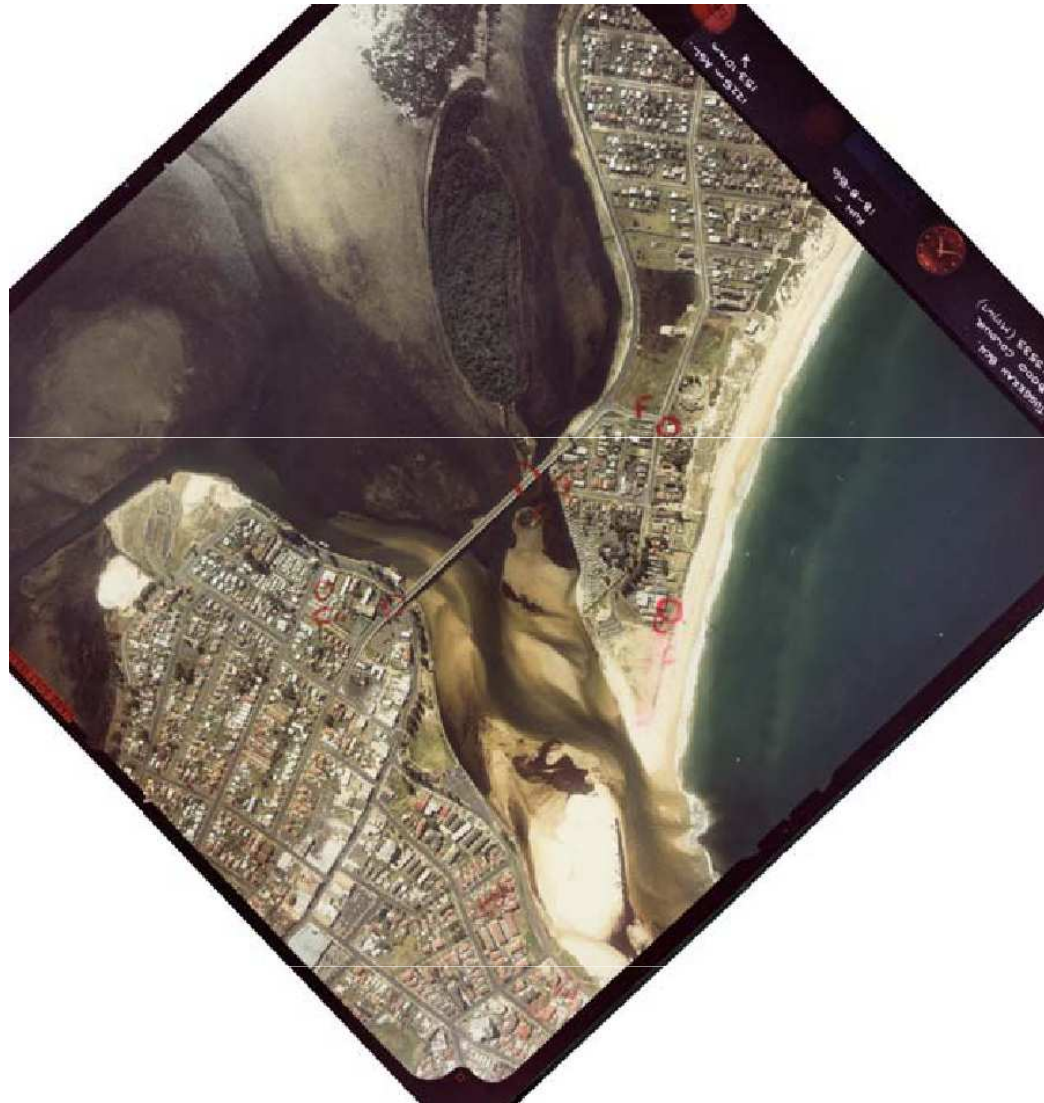
## **1986**

- **Entrance channel broken through on northern side of spit, isolating the southern entrance shore and The Entrance Beach from the main beach**
- **Reclamation and further dredging on western shore, inside the bridge reclamation**

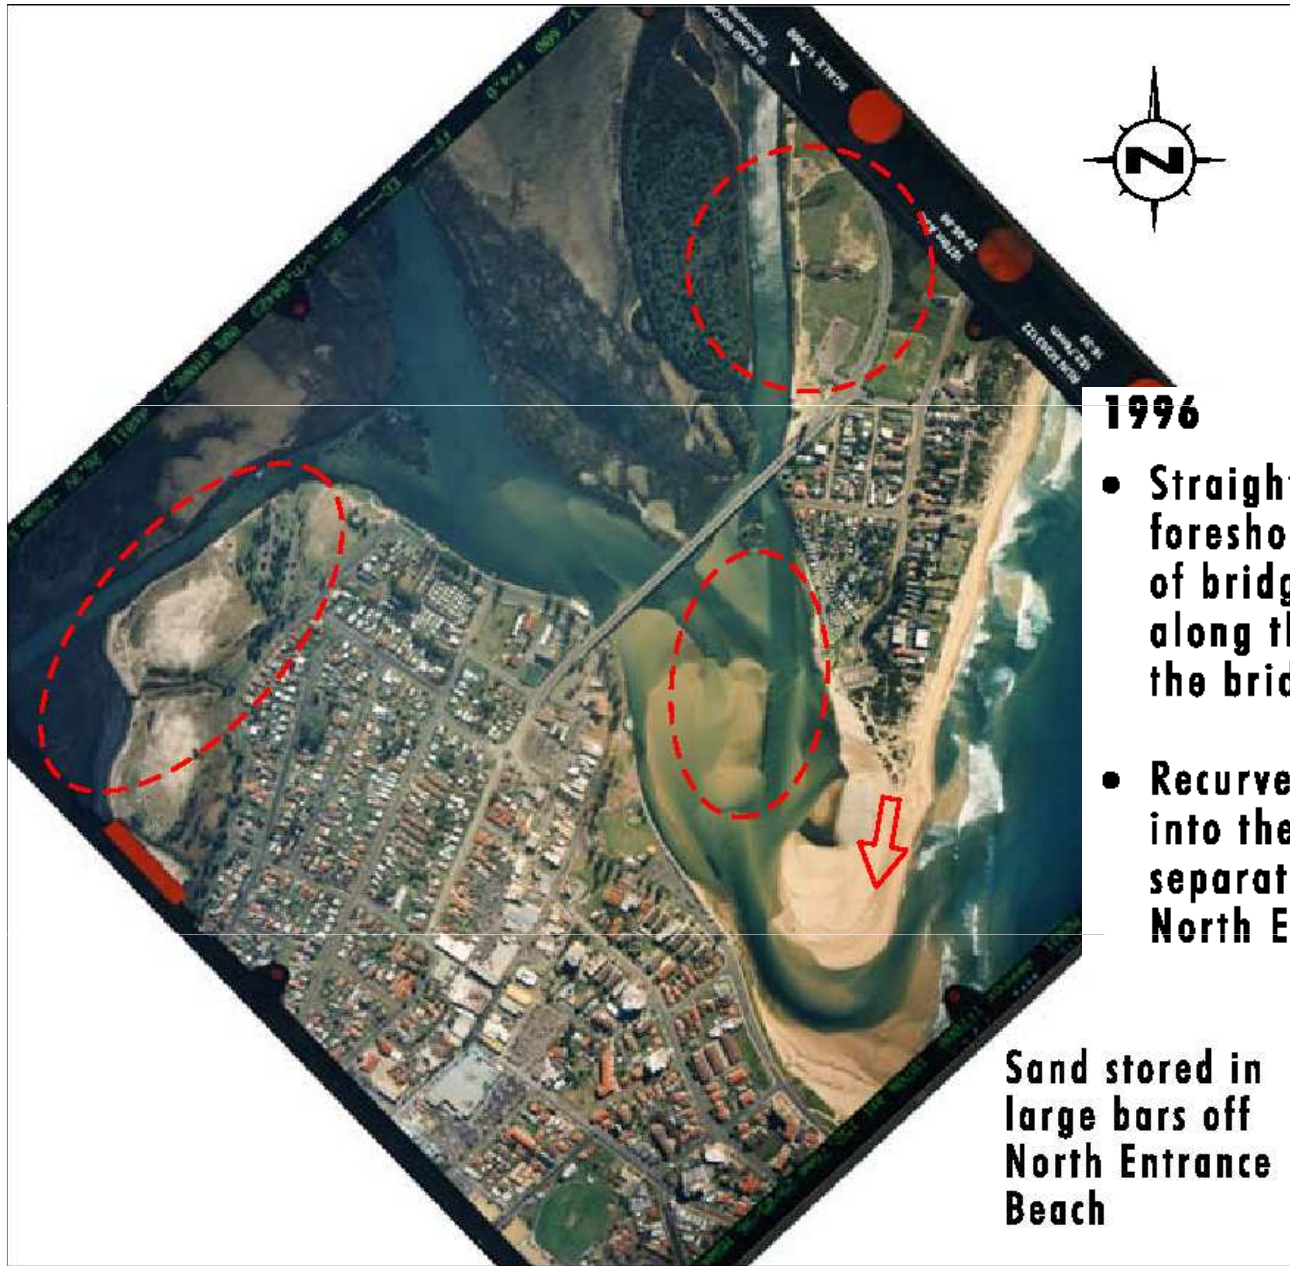
**1996**

- Straightening and reclamation of lake foreshore and channel dredging to north of bridge, in outer entrance area, and along the western foreshore inside the bridge
- Recurve on spit shows sand moving south and into the entrance. Wide curved entrance channel separates an accreted Entrance Beach from North Entrance

**Sand stored in large bars off North Entrance Beach**

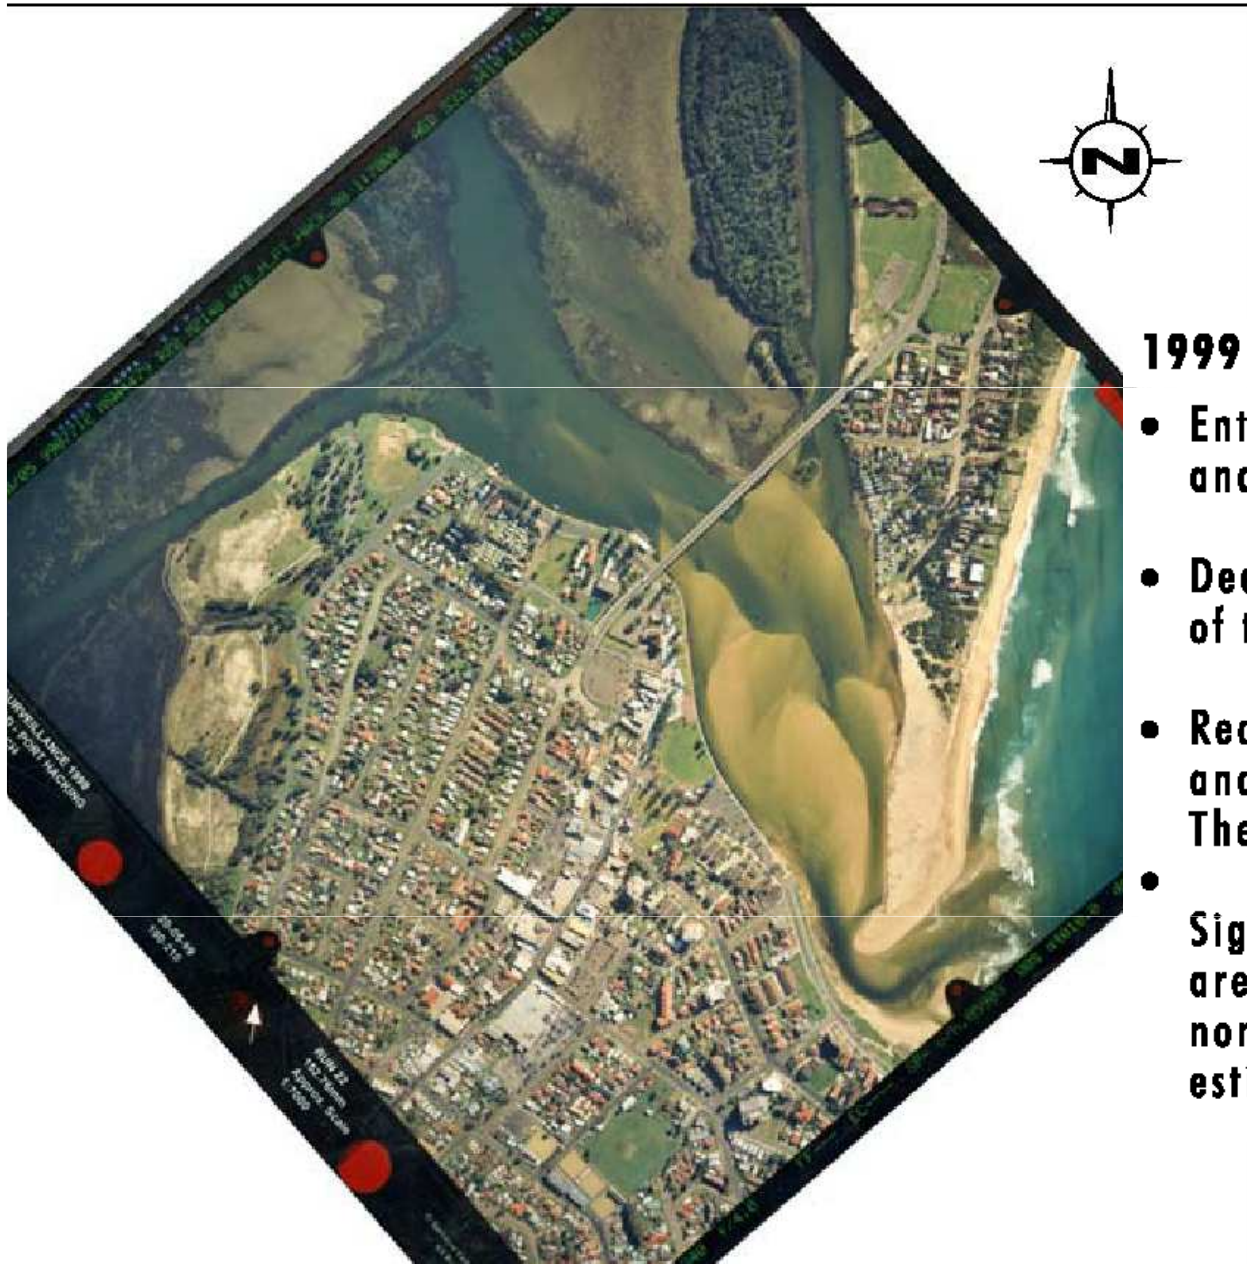
**1999**

- Entrance almost closed, with straight spit and widespread shoaling in the outer entrance
- Deep channels (dredged) control flows upstream of the bridge
- Reduced sand volumes on The Entrance Beach and North Entrance Bench sand has moved into The Entrance
- Significant volume of sand from the tidal delta are locked into the reclaimed foreshores to the north east and west of the entrance (minimum estimate  $\sim 200,000\text{m}^3$ )

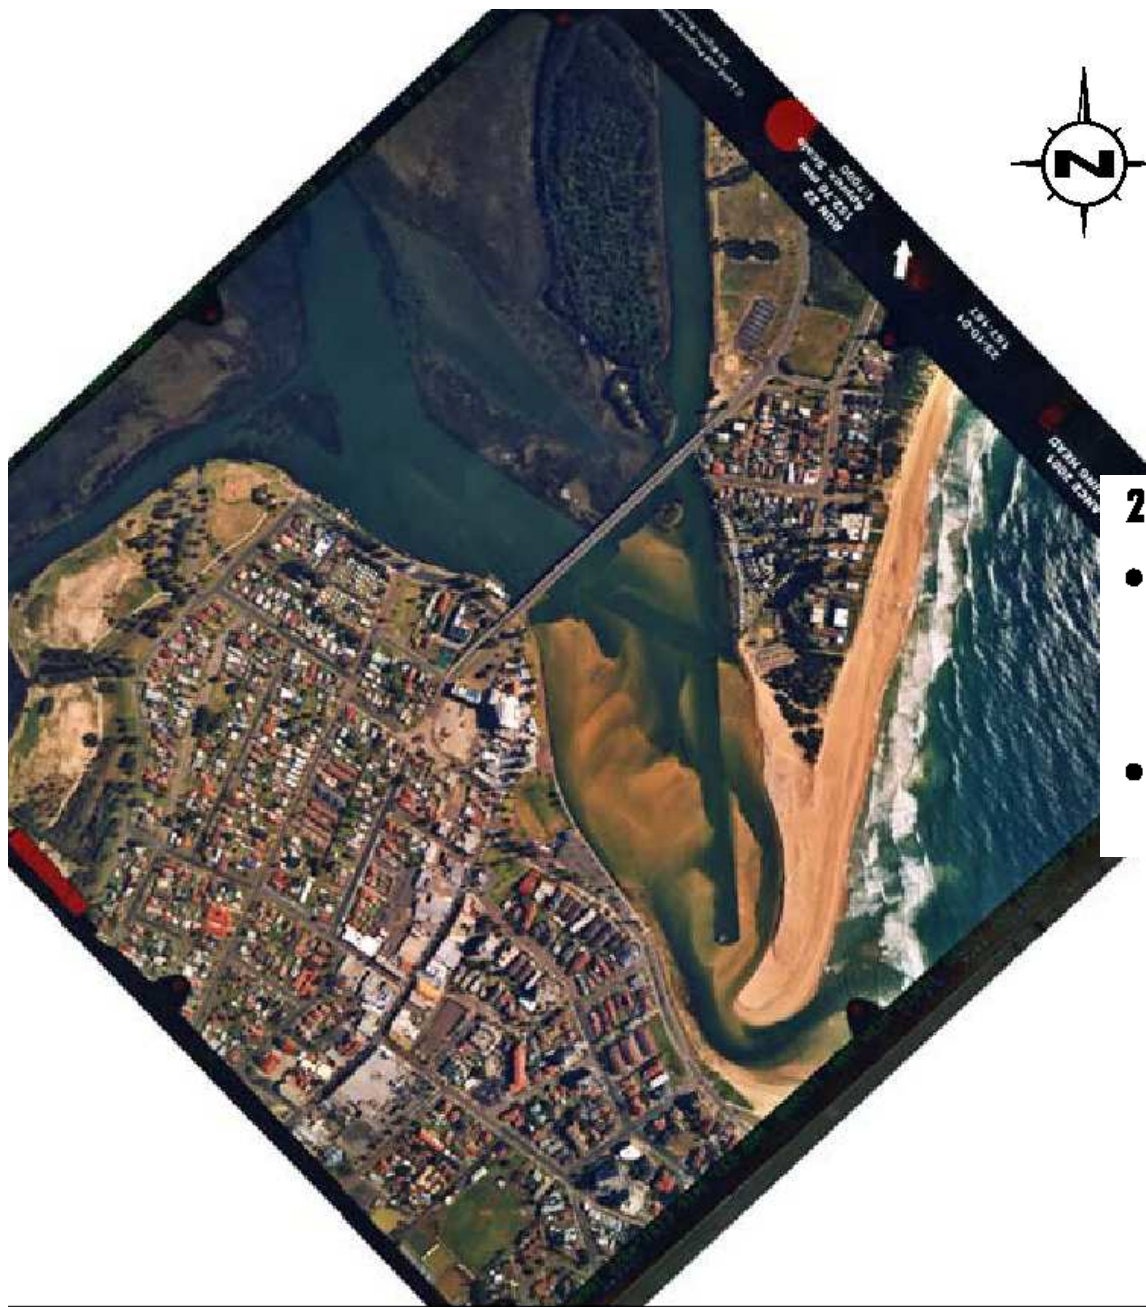
### **2001**

- Dredged channels in outer entrance area have reduced shoaling. North Entrance Beach accreted
- Reclaimed areas and dredged channels control flows and sediment movement inside the bridge

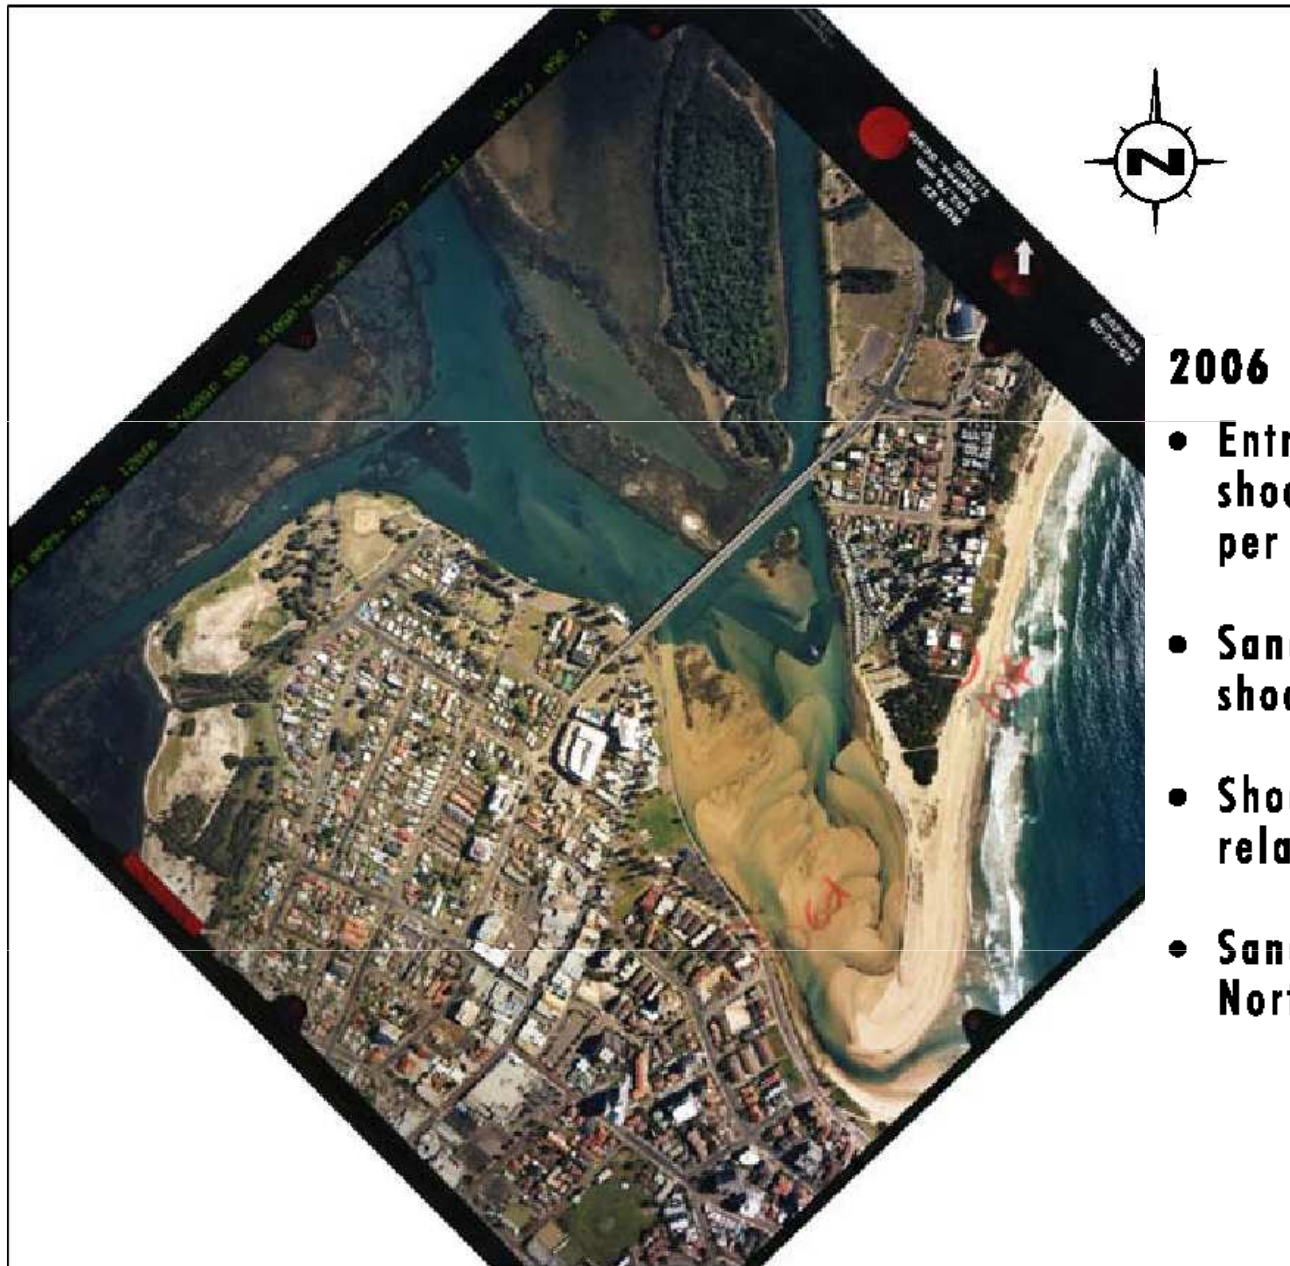
**2006**

- Entrance almost closed and channels heavily shoaled. North Entrance Beach is narrow (as per 1999)
- Sand volume stored in the spit and entrance shoals
- Shoal areas inside bridge vegetated and relatively stable
- Sand also accumulating in nearshore area of North Entrance Beach
