Breakwaters & Training Walls

The good, the bad and the ugly

Lex Nielsen, Principal Consultant, Advisian

November 2016

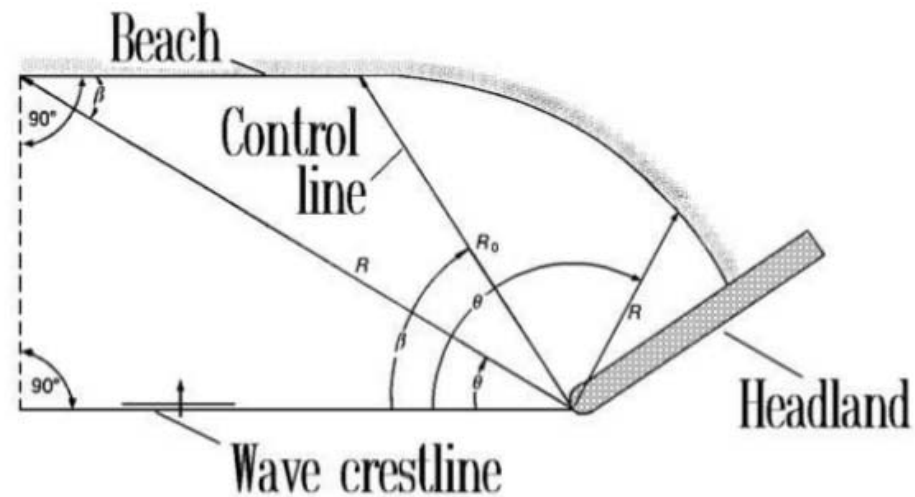
Mobile bed scale modelling is used to predict future stable shoreline accurately (e.g. Brunei scale modelling by Angus Gordon)

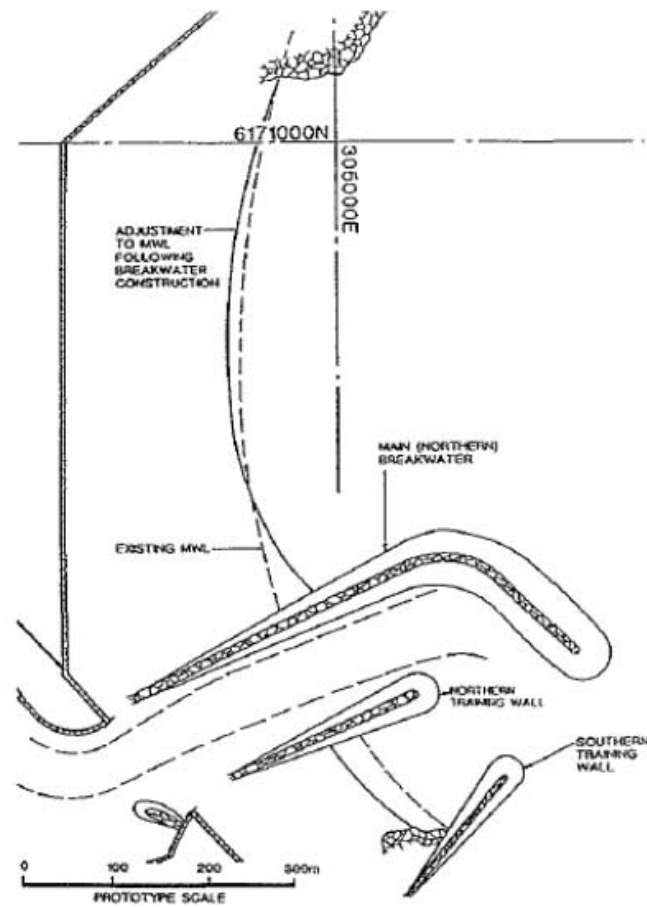
Mobile bed scale models study the impact of breakwaters on beach alignment

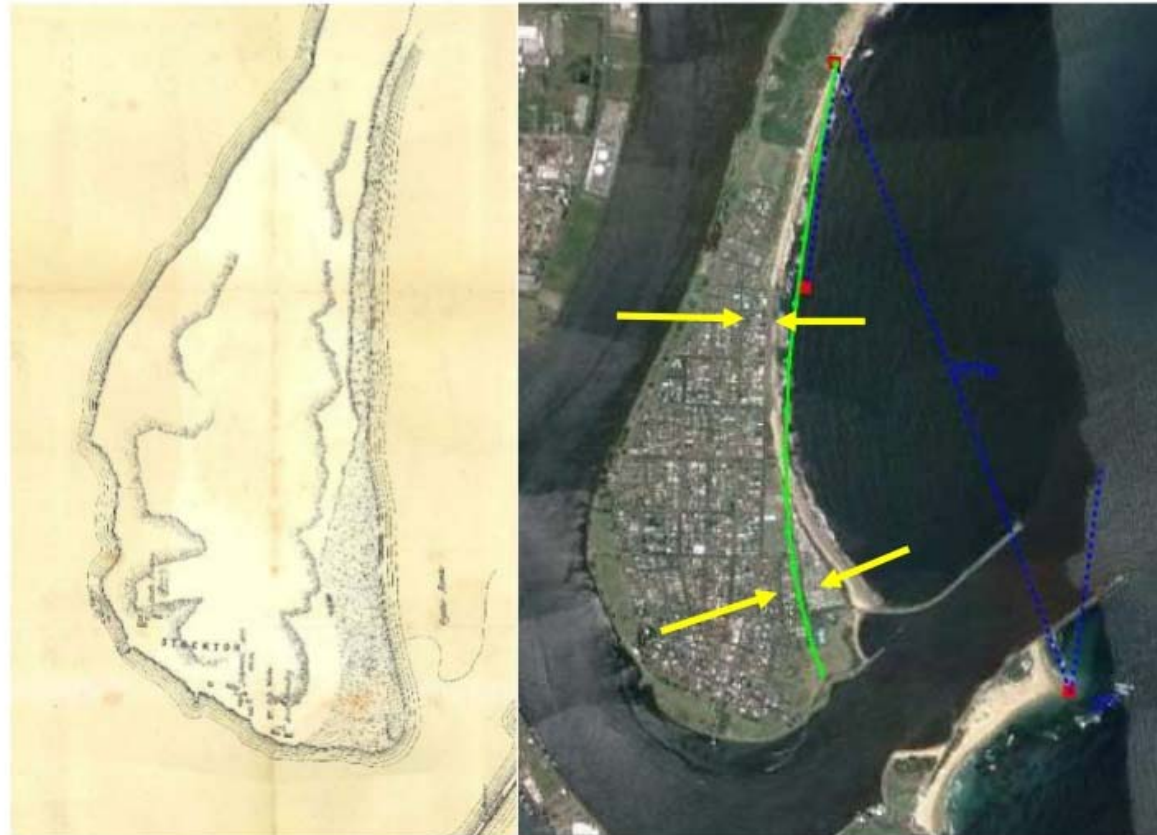
Computer model study of Stockton Beach Newcastle

The northern Hunter River breakwater had a significant impact on the shoreline at Stockton:

- Cut off the flood tide channel that had run along the beach and into the entrance - removing the entrance bar and accretion of sand
- Induced erosion to the north as the shoreline responded to the changed tidal flow and wave conditions

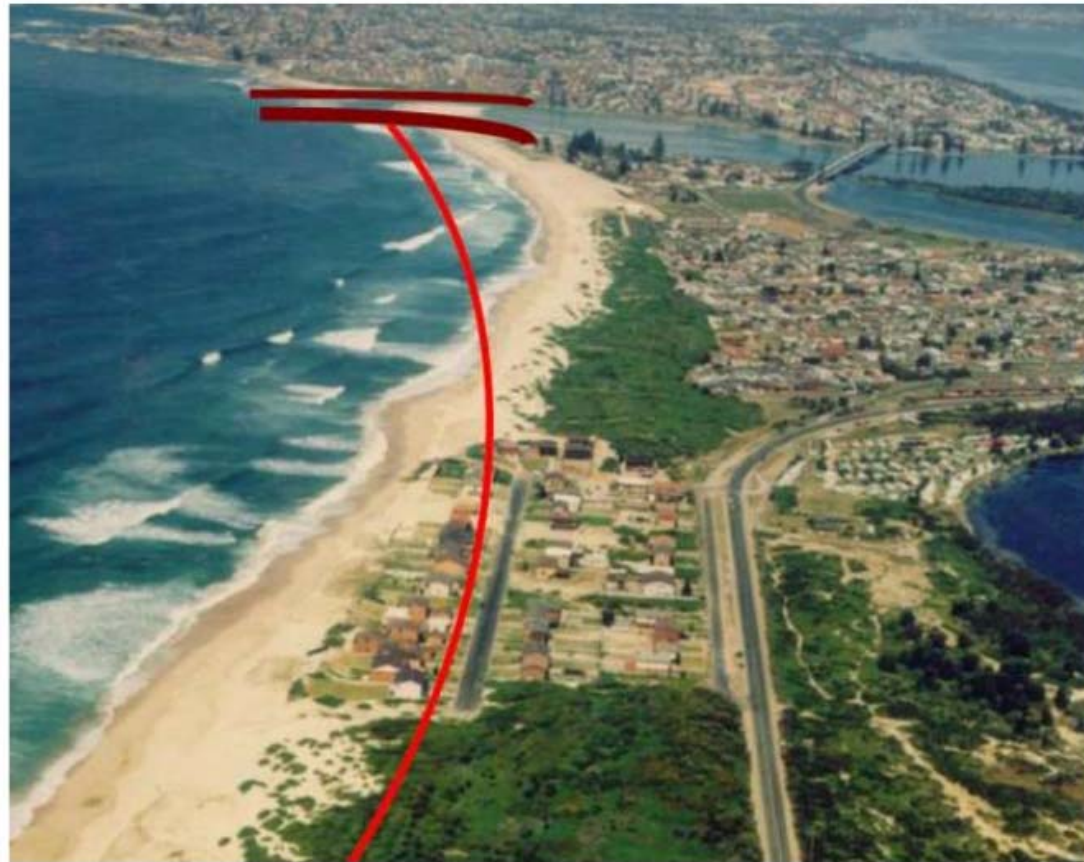
Similar could occur if breakwater are constructed at The Entrance on the NSW Central Coast

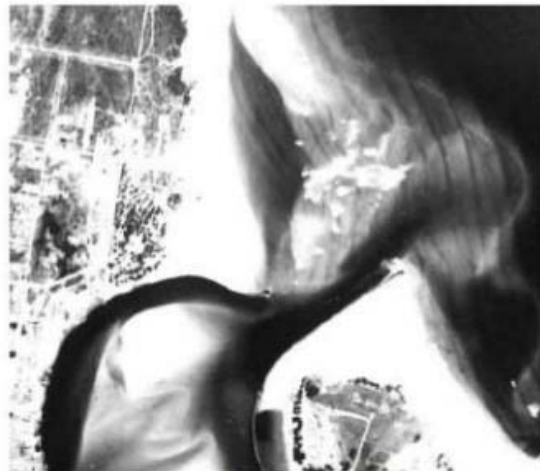
Wallis Lake Inlet 1952 (Photograph courtesy NSW Governm

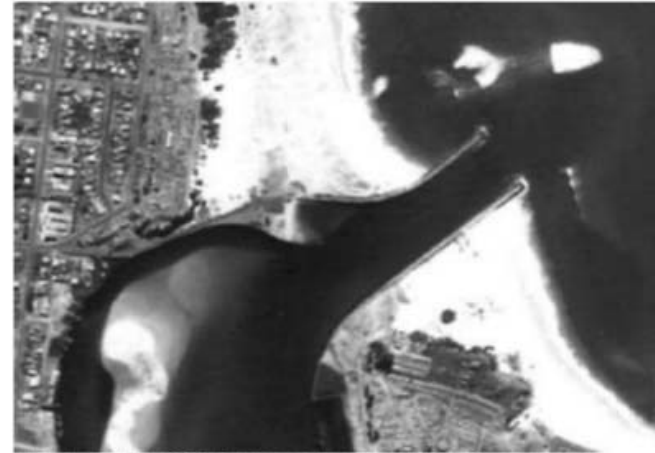
Wallis Lake Inlet 1974 (Photograph courtesy NSW Government)

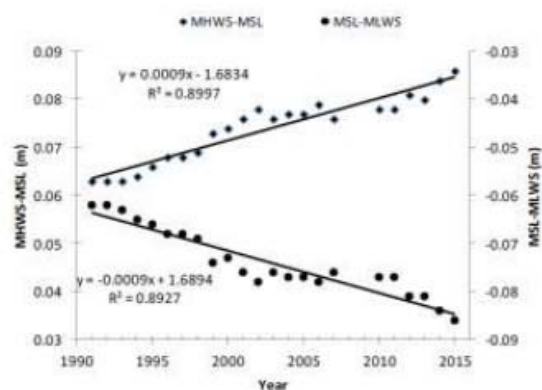
(a) Wallis Lake

The construction of entrance breakwaters on Wallis Lake, Lake Macquarie, Lake Illawarra and Lake Wagonga has triggered unstable scouring modes at these estuary entrance channels.

High water levels are increasing while low water levels are decreasing (note various scales).

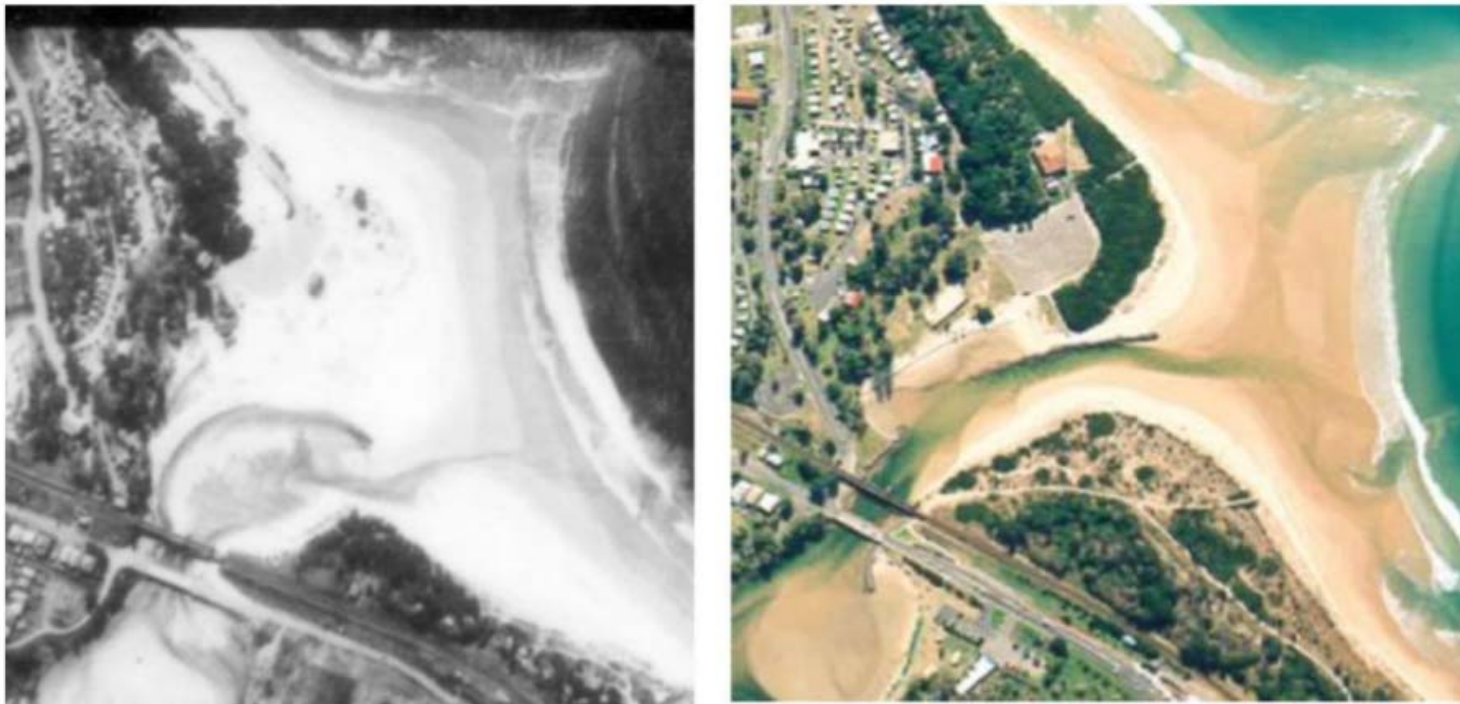
Figure 8. Coffs Creek entrance 1969 (left) and 1996 (right) © NSW Land Information Centre

A rock training wall was constructed on the northern bank of the Coffs Creek entrance changed an ICOLL (Intermittently Closed and Open Lakes and Lagoons) to a permanently open estuary.

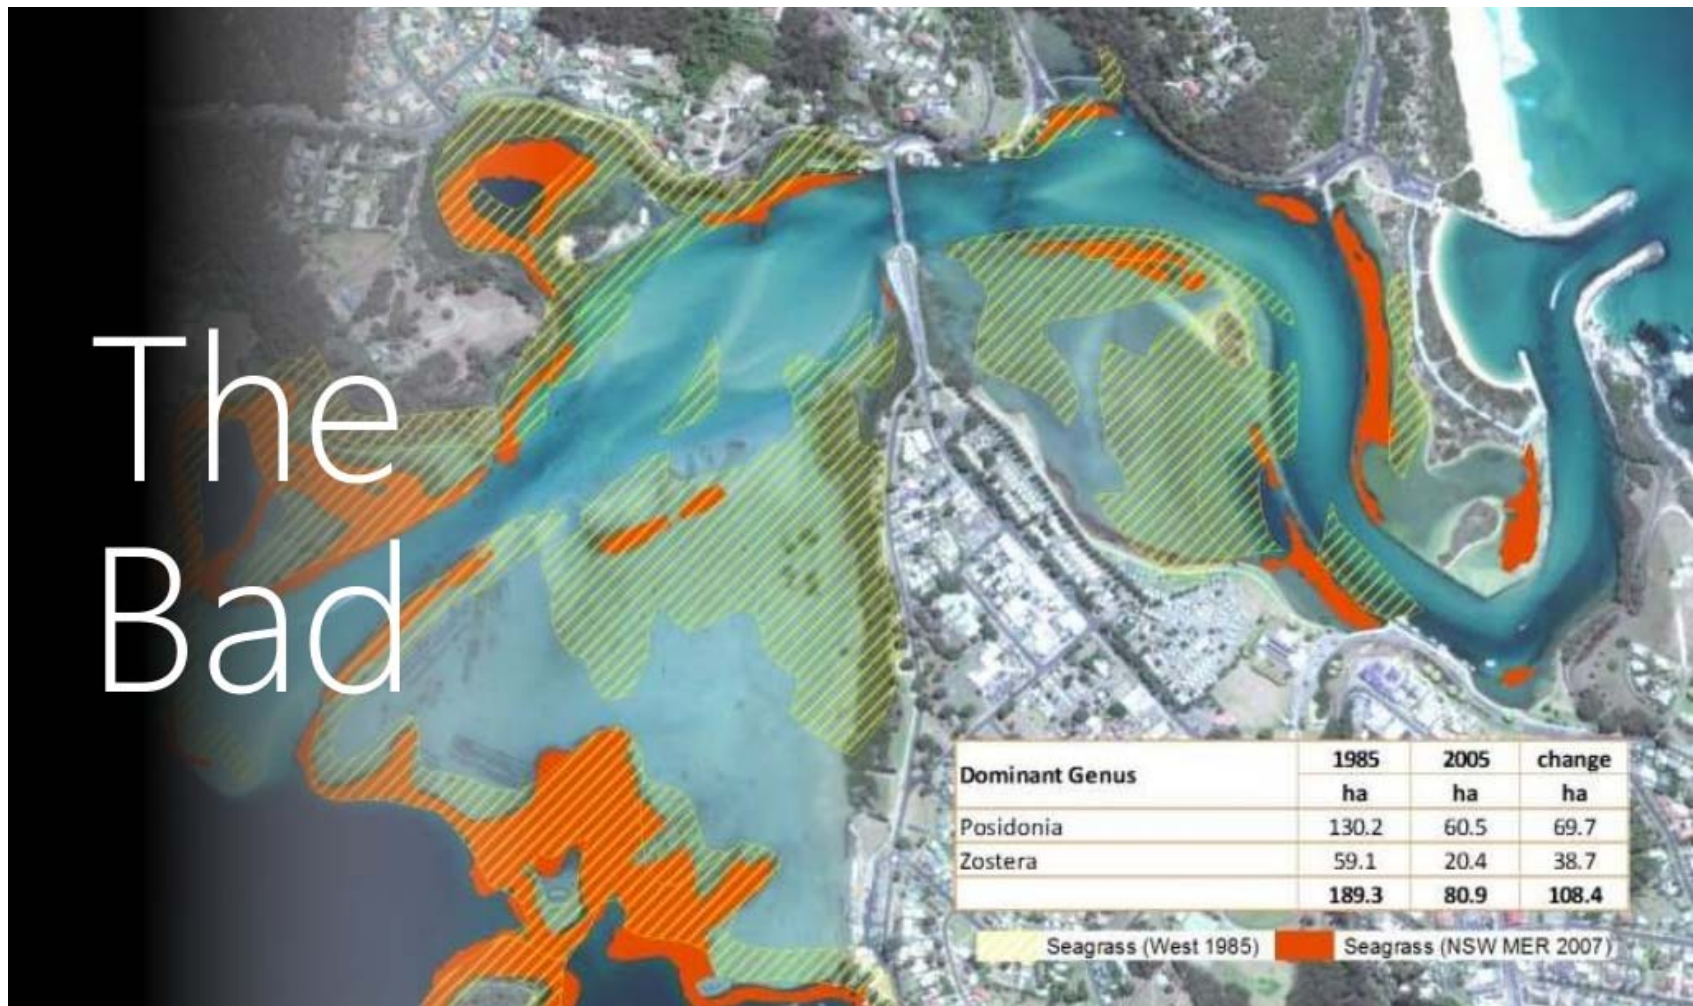
Channel scour has removed seagrass and sand transport into the lakes as flood tide delta growth has smothered seagrass

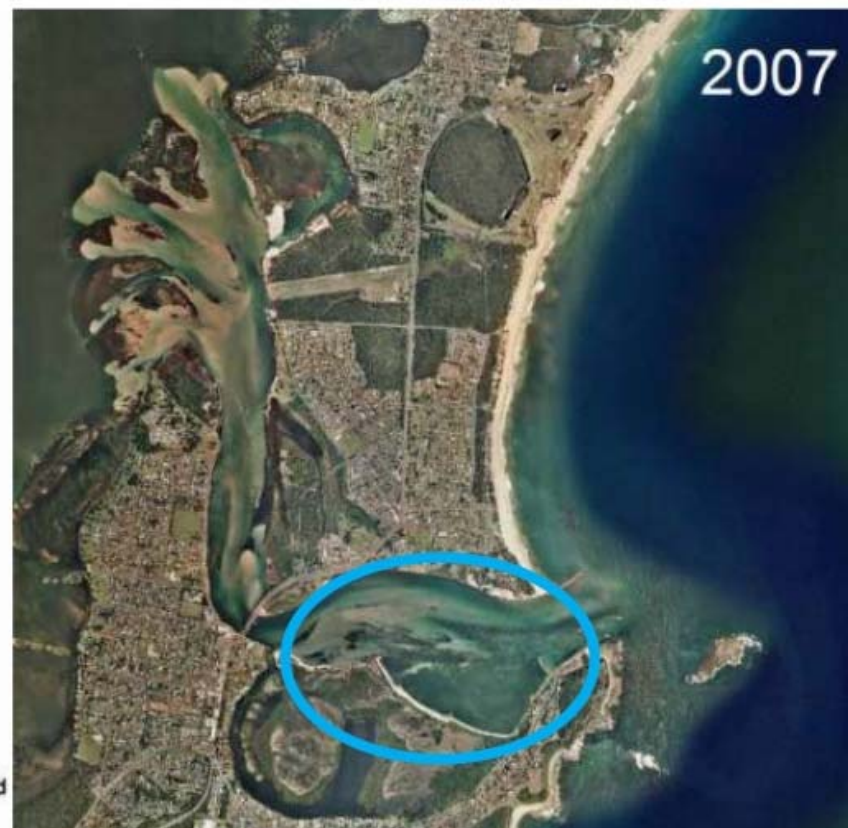
Wetland areas have been eroded (e.g. Lake Macquarie)

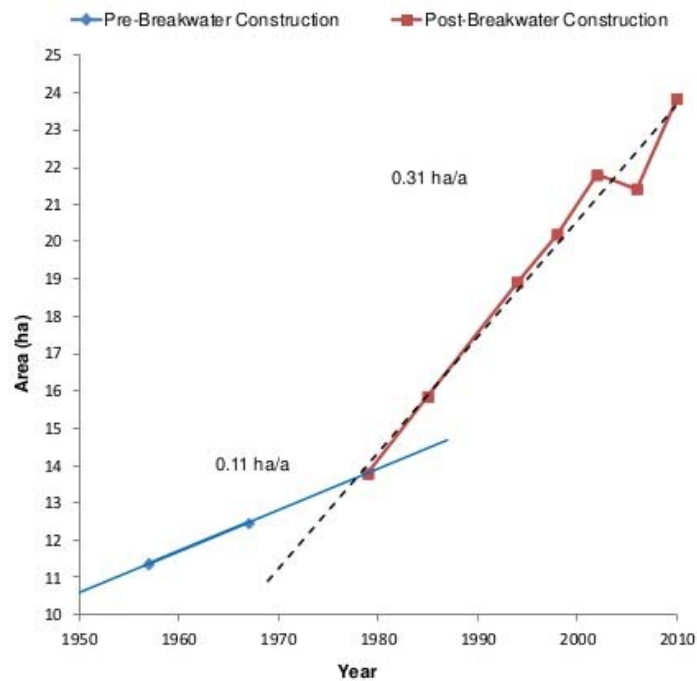
Mangrove Increase

Changing tidal planes have increased the rates of mangrove colonisation and salt marsh loss (e.g. Lake Wagonga).

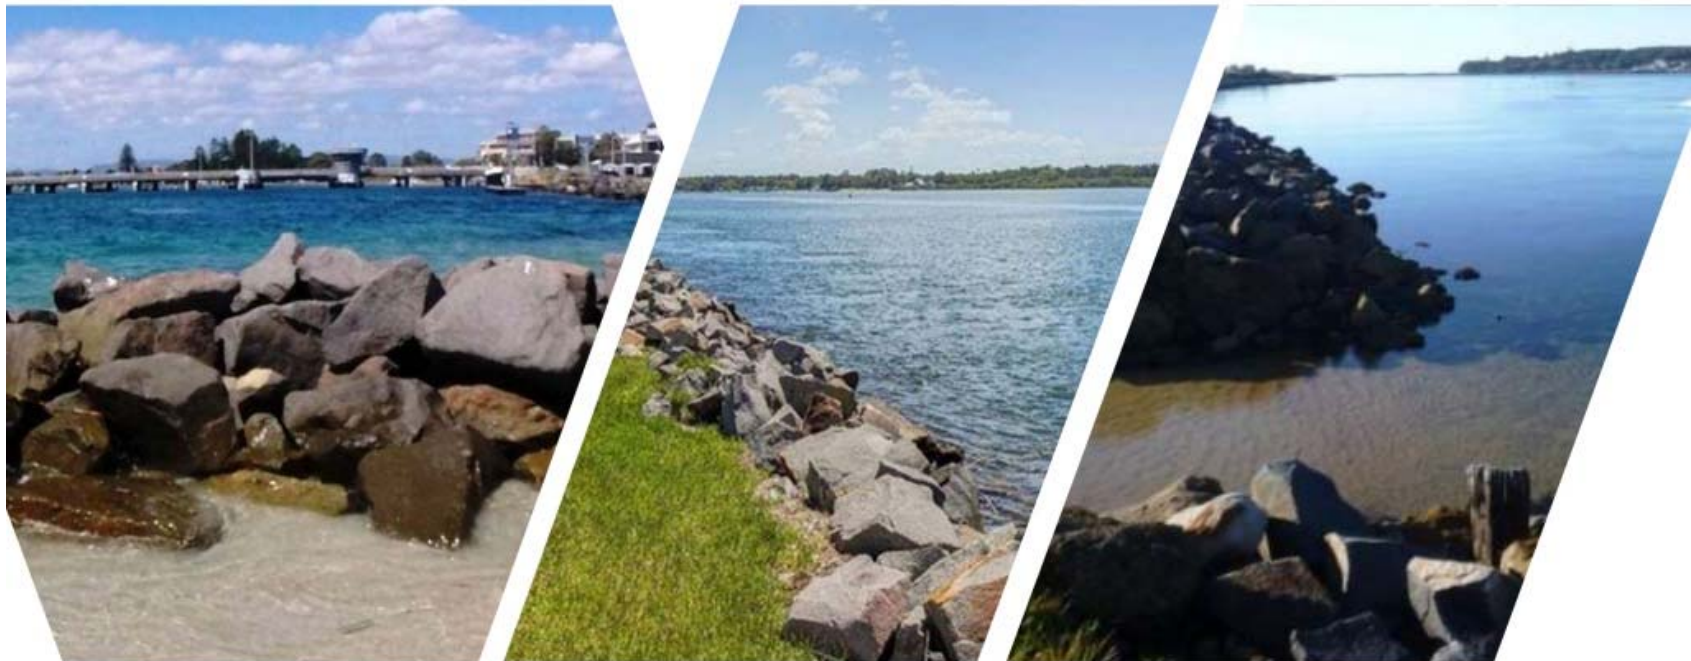
Channel scour has necessitated rock works along the banks (e.g. Lake Macquarie, Lake Wagonga).

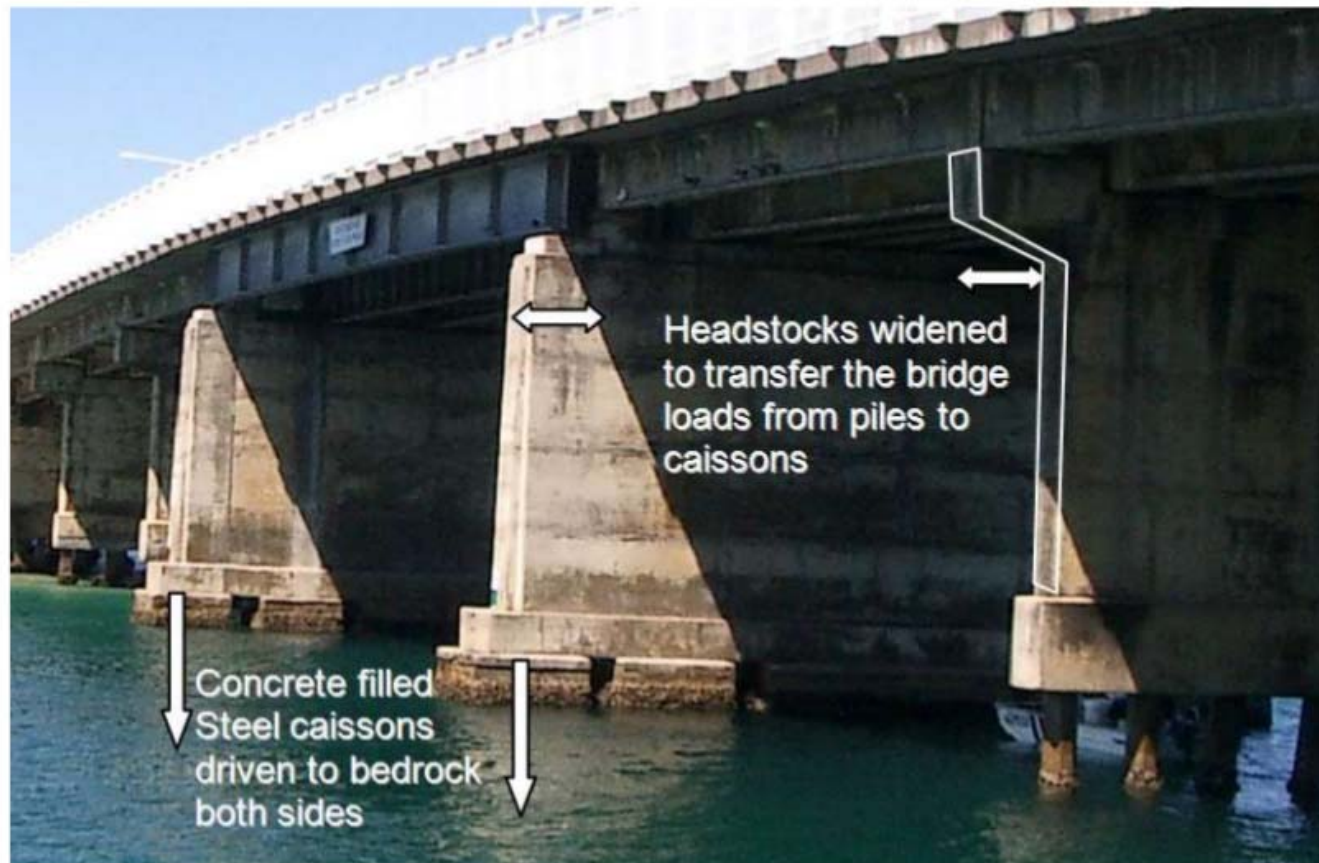
Channel scour has necessitated expensive bridge foundation works
(e.g. Wallis Lake)

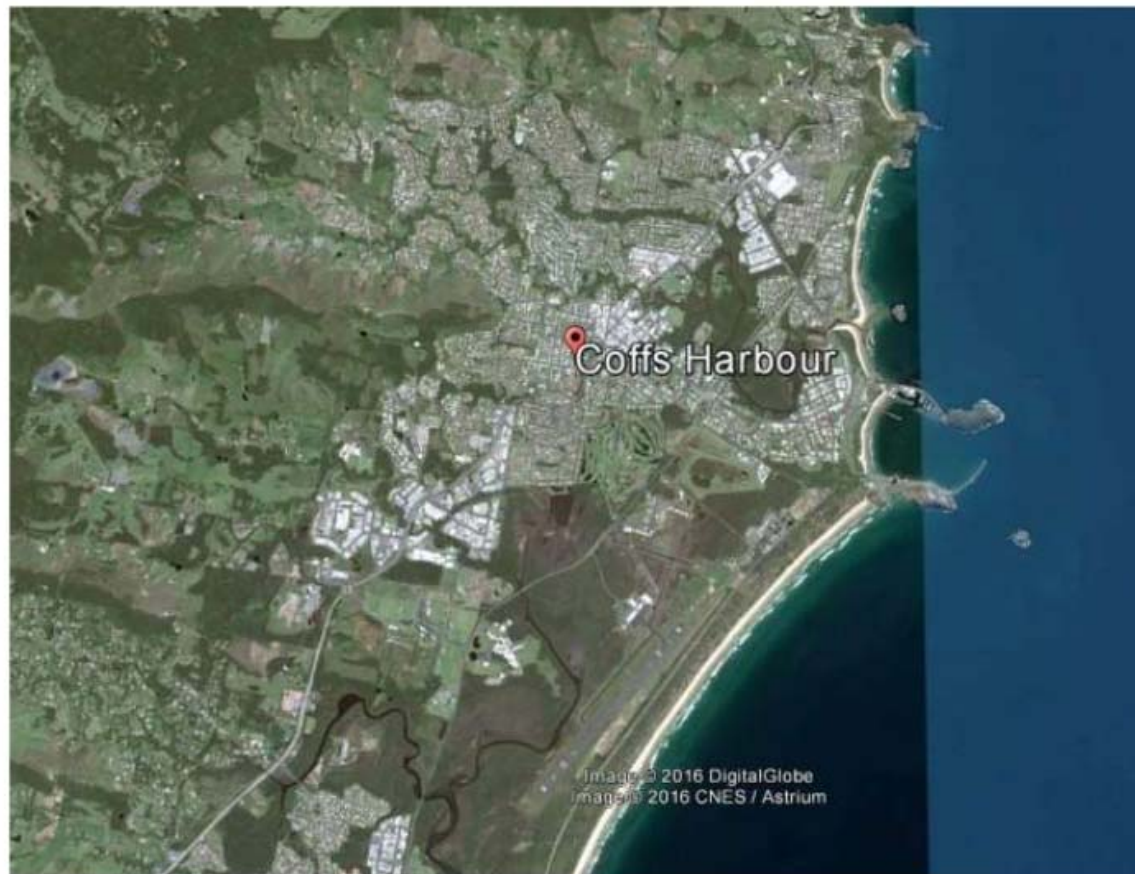
Coastal littoral drift has been interrupted (e.g. Coffs Harbour), harbour siltation.

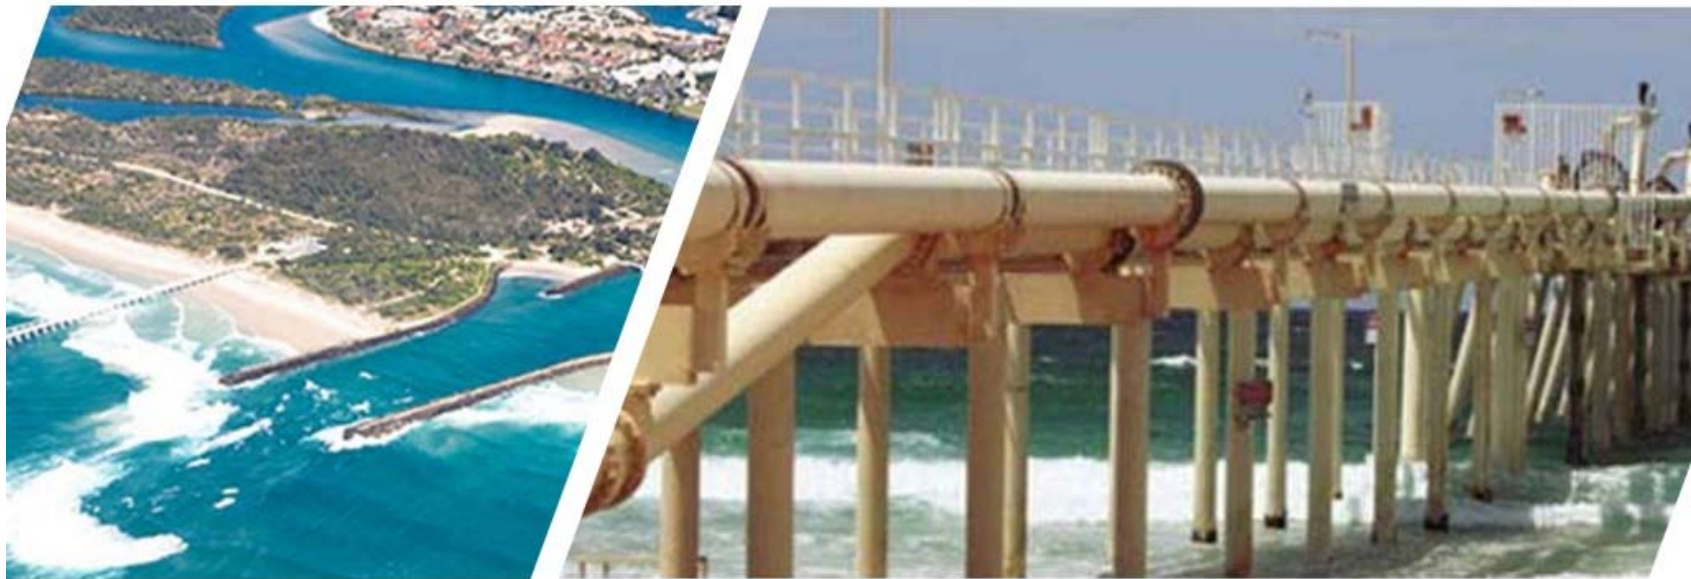
Expensive capital works have been necessary to reinstate beaches that have eroded as a consequence of breakwater construction (e.g. Tweed River)

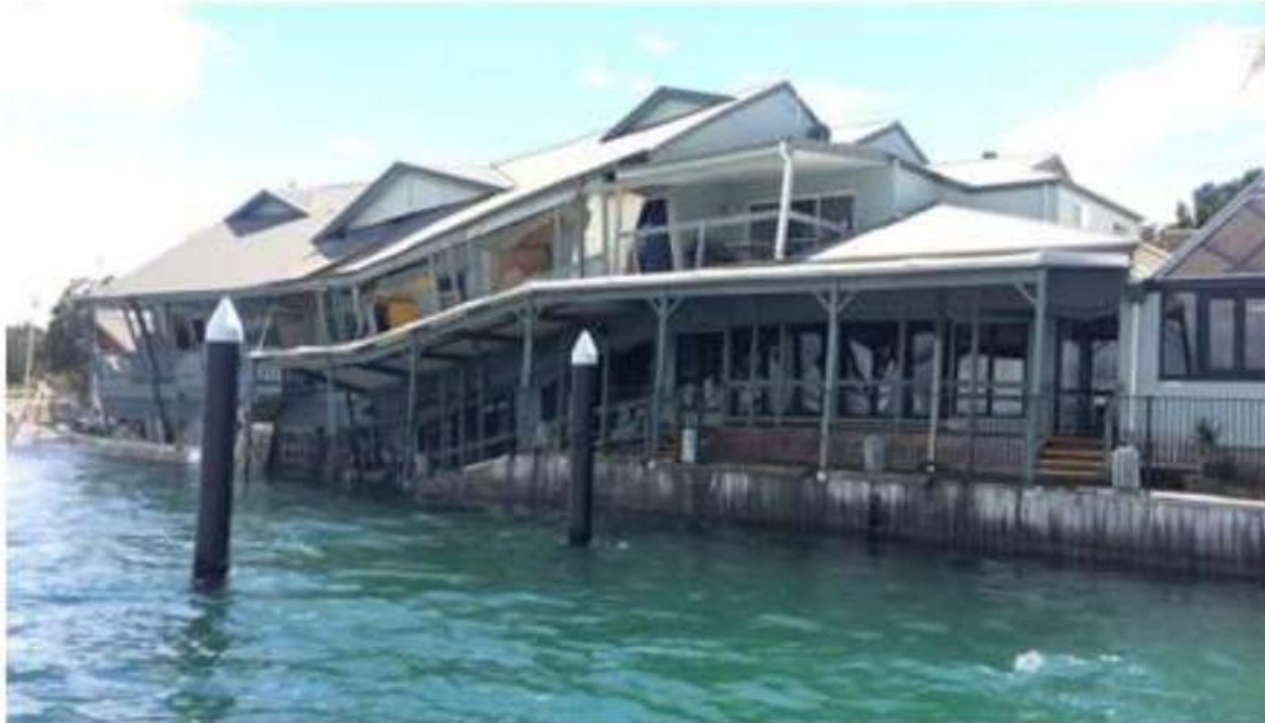
Channel scour has resulted in the total collapse of some foreshore buildings and undermined bridge foundations as well as undermining river training works (e.g. Swansea Channel Lake Macquarie)

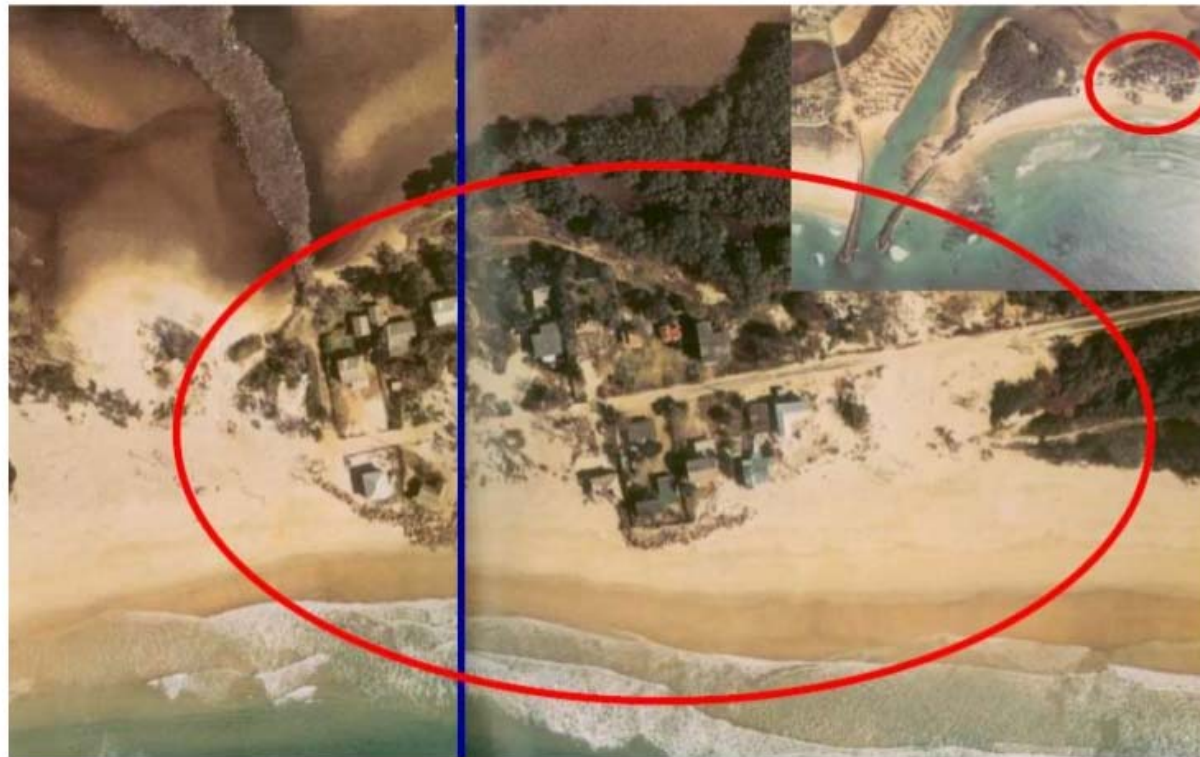
Breakwaters have re-aligned the foreshore causing beach erosion, loss of residential development and other infrastructure (e.g. loss of the entire village of Sheltering Palms at Brunswick Heads)

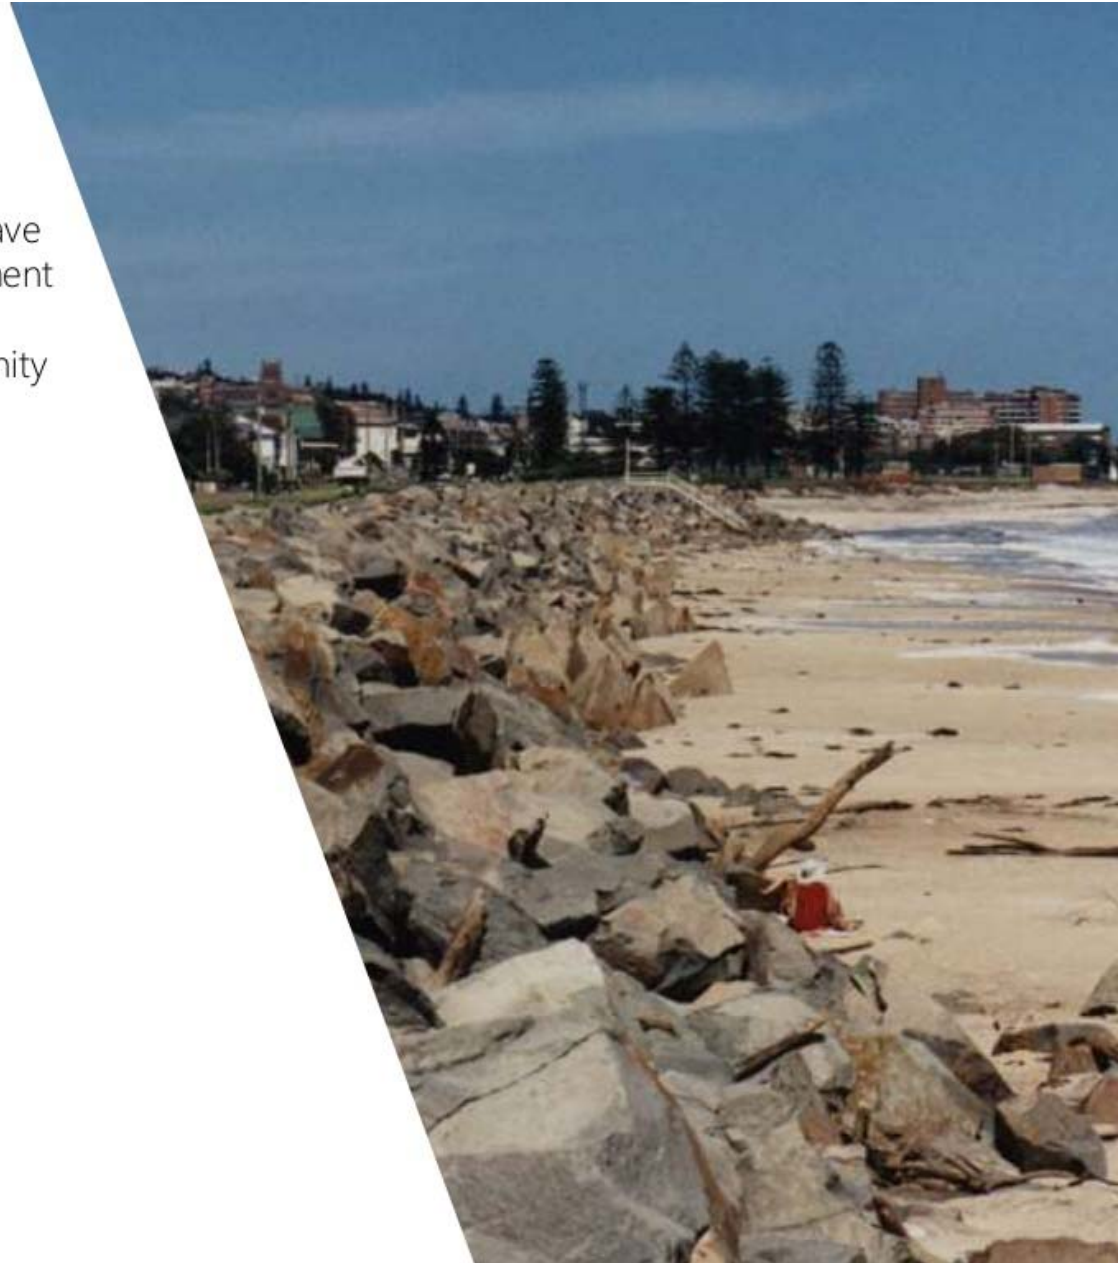
Breakwaters causing erosion have sometimes necessitated revetment construction to limit erosion thereby destroying beach amenity (e.g. Stockton Beach at Hunter River Newcastle).
