Breakwaters and training walls: the good, the bad and the ugly

Across the eastern seaboard of Australia, breakwaters and training walls have instigated fundamental perturbations to coastal and estuary processes.

by Lex Nielsen

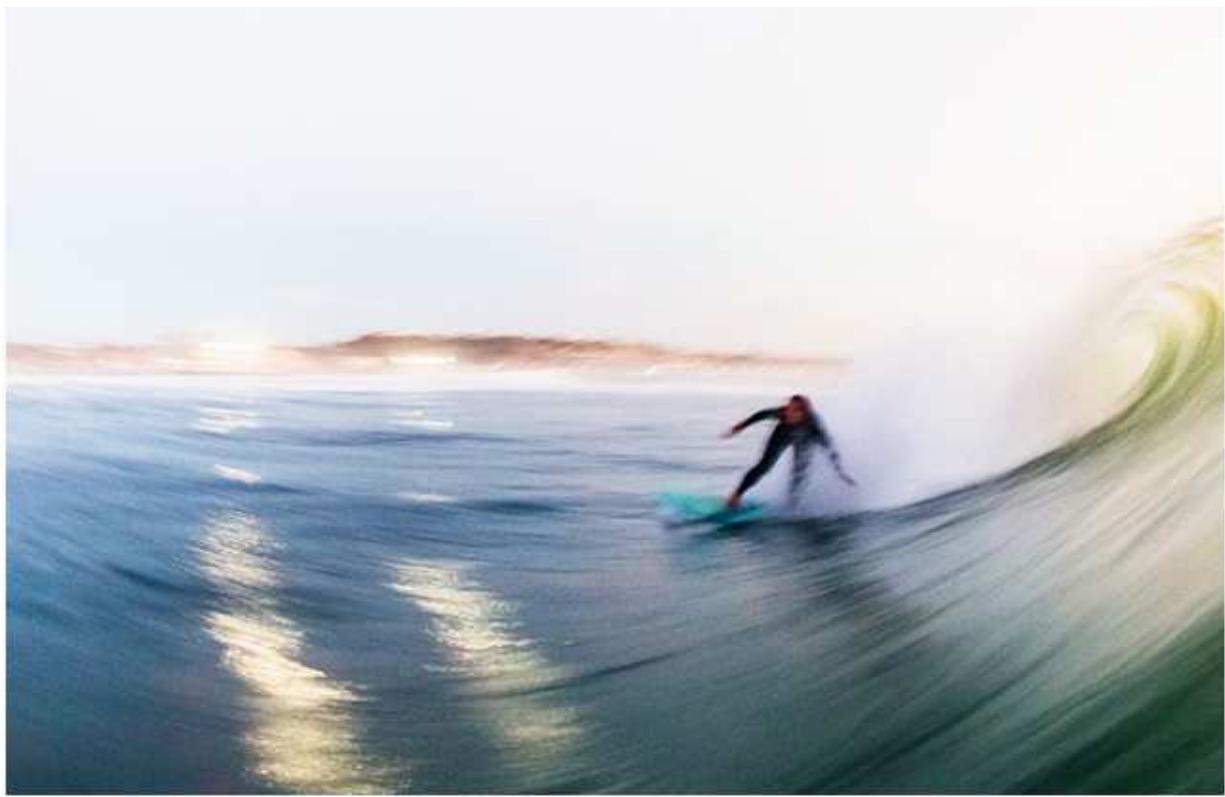
Improved surfing opportunities due to 'new breaks' created by breakwaters

- Enhanced hydraulic conveyance of entrance channels has increased discharge capacity which has eliminated nuisance flooding of low-lying areas and improved water quality (e.g. Tuncurry, NSW)
- Channel thalwegs have stabilised and depths have increased, which has improved navigation (e.g. Narooma, NSW)
- Marine sands have been added to the littoral system and nourished beaches where entrance scour has jetted sand out into the littoral system (e.g. Forster/Tuncurry, Lake Macquarie and Lake Wagonga, NSW)
- In some situations breakwaters have made entrance navigation safer (e.g. Newcastle and Coffs Harbour, NSW)
- Improved surfing opportunities due to 'new breaks' created by breakwaters (e.g. Foster/Tuncurry, NSW)

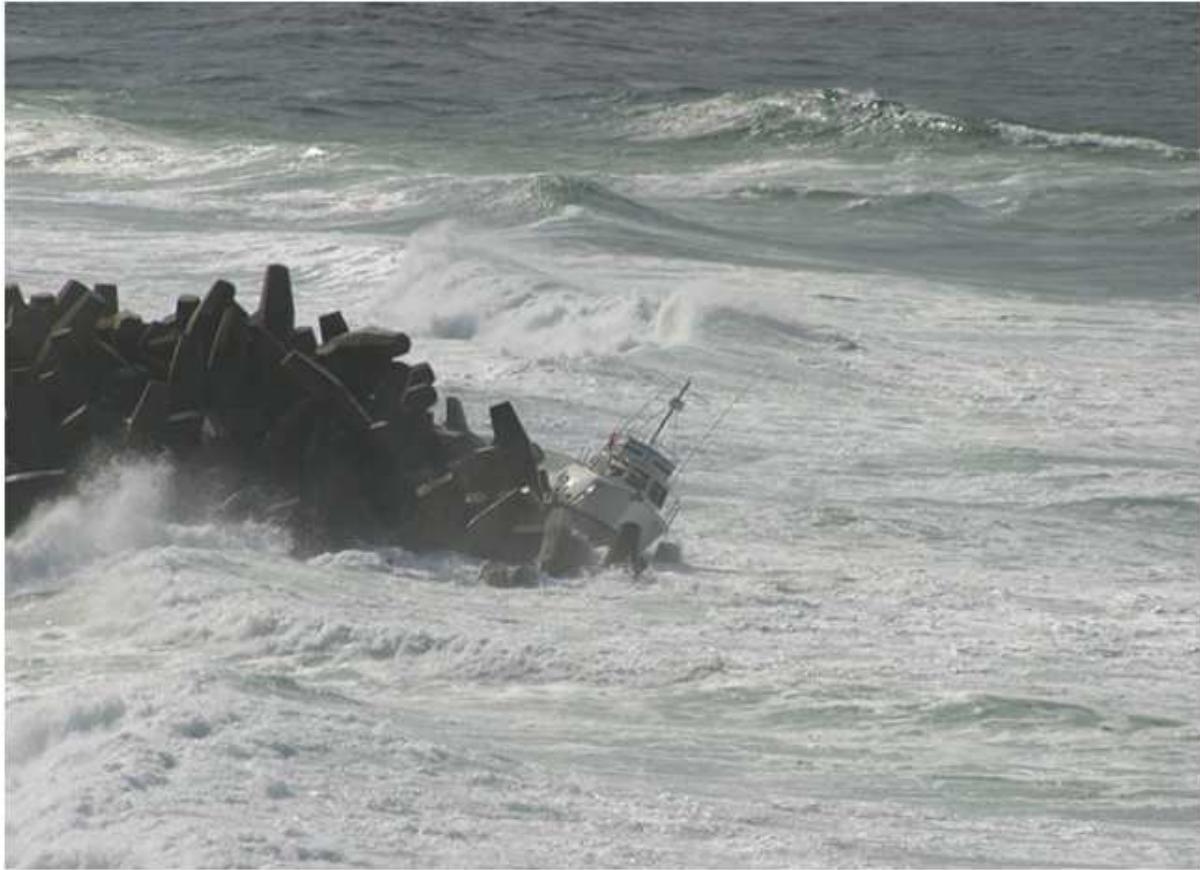
Some dangerous entrances have been created

- Some dangerous entrances have been created where the entrance bars remain and are a hazard to navigation, particularly during periods of moderate to high waves (e.g. Lake Wagonga, NSW) or high spring tides (e.g. Wallis Lake, NSW)

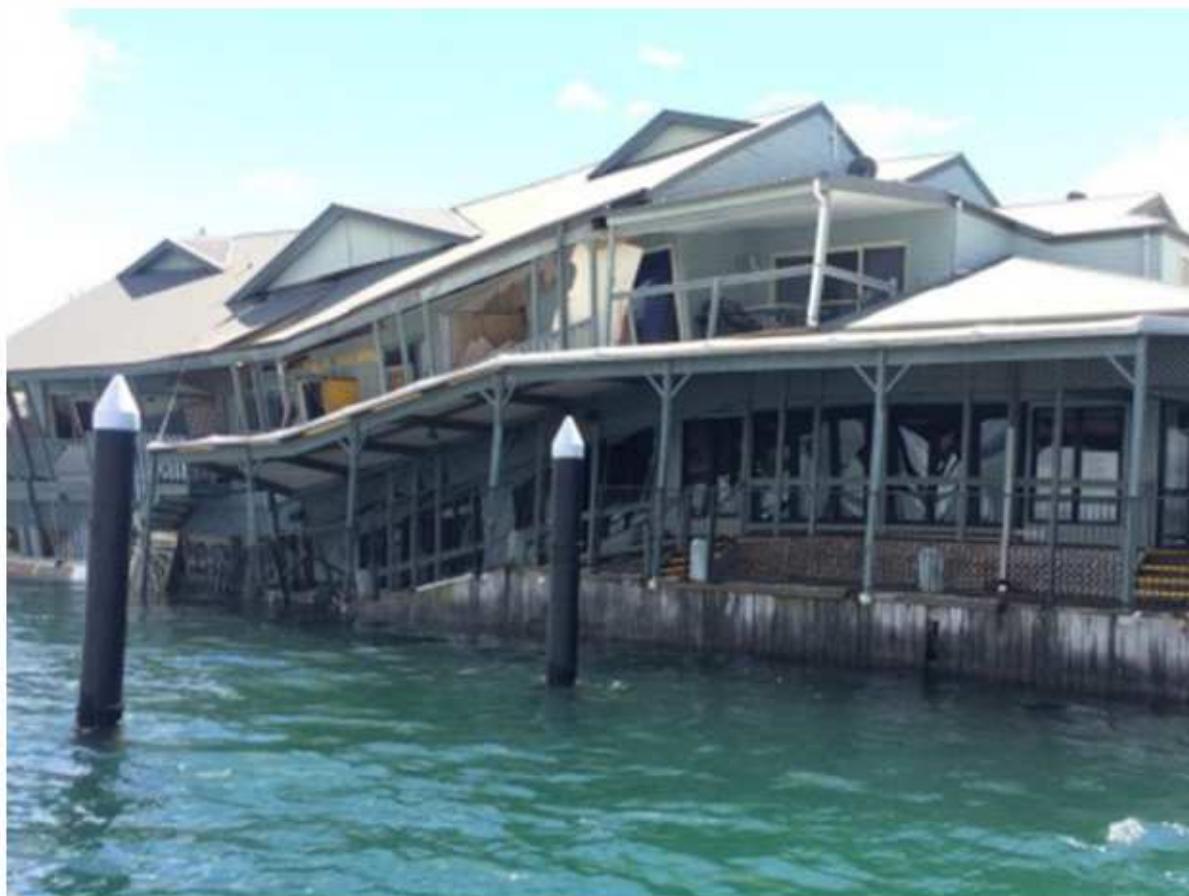
At Lake Macquarie, the collapse of a Swansea Channel foreshore building comprising restaurant, offices and residences on 8 February 2016 (Photo: Fire & Rescue NSW)

- Channel scour has resulted in the total collapse of some foreshore buildings and undermined bridge foundations as well as undermining river training works (e.g. Swansea Channel Lake Macquarie, NSW)
- Breakwaters have re-aligned the foreshore causing beach erosion, loss of residential development and other infrastructure (e.g. Brunswick Heads, NSW)
- Breakwaters causing erosion have sometimes necessitated revetment construction to limit erosion thereby destroying beach amenity (e.g. Stockton Beach at Hunter River Newcastle, NSW)
- Training walls in tidal channels can create dangerous conditions that may cause serious injury to swimmers (e.g. Coffs Creek, NSW)
