Tuggerah Lakes estuary Monitoring and Management

Vanessa McCann's (Ecologist, Waterways and Coastal, Central Coast Council) presentation to CEN's Waterwatch QA Day on 20th September, 2016 at Bill Sohier Park Community Hall, Shirley Street Ourimbah

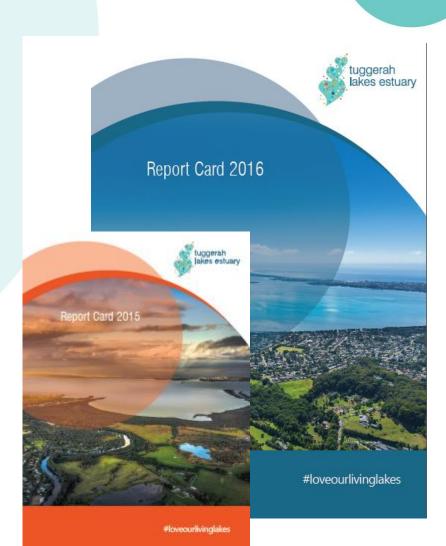
Tuggerah Lakes estuary Monitoring & Report Card

- Annual data collection in Lake Munmorah, Budgewoi Lake and Tuggerah Lake since 2010
- Indicators: chlorophyll-a, turbidity & seagrass depth range
- Healthy estuaries have low levels of microalgae and turbidity and strong seagrass communities

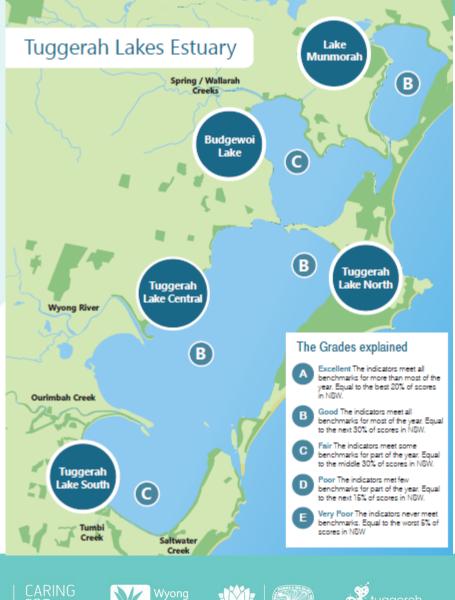
2016 results

Lake Munmorah 2015 **B** 2014 A 2013 2016 **Budgewoi Lake C** 2015 **C** 2014 **C** 2013 2016 **Tuggerah Lake North C** 2015 **C** 2014 B **B** 2013 2016 **Tuggerah Lake Centre** B 2016 C 2015 C 2014 C 2013 **Tuggerah Lake South** C 2014 2016 C 2015 **B** 2013

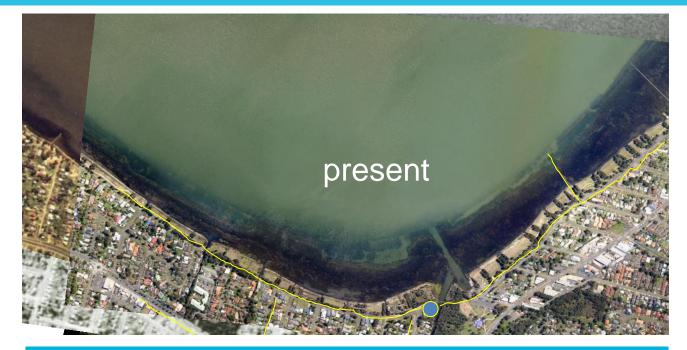
This series of images show the progressive colonisation of the nearshore zone by macrophytes adjacent to the Killarney Vale and Long Jetty shoreline. This colonisation is accompanied by an increase in fine sediments and organic loading of sediments.

The gradual enrichment of the nearshore zone is widespread, but appears to be particularly bad adjacent to heavily urbanised areas. This implicates persistent sources of bio-available nutrients from urban runoff and groundwater.

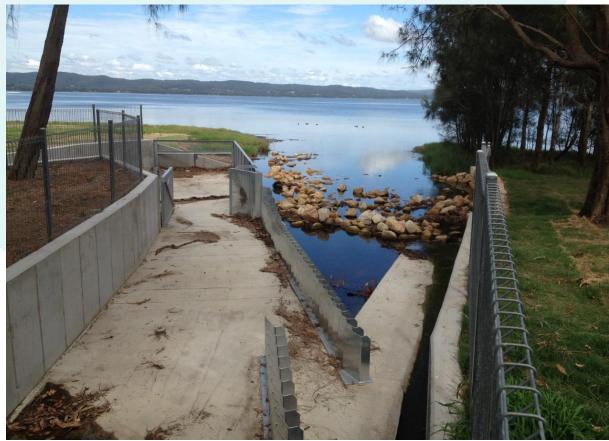
Recent stormwater upgrades – Long Jetty

2010 - Tuggerah Pde/ Anzac Ave Baramy GPT

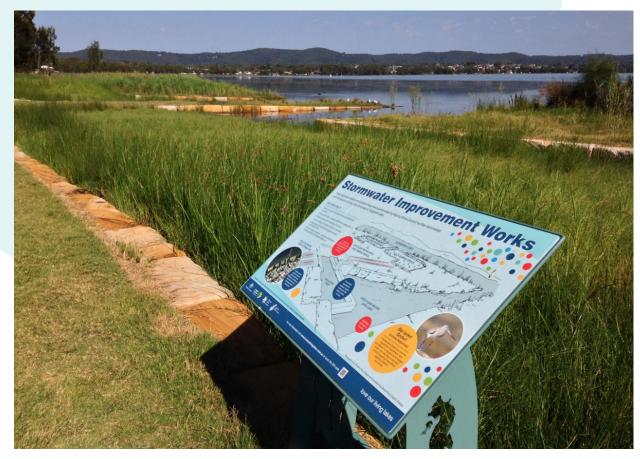
Recent stormwater upgrades – Long Jetty

2015 – Venice St/ Gladstan Ave GPTs and Saltmarsh Swales

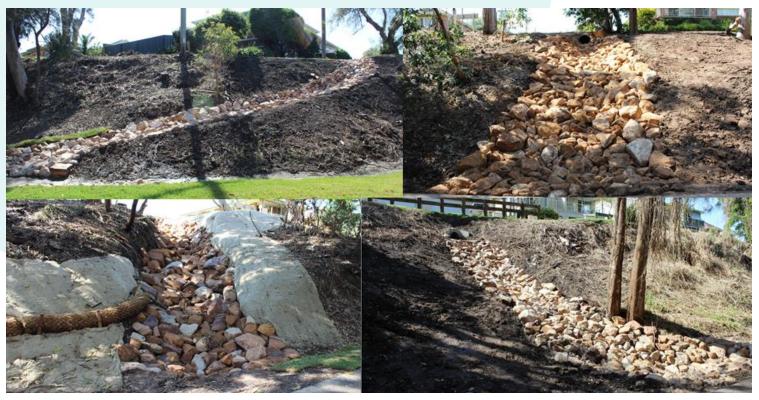
Recent stormwater upgrades – Long Jetty

2016 – Willow St to Battley Ave – 6 drains upgraded

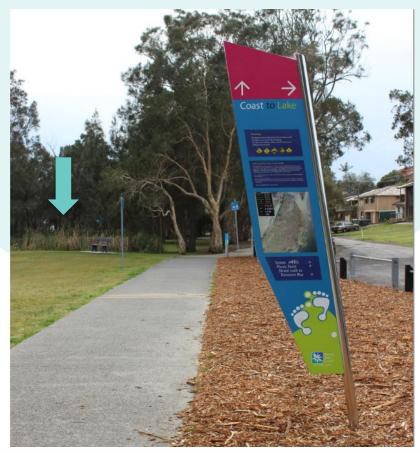
Future stormwater upgrades – Long Jetty

2017 – Tuggerah Pde/ Archibold St stormwater consolidation, saltmarsh swale and foreshore saltmarsh regeneration
