Tuggerah Lakes – The Entrance Morphodynamic Modelling
 Effect of Major Ocean Storm on Karagi Point
 ESE Waves , $H_s=10m$, $T_p=13$ seconds, Storm Tide = 1.2m AHD

Tuggerah Lakes – The Entrance Morphodynamic Modelling
 Post 100yr ARI Flood Event: Difference in Entrance Bathymetries
 Cross-Sections of Existing and Dual Training Wall 150m Apart

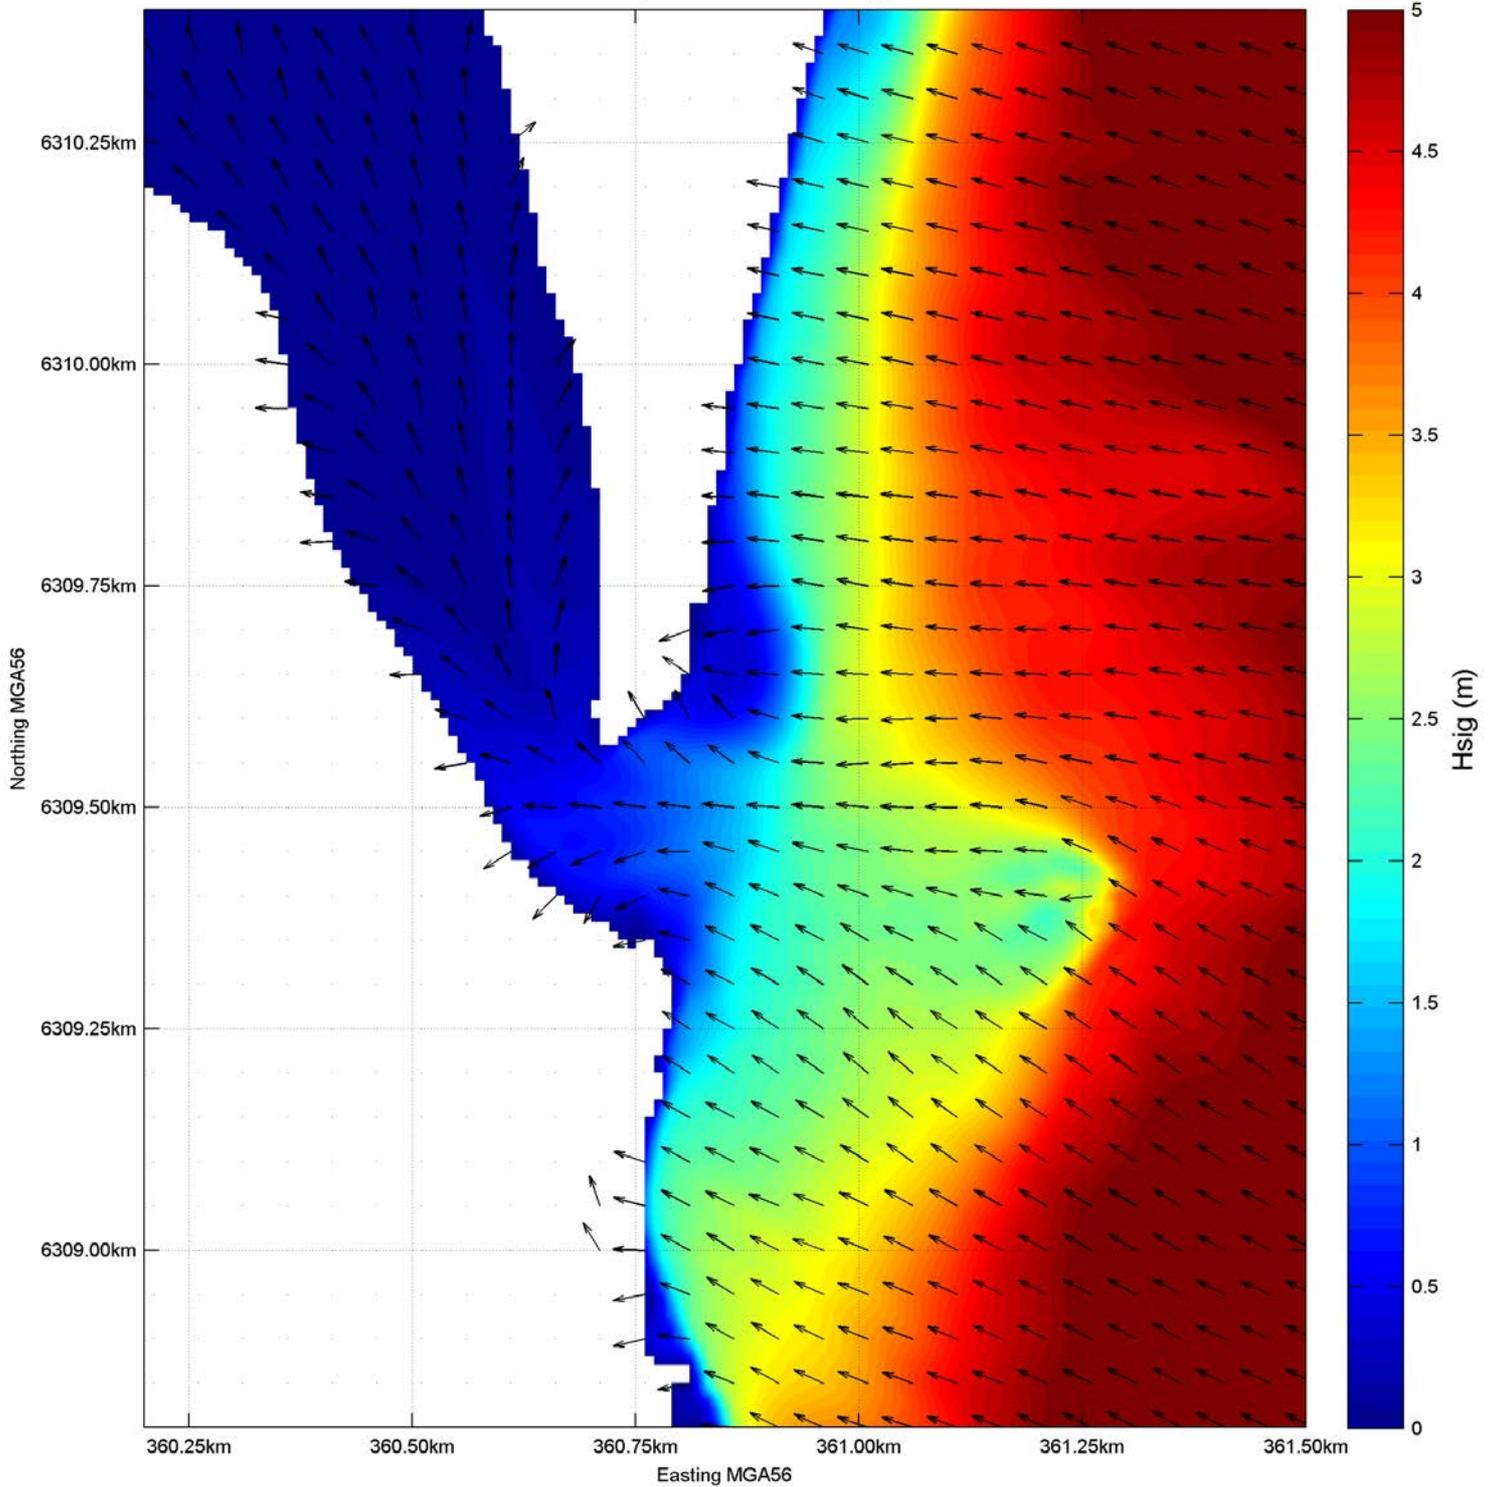
Wave Penetration Post 100yrARI Flood: Existing Entrance Conditon

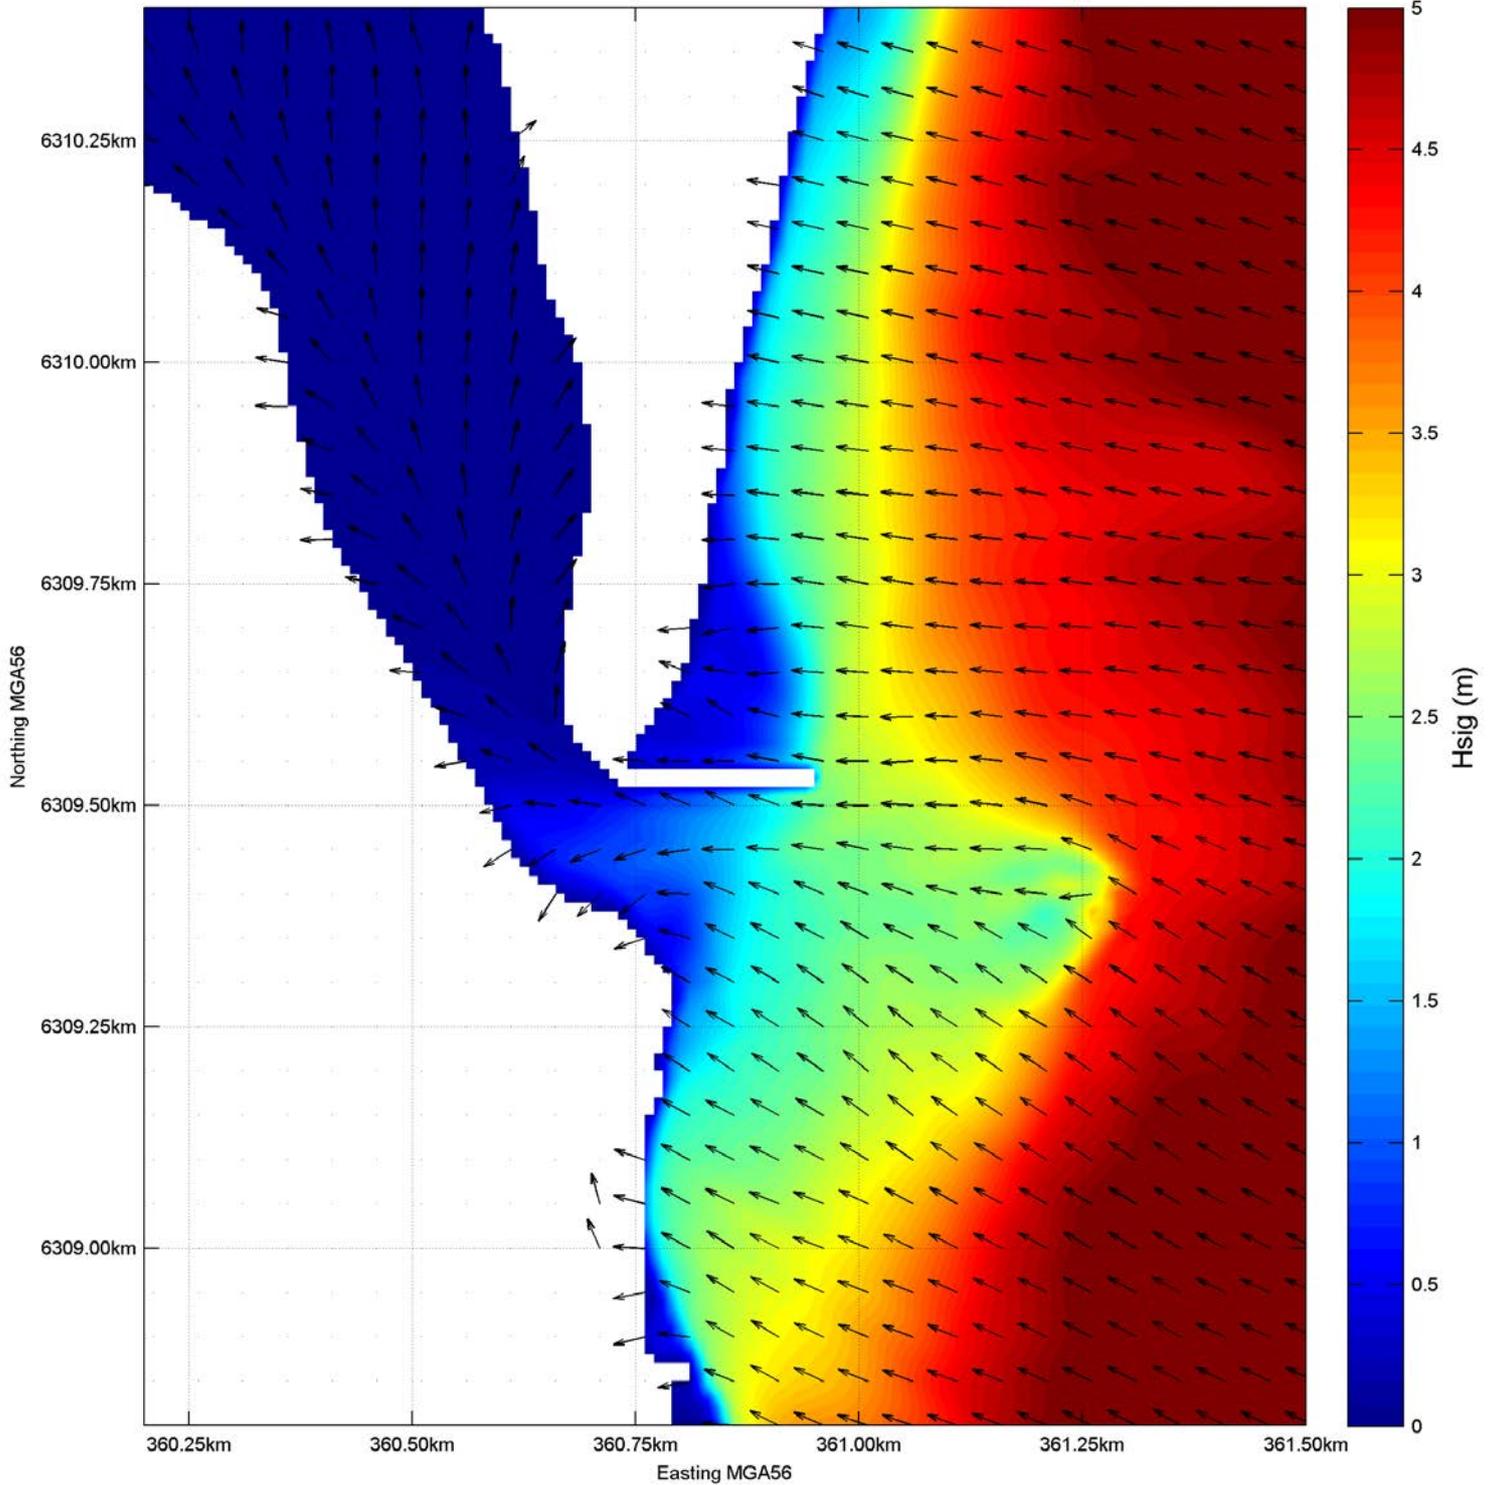
Wave Penetration Post 100yrARI Flood: Single Northern Training Wall

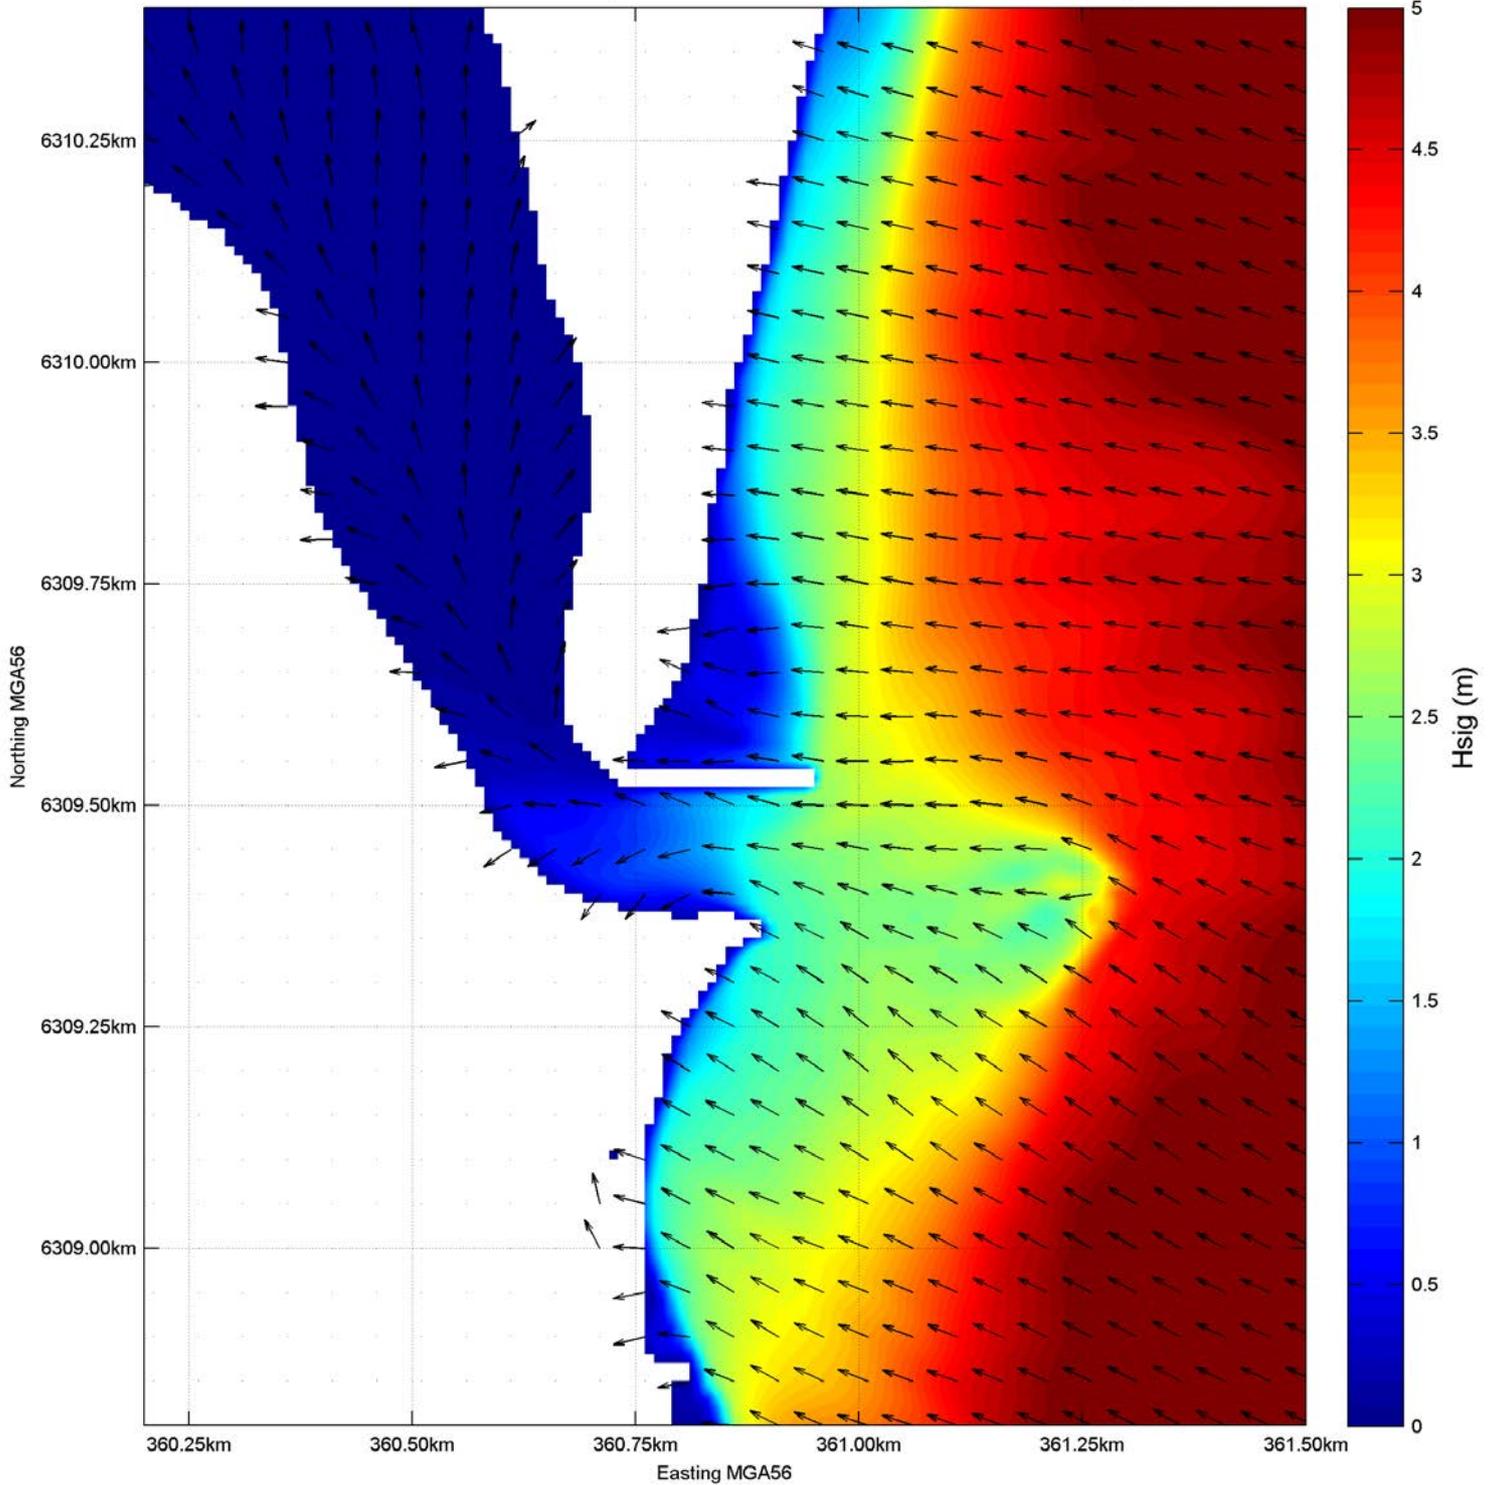
Wave Penetration Post 100yrARI Flood: Dual Training Walls - 150m Apart

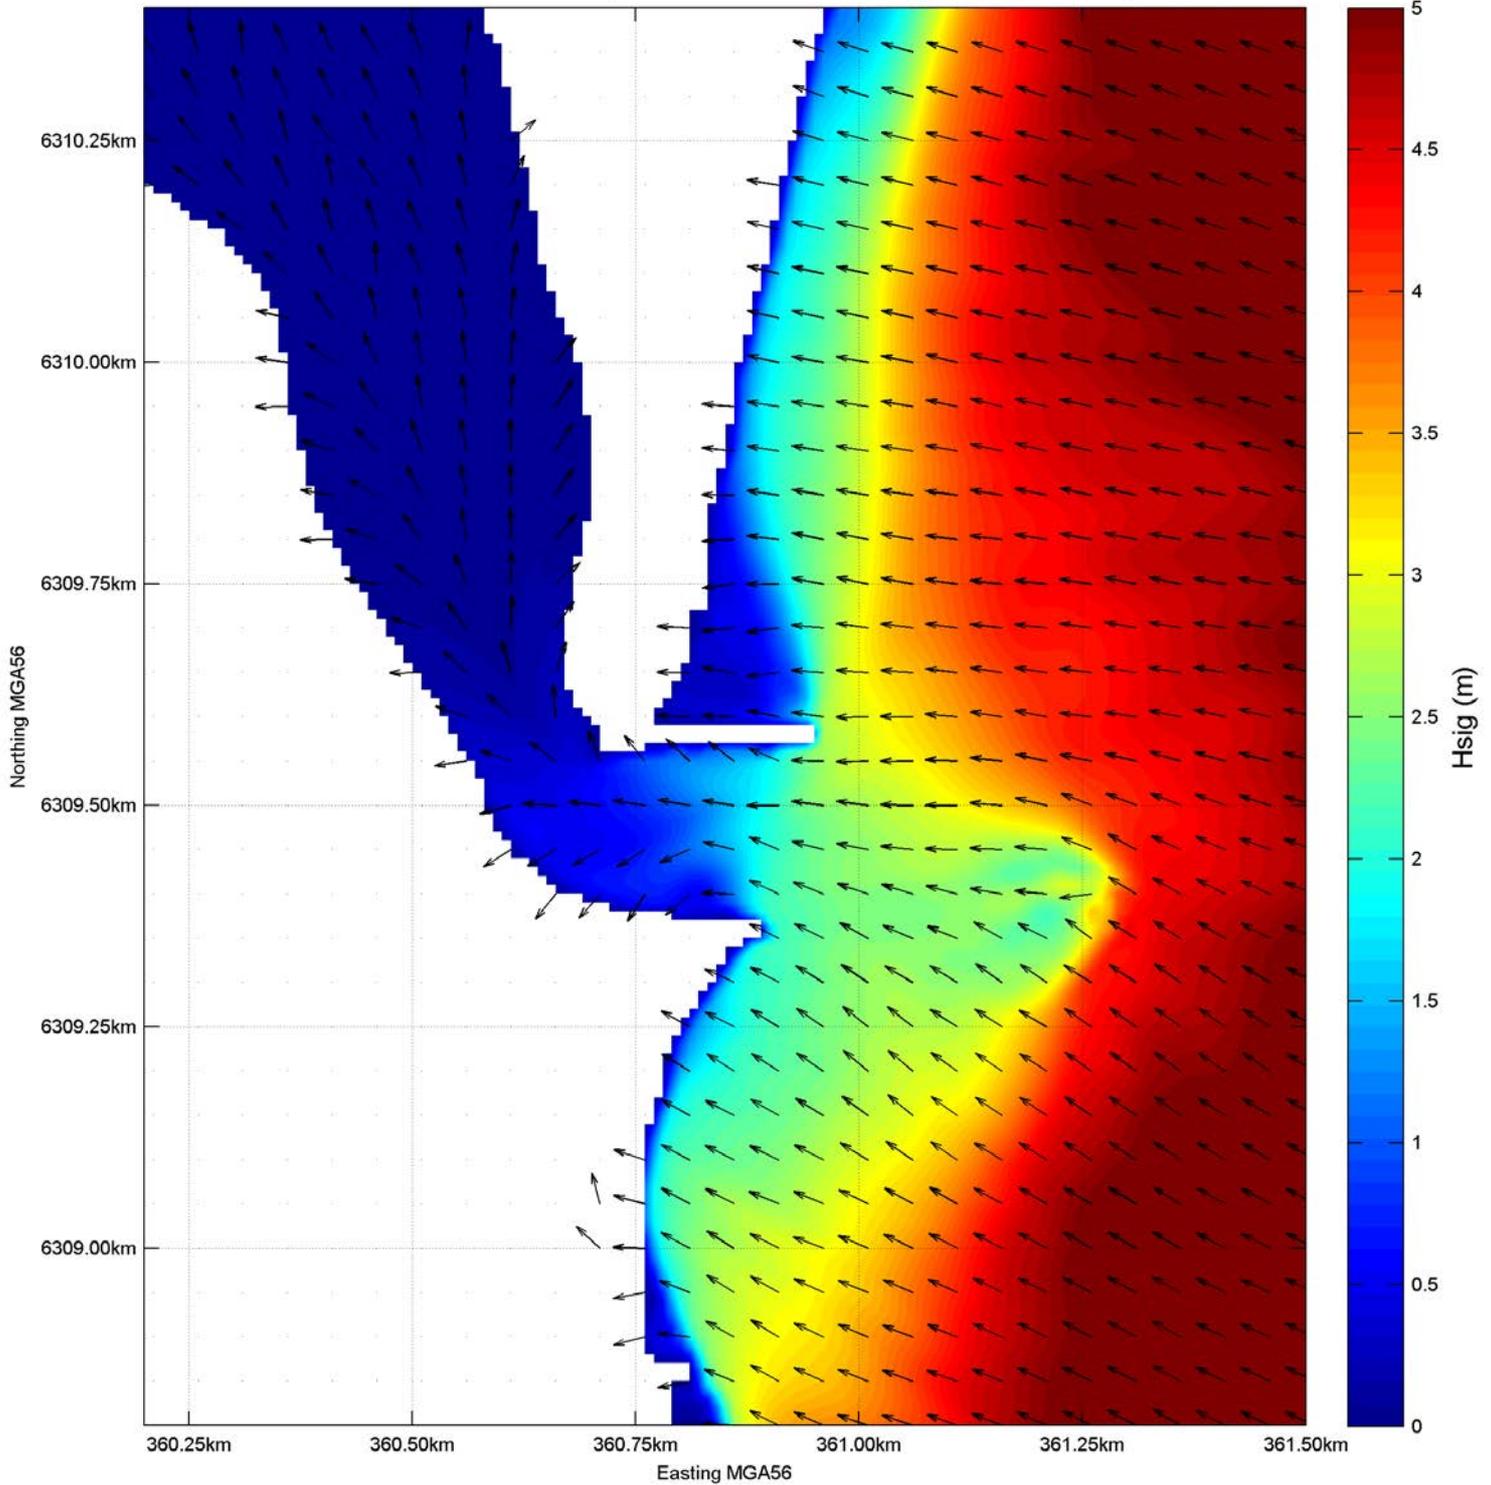
Wave Penetration Post 100yrARI Flood: Dual Training Walls - 200m Apart

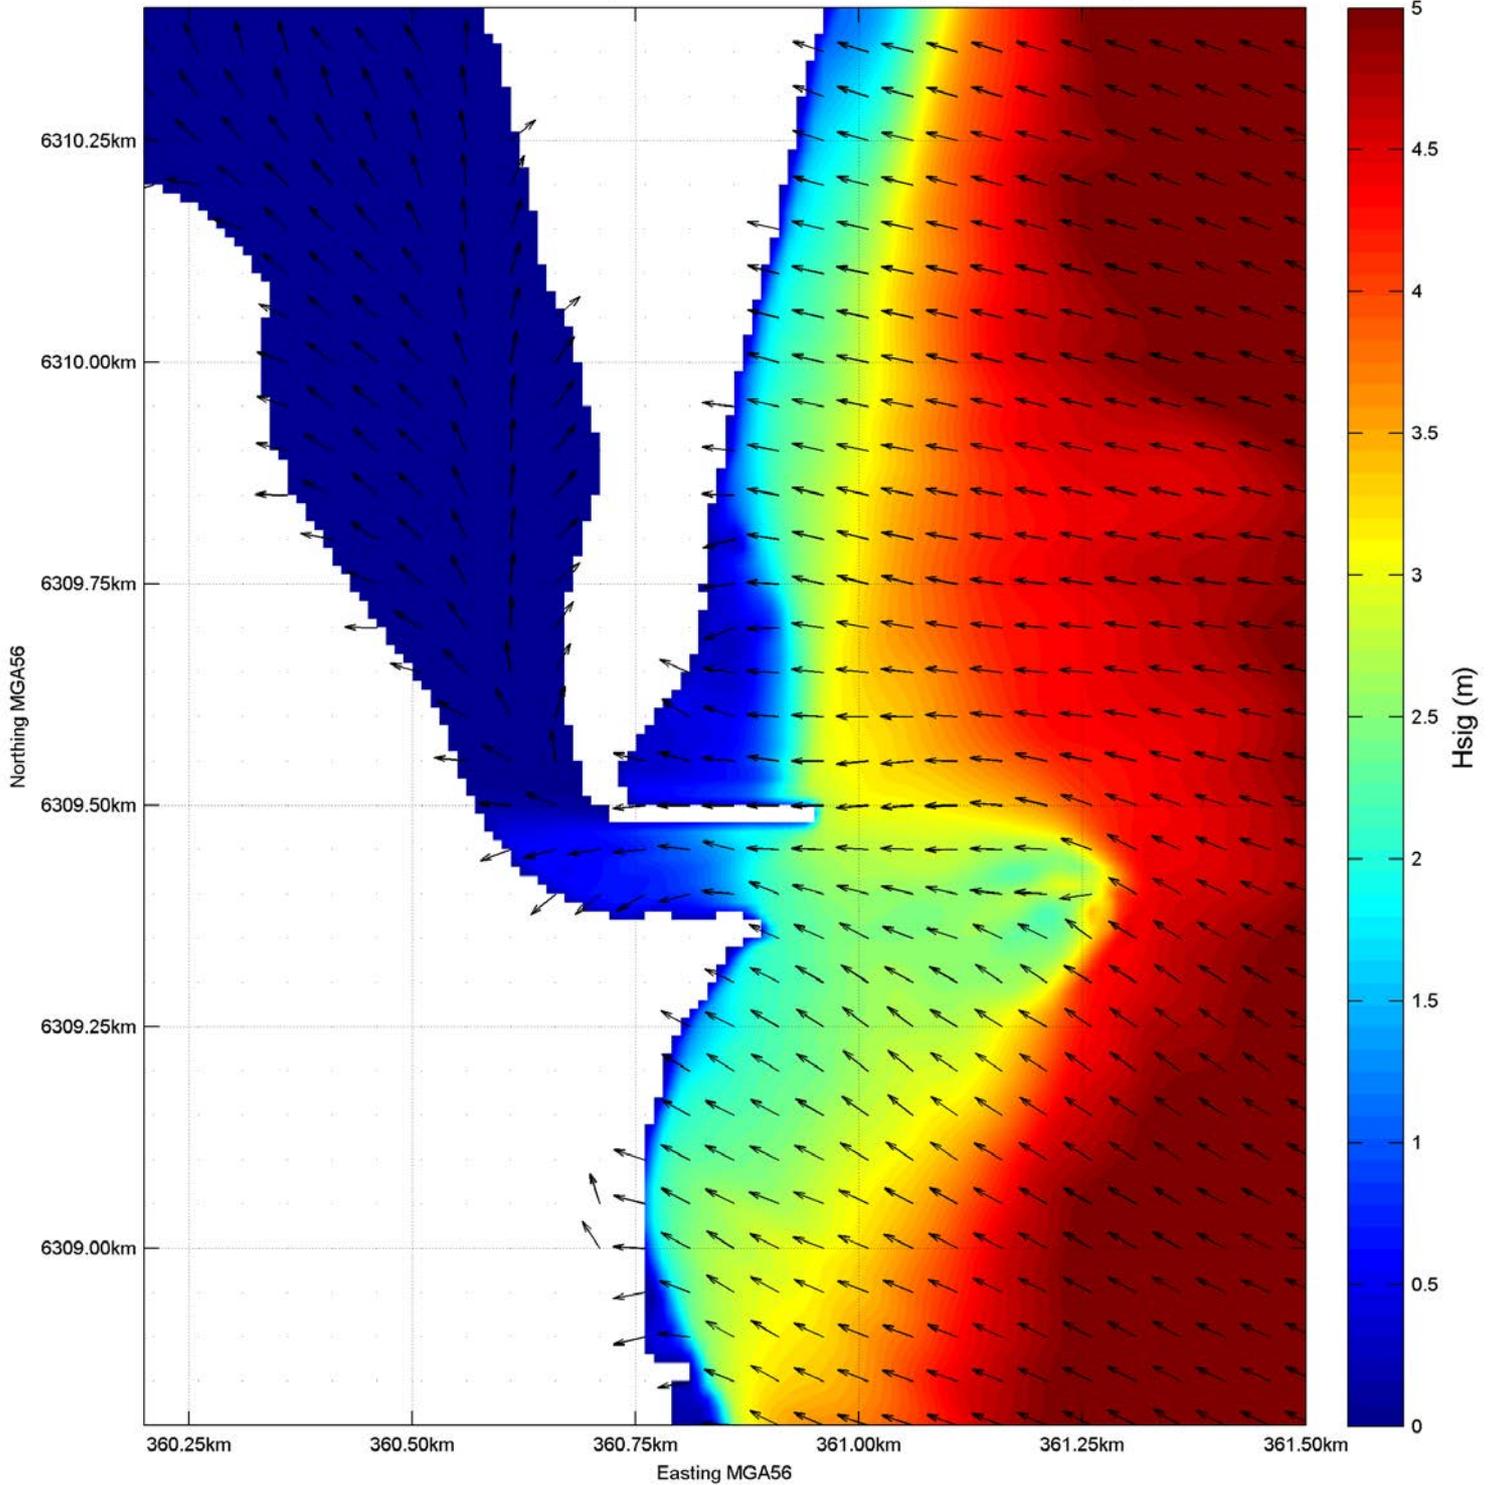
Wave Penetration Post 100yrARI Flood: Dual Training Walls - 100m Apart

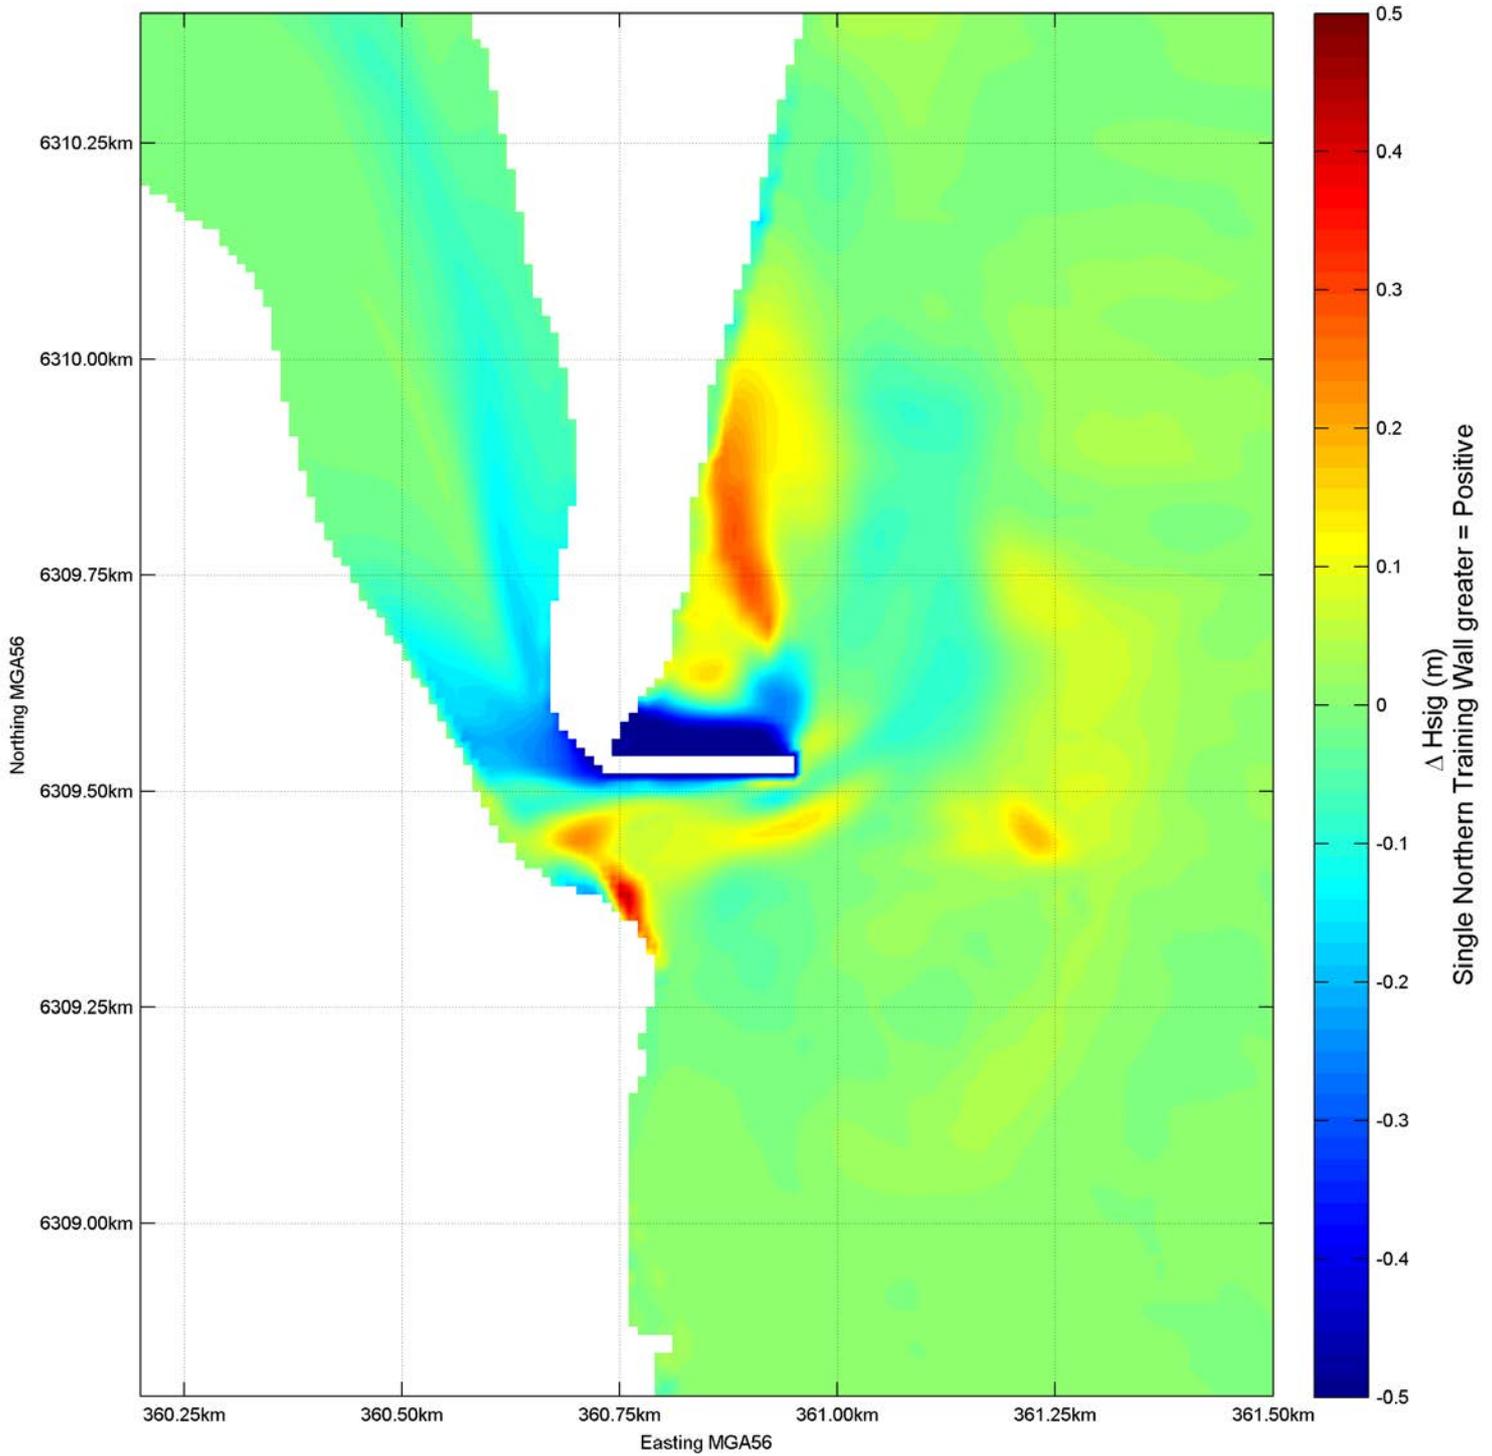
Wave Penetration Post 100yrARI Flood:
Difference between Single Northern Training Wall and Existing Entrance Condition

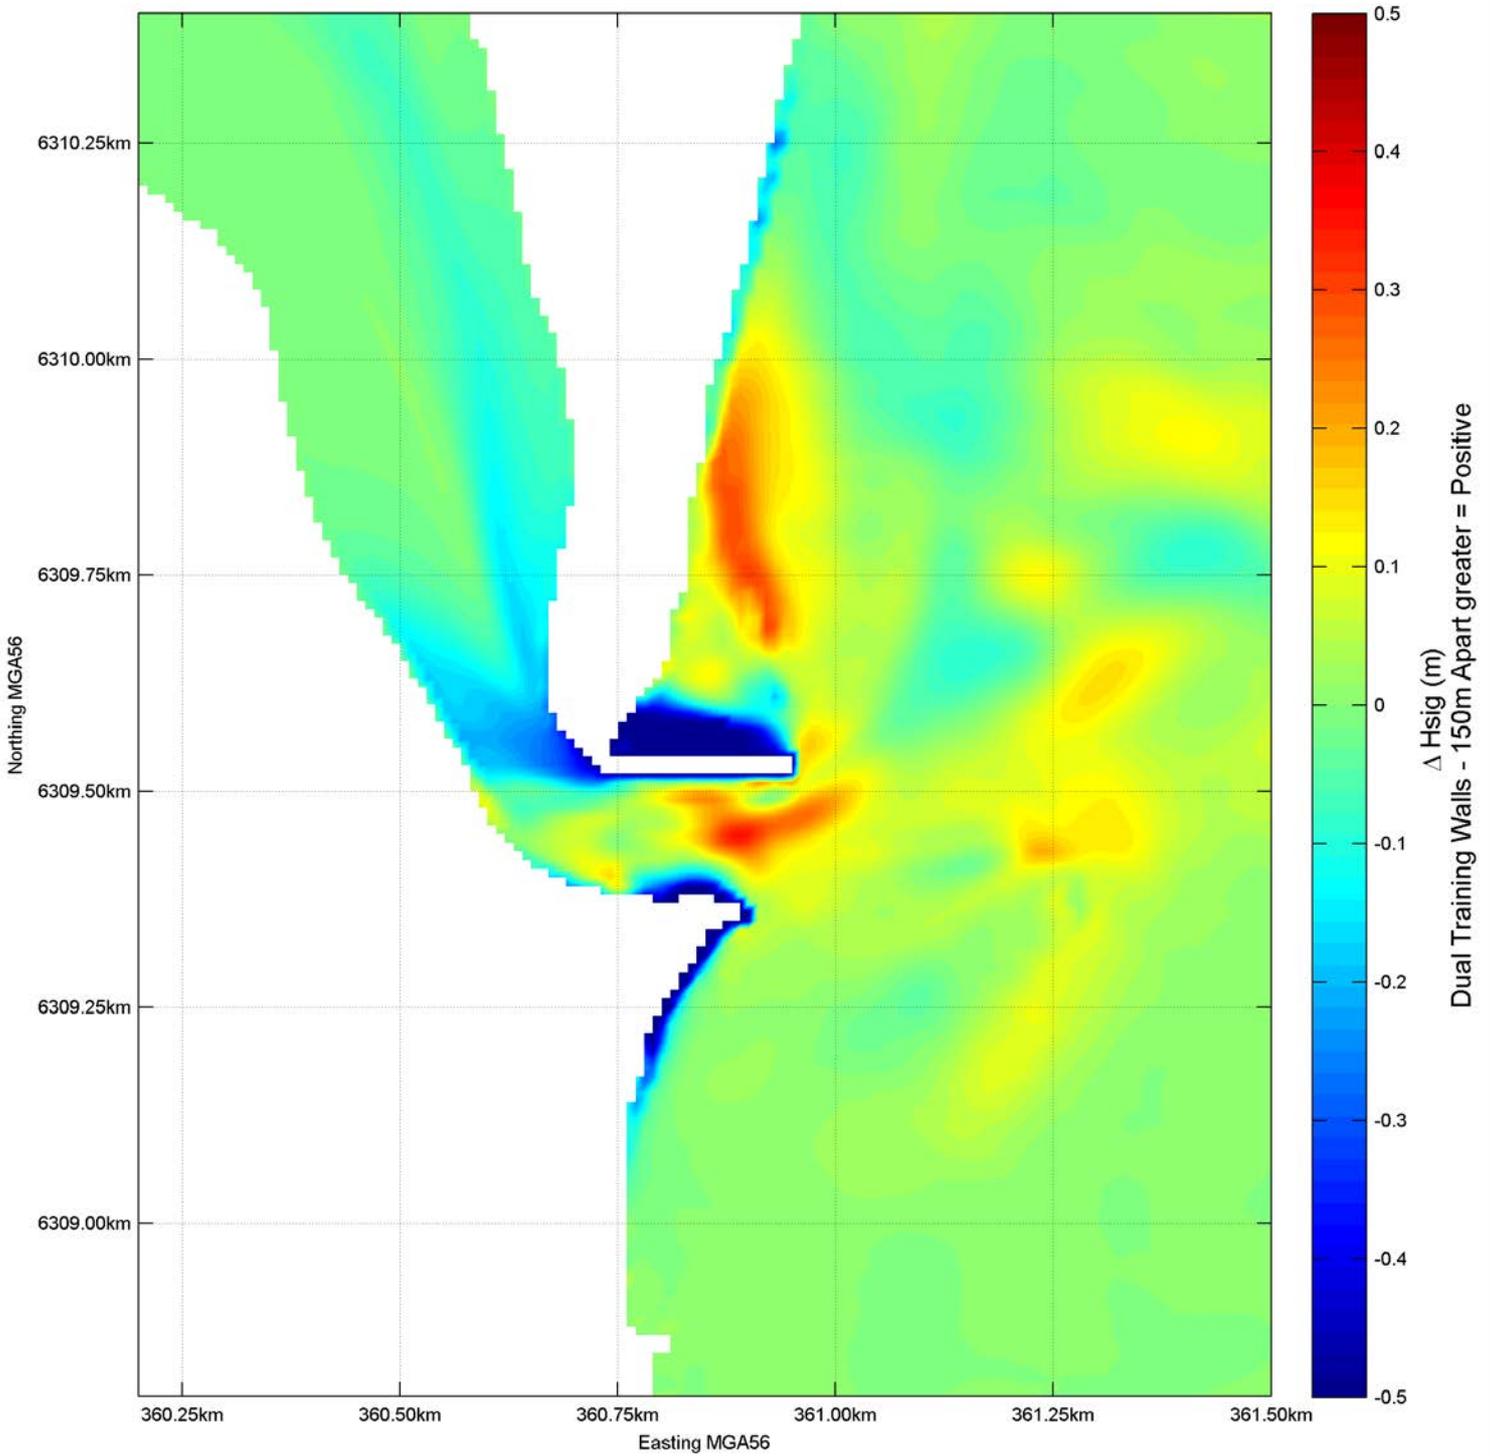
Wave Penetration Post 100yrARI Flood:
 Difference between Dual Training Walls - 150m Apart and Existing Entrance Conditon

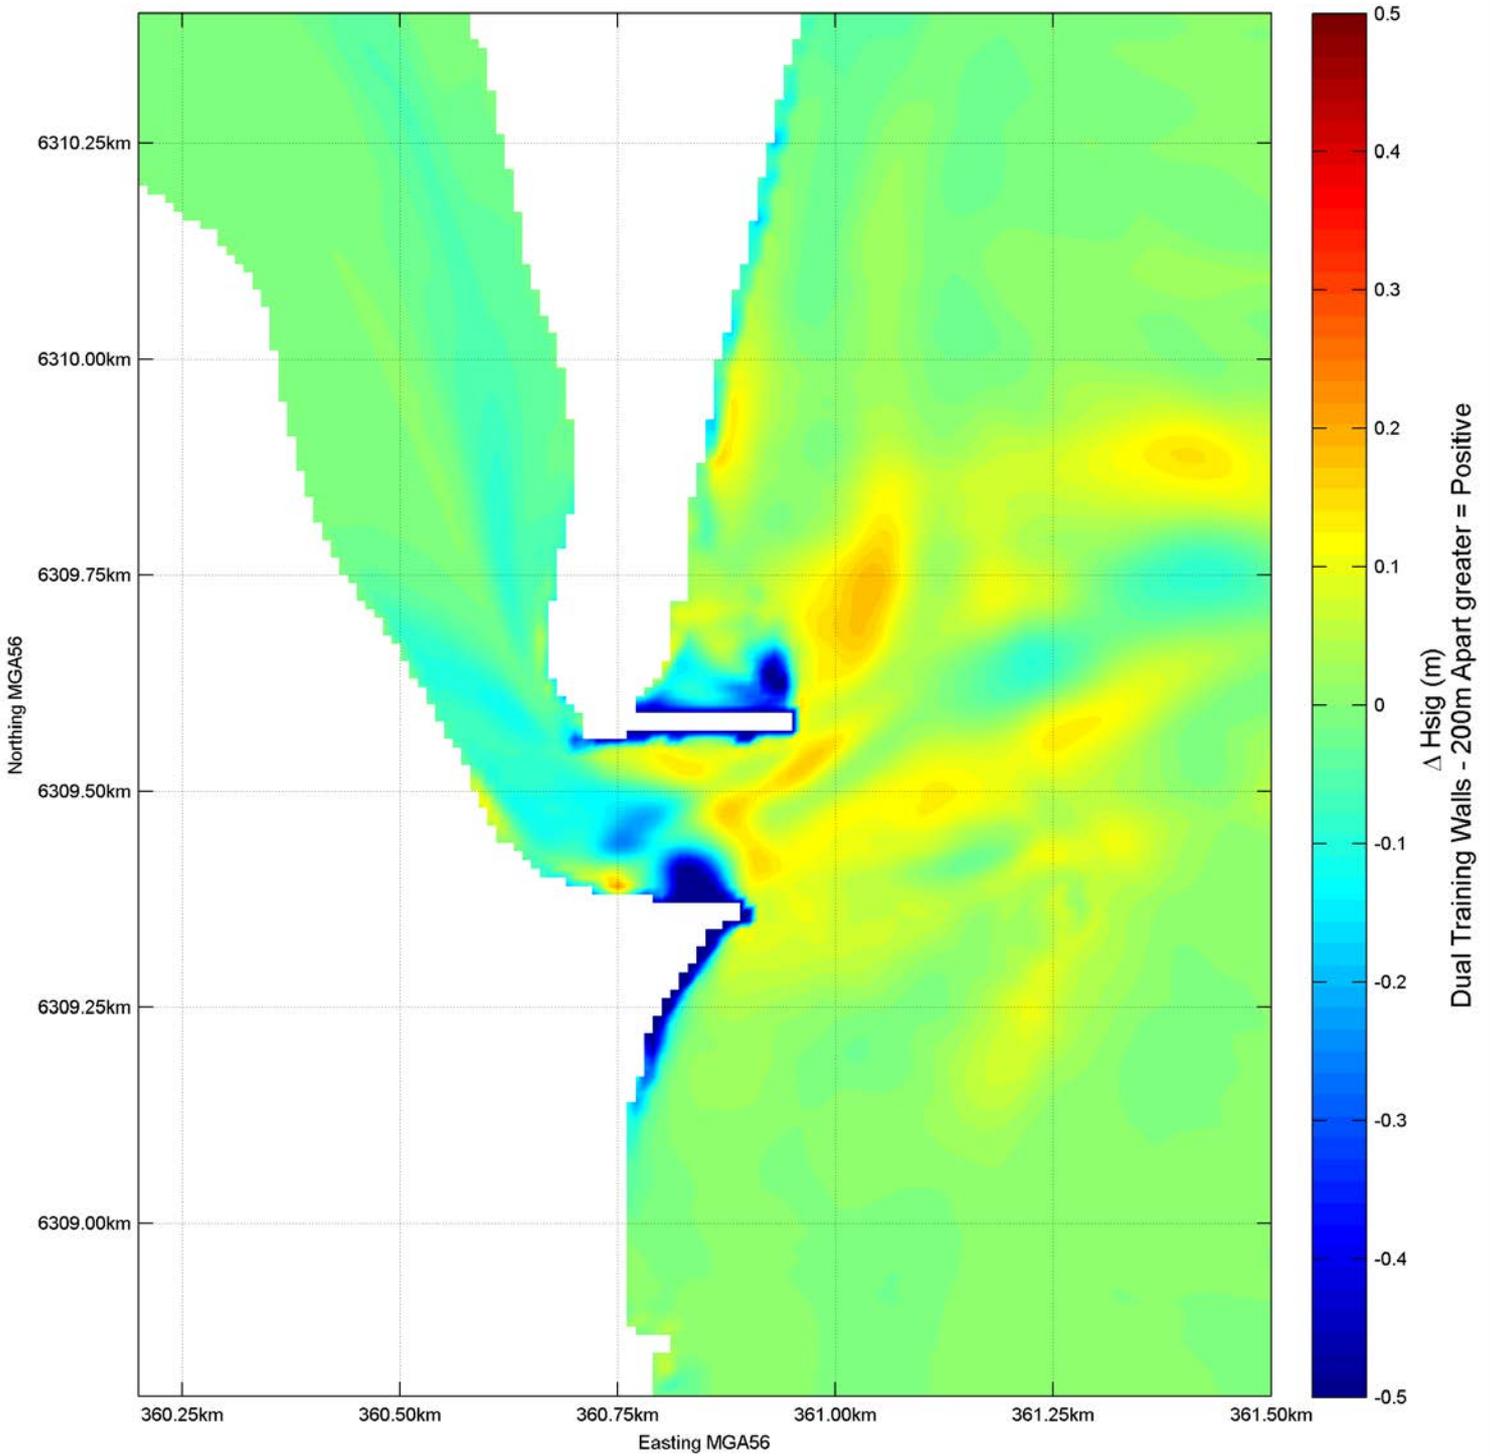
Wave Penetration Post 100yrARI Flood:
Difference between Dual Training Walls - 200m Apart and Existing Entrance Conditon

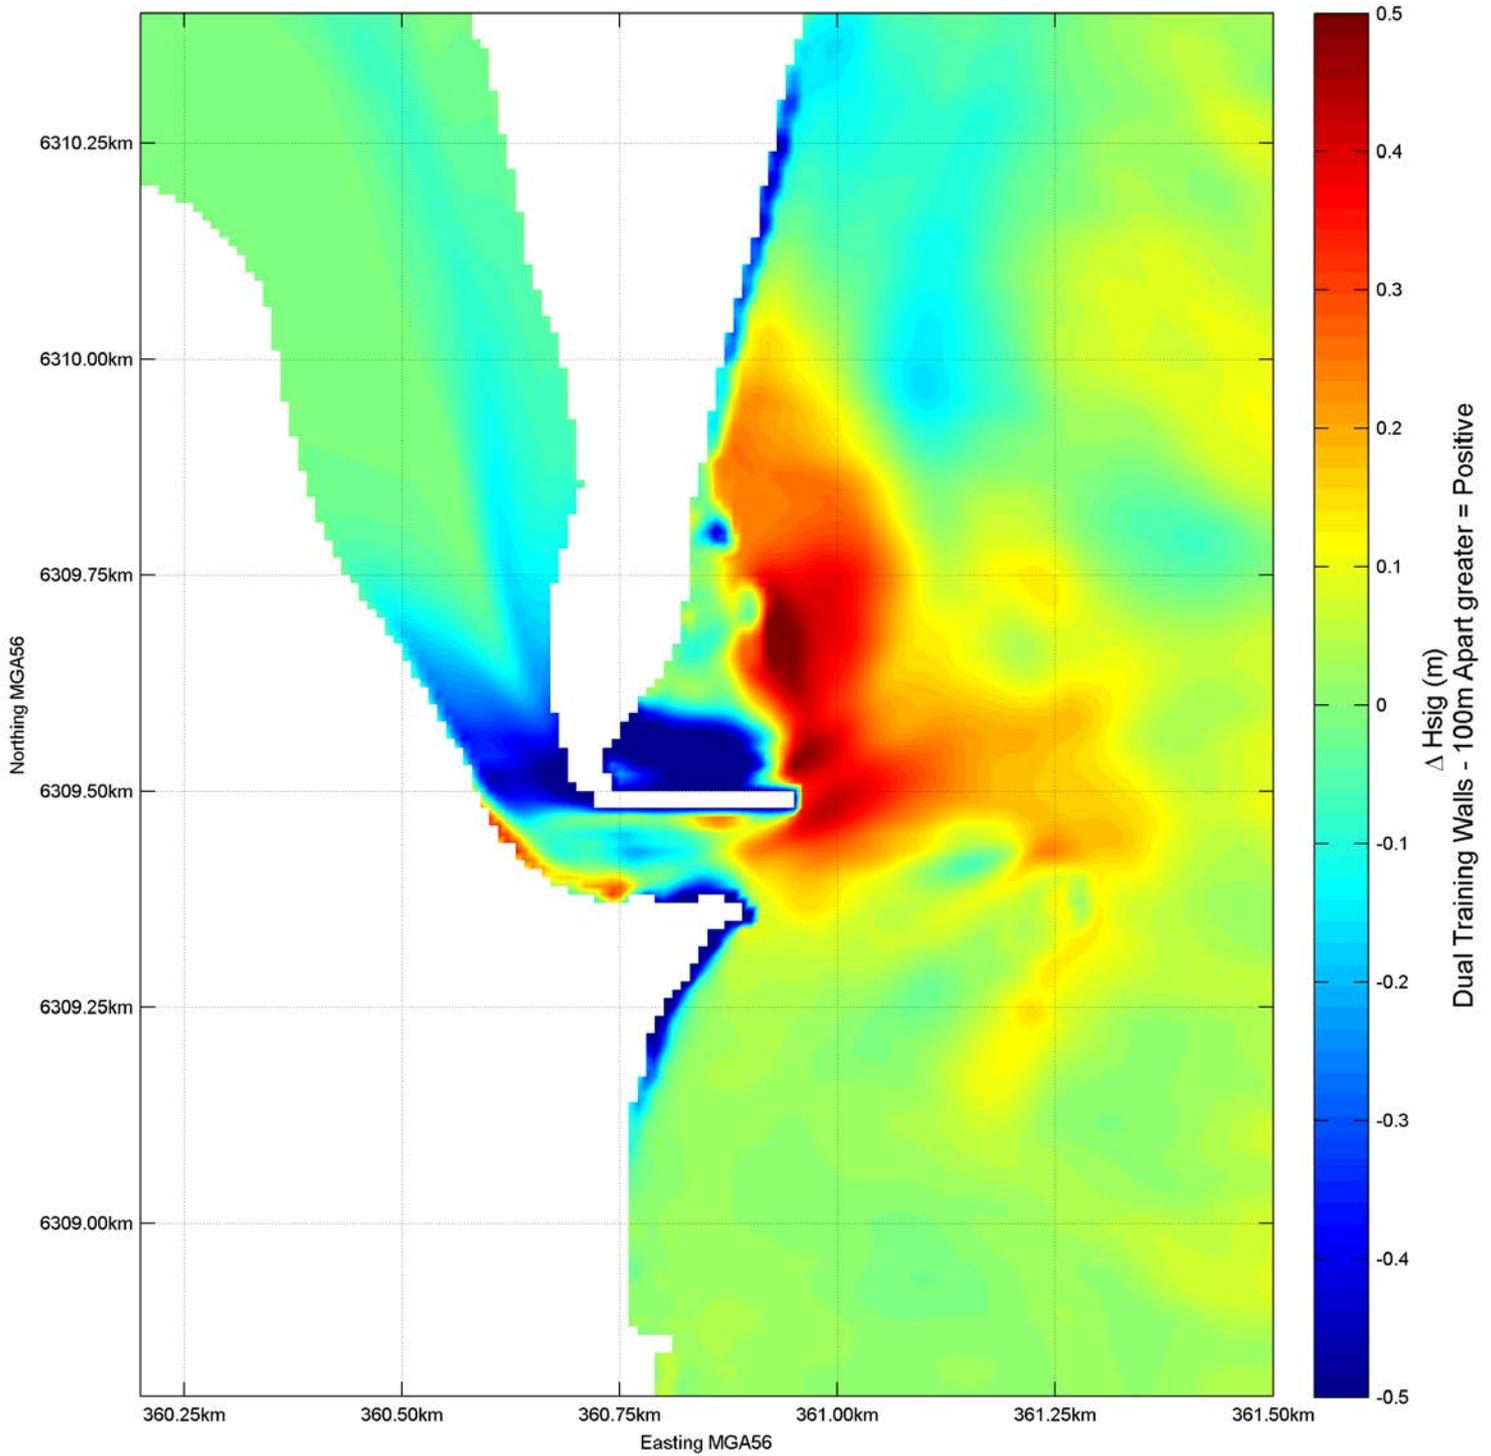
Wave Penetration Post 100yrARI Flood:
Difference between Dual Training Walls - 100m Apart and Existing Entrance Conditon

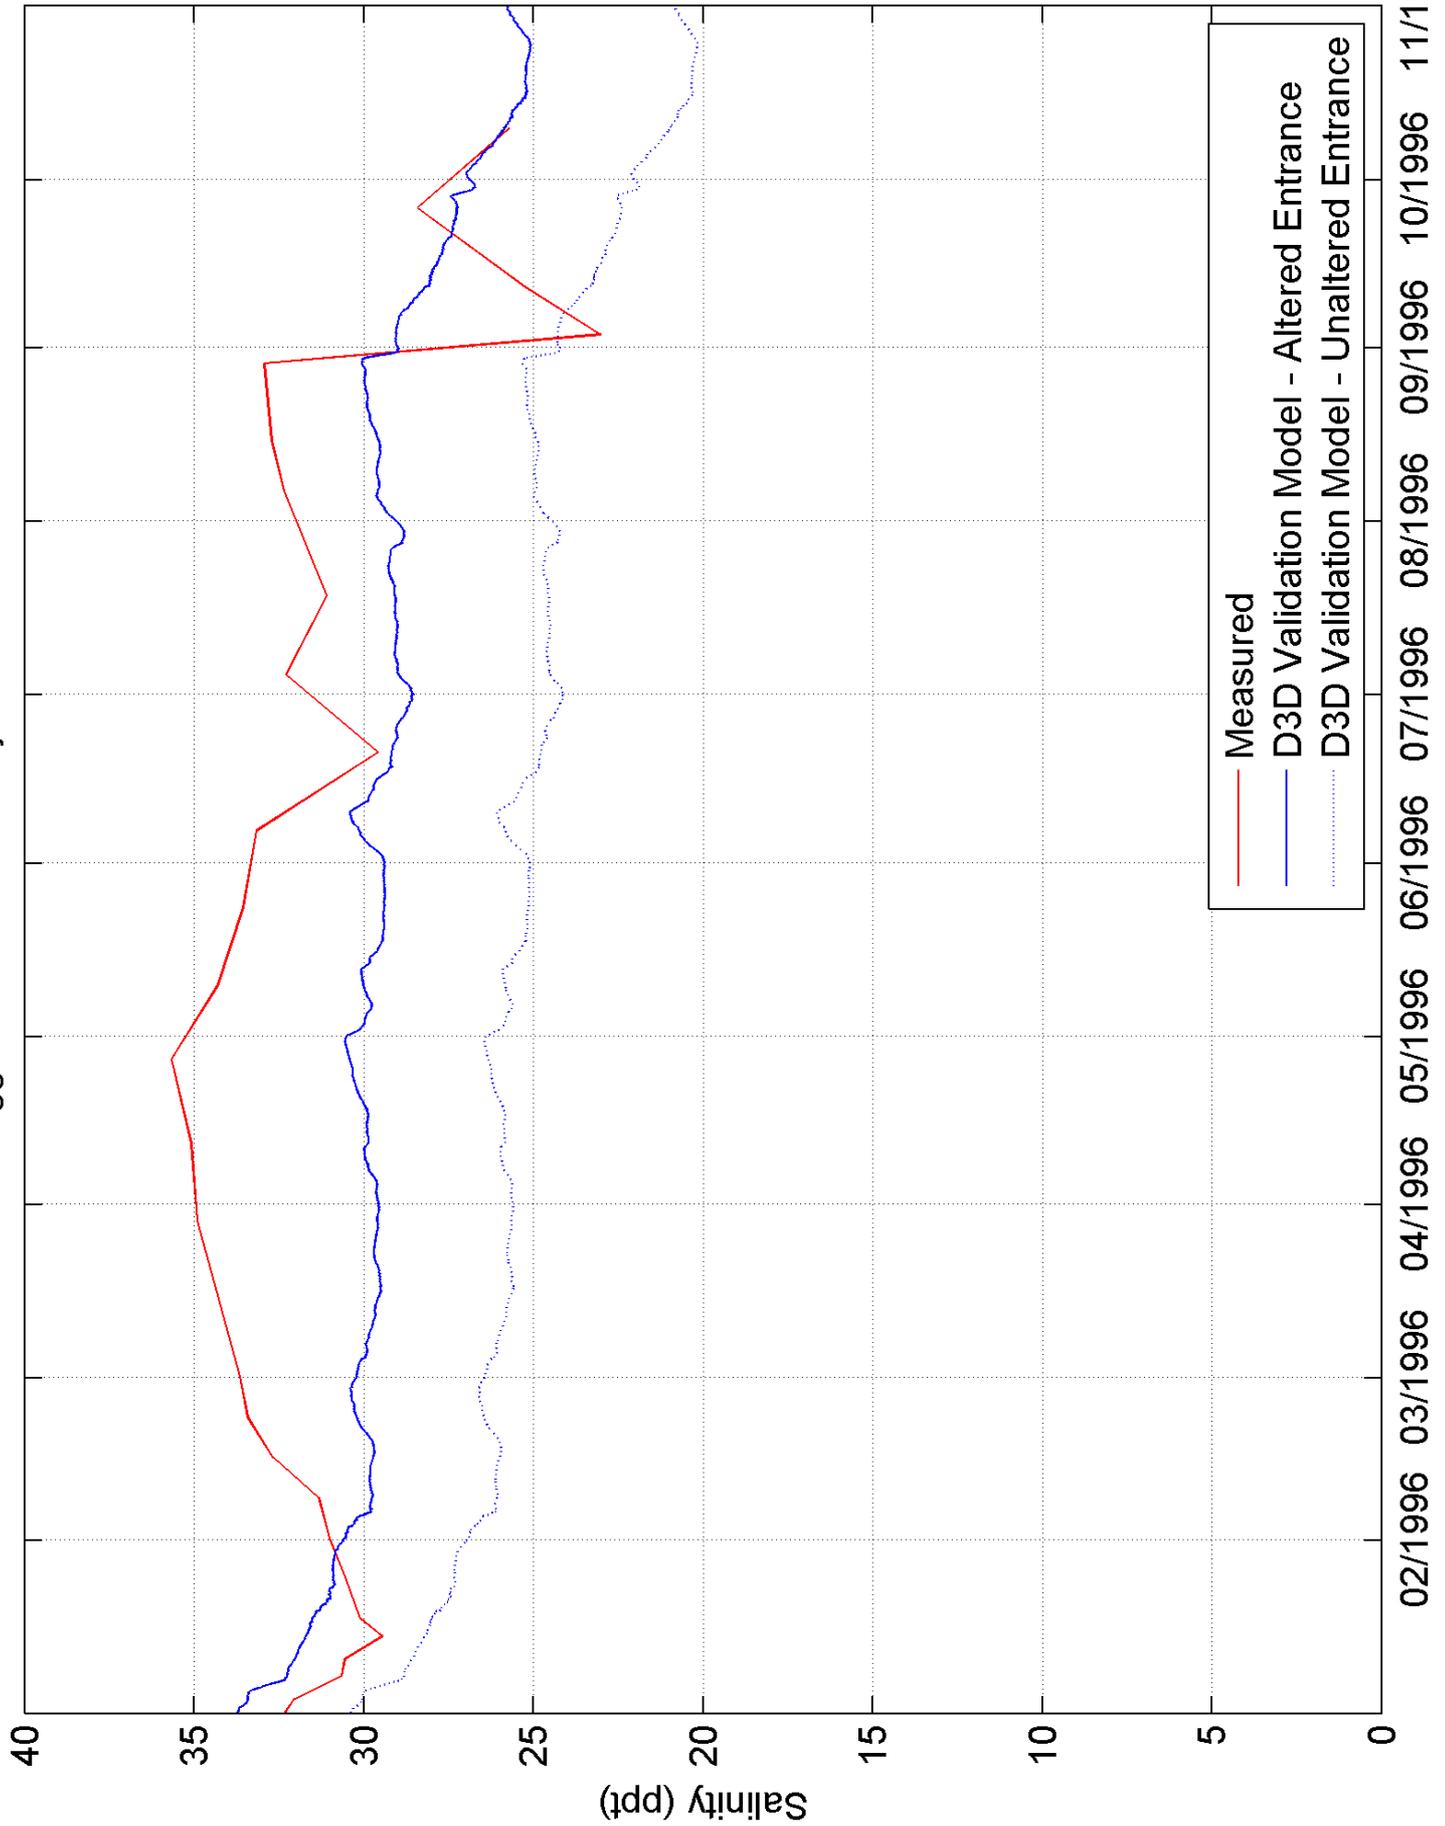
Tuggerah Lakes - Salinity at Site L2
