Tuggerah Lakes – The Entrance Morphodynamic Modelling
 Effect of Major Ocean Storm on Karagi Point
 ESE Waves , $H_s=10m$, $T_p=13$ seconds, Storm Tide = 1.2m AHD

Tuggerah Lakes – The Entrance Morphodynamic Modelling
 Post 100yr ARI Flood Event: Difference in Entrance Bathymetries
 Cross-Sections of Existing and Dual Training Wall 150m Apart

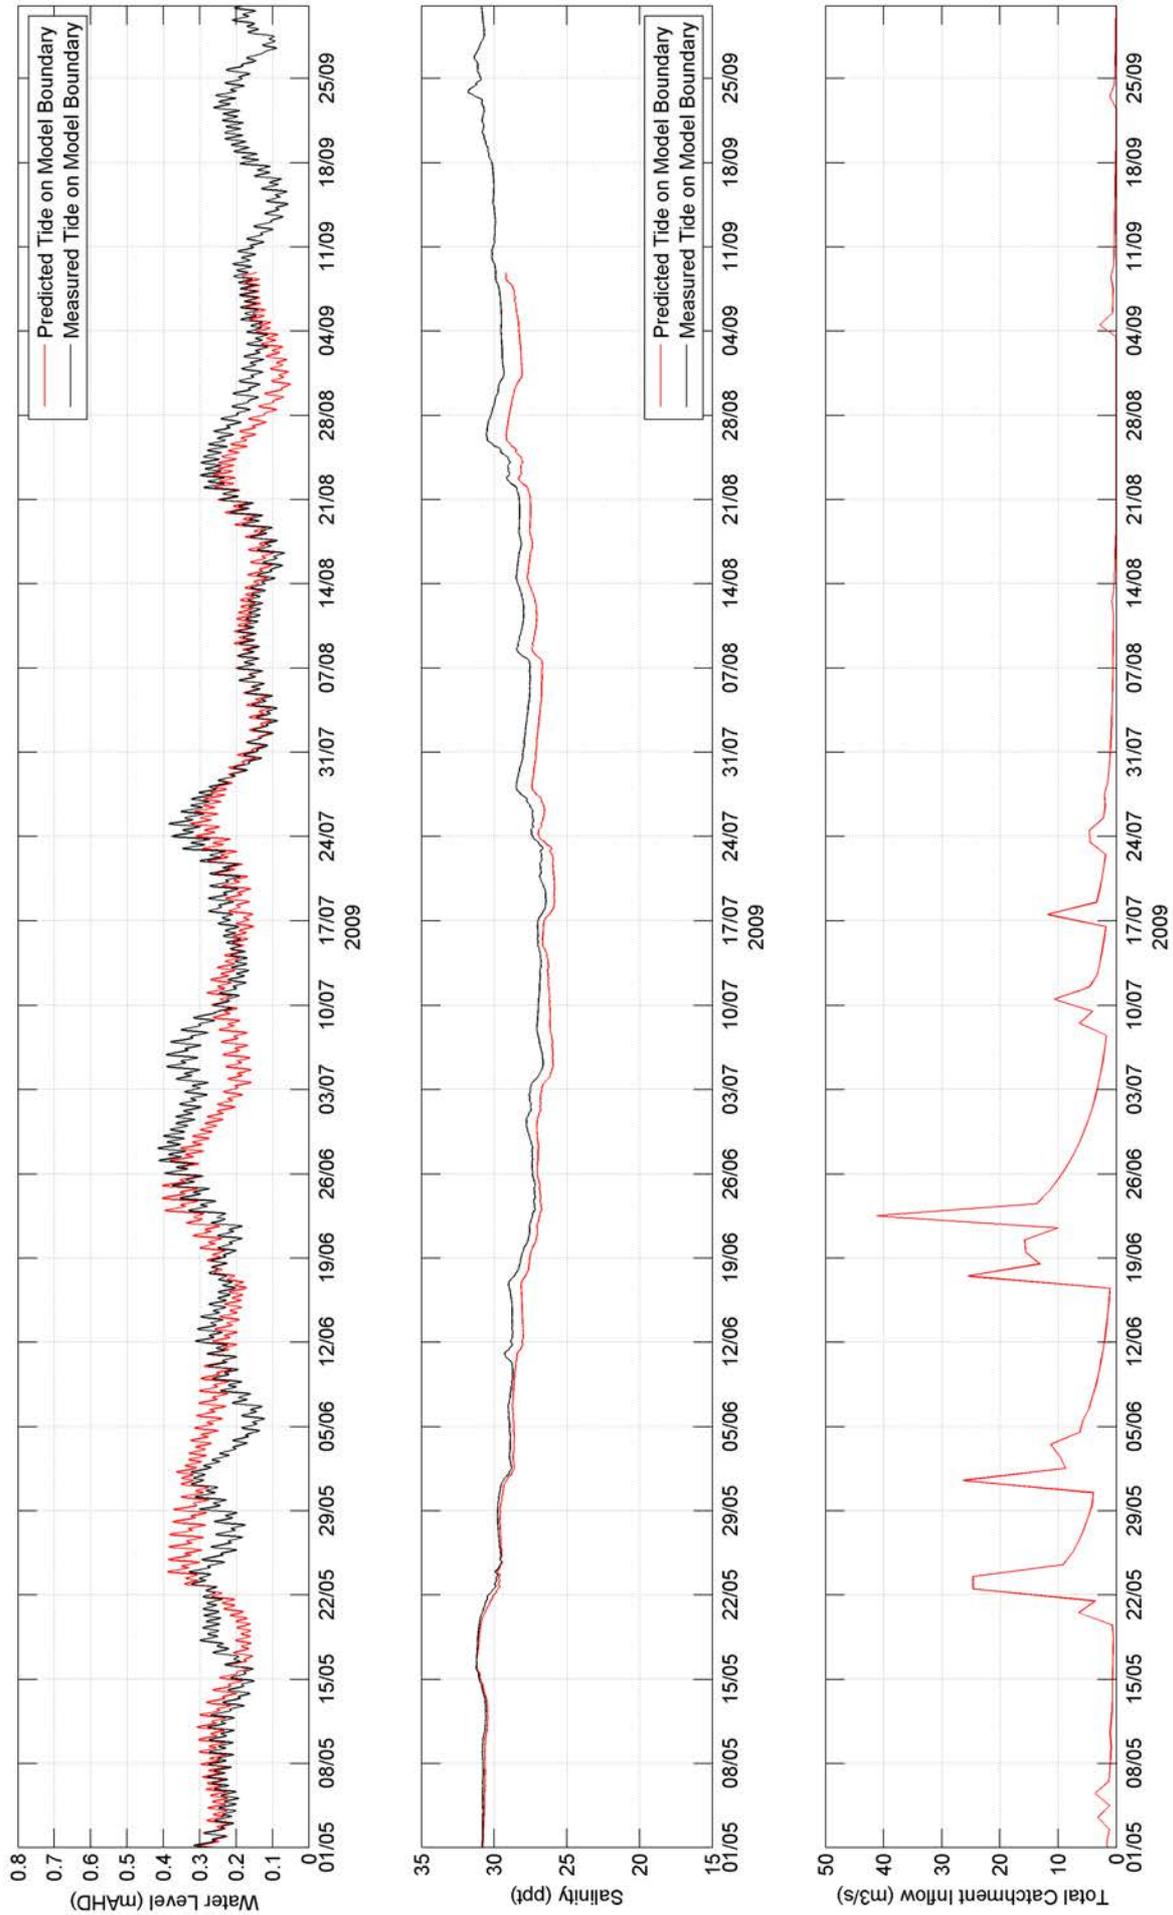
Figure 6.52

Tuggerah Lakes – The Entrance Morphodynamic Modelling
 Comparison of Lake Salinity Using Predicted and Measured Tides
 1996 – MHL Site L2

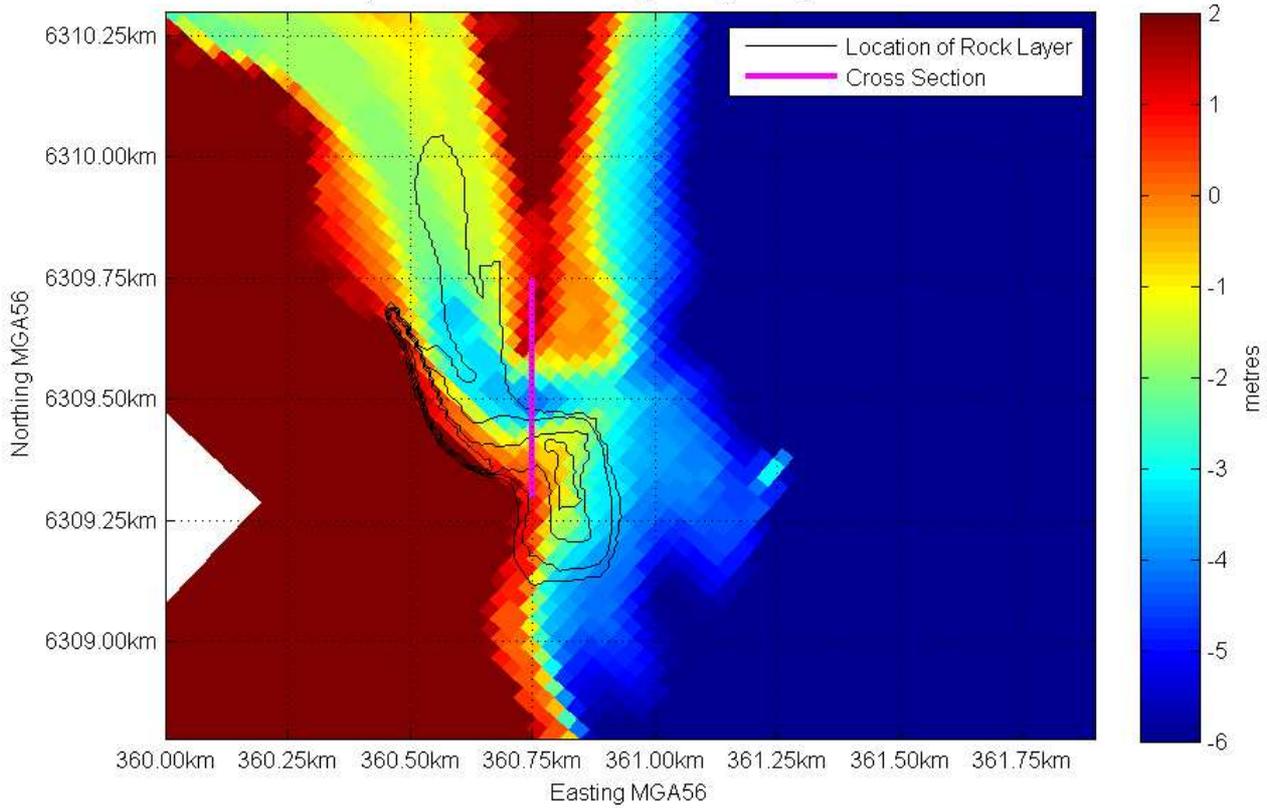
Bathymetric Plot 100yr ARI Flood Existing Bathymetry - 12 June

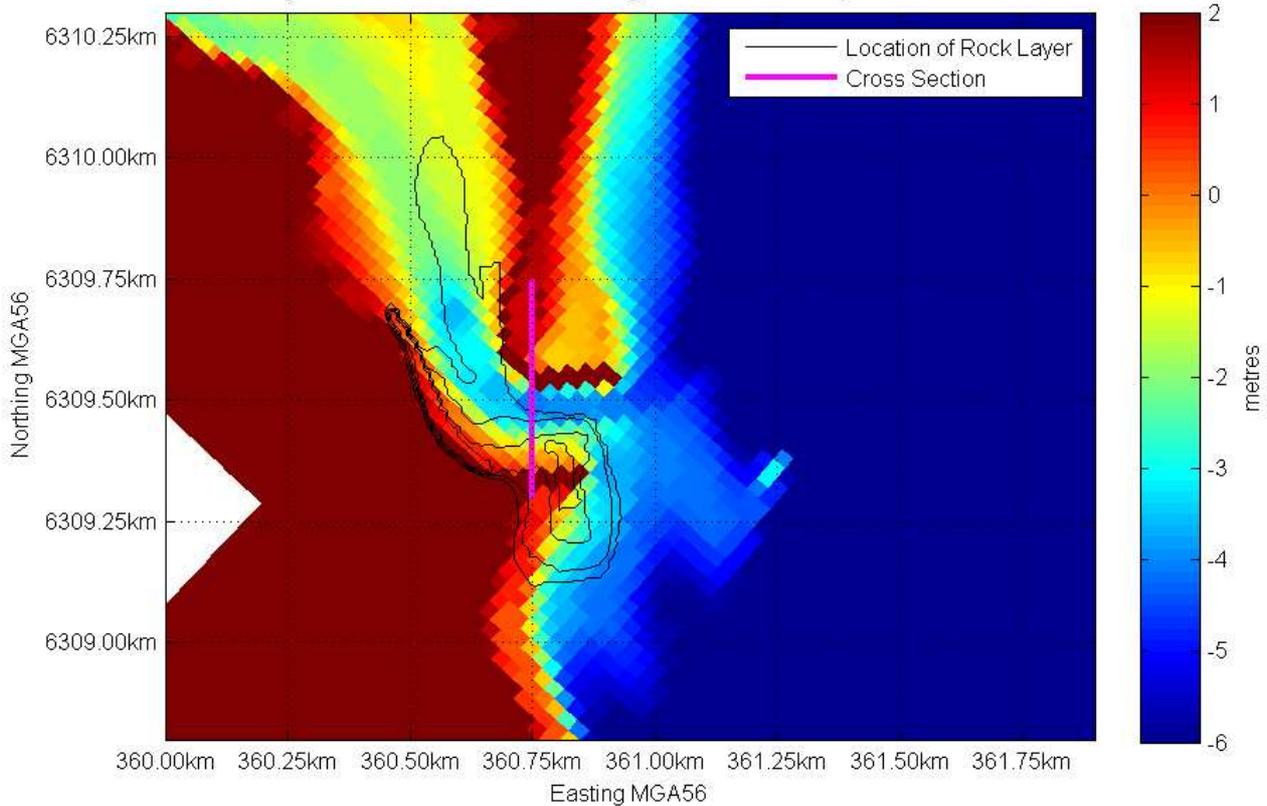
Bathymetric Plot 100yr ARI Flood Dual Training Walls 150m Apart - 12 June

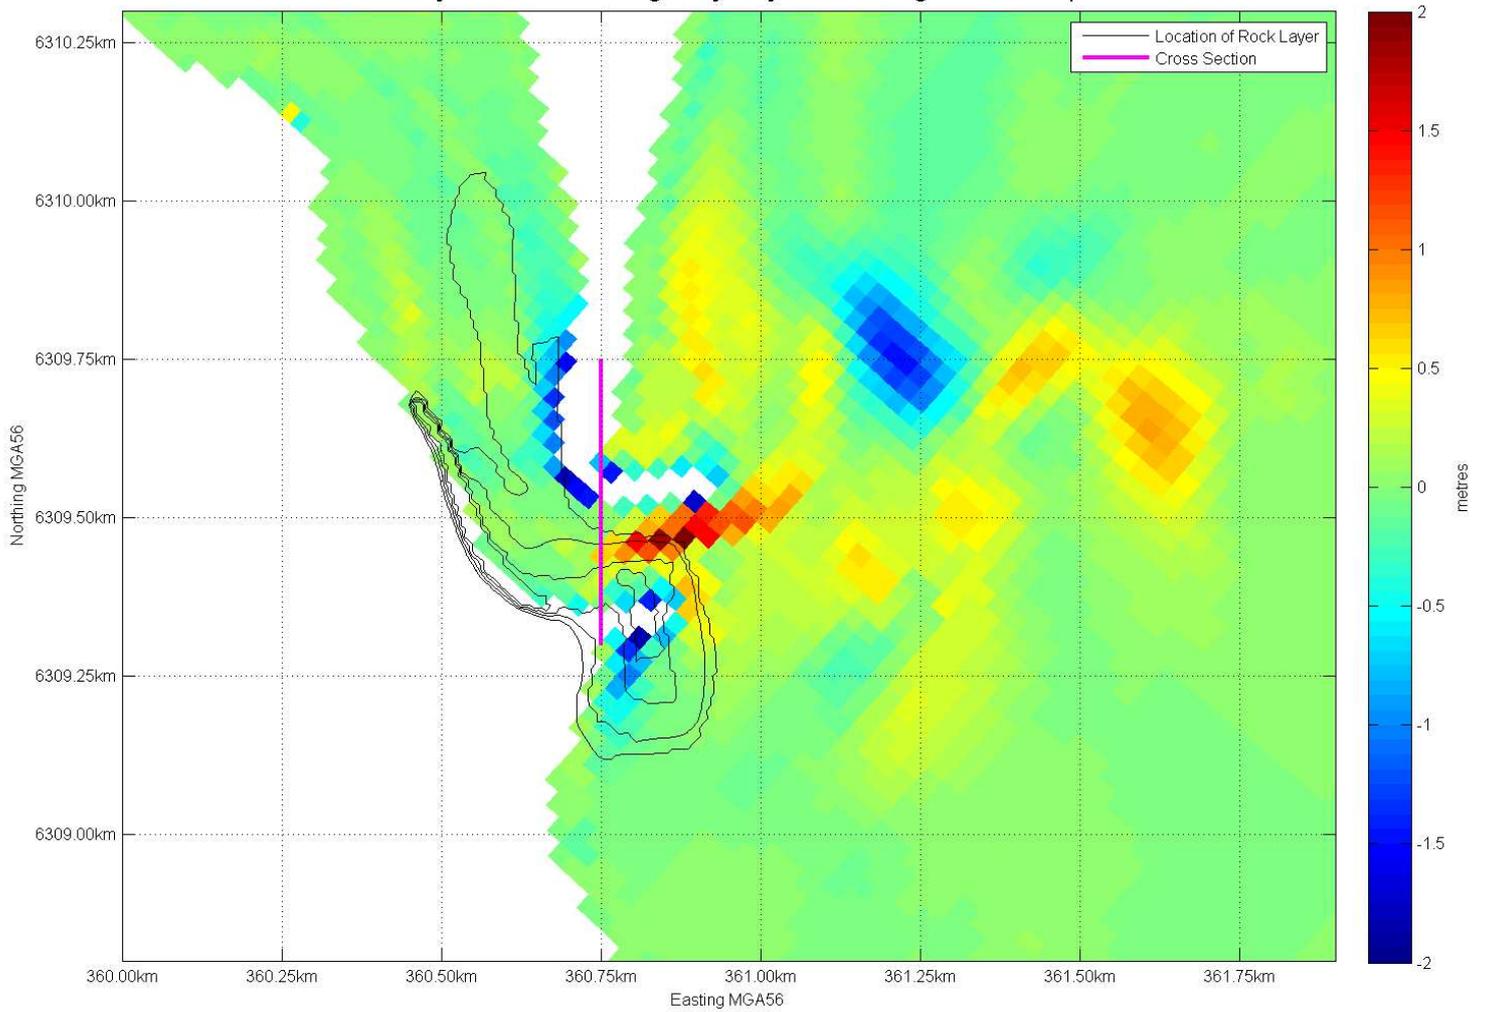
Bathymetric Difference Plot
Post 100yrs ARI Flood: Existing Bathymetry - Dual Training Walls 150m Apart

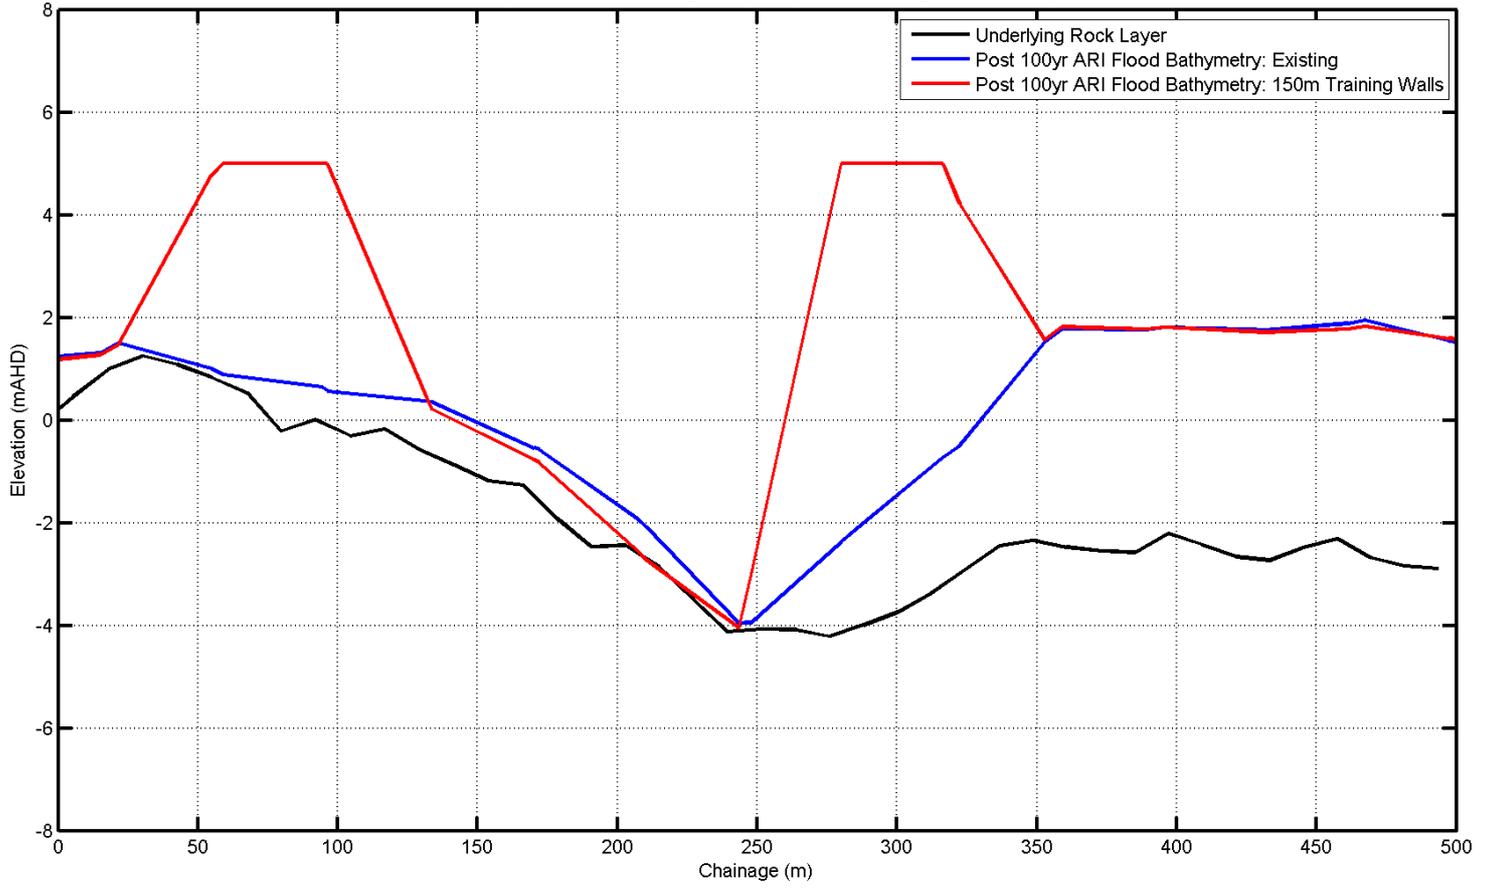
Cross-Sectional Bathymetric Difference Plot
 Post 100yrs ARI Flood: Existing Bathymetry - Dual Training Walls 150m Apart

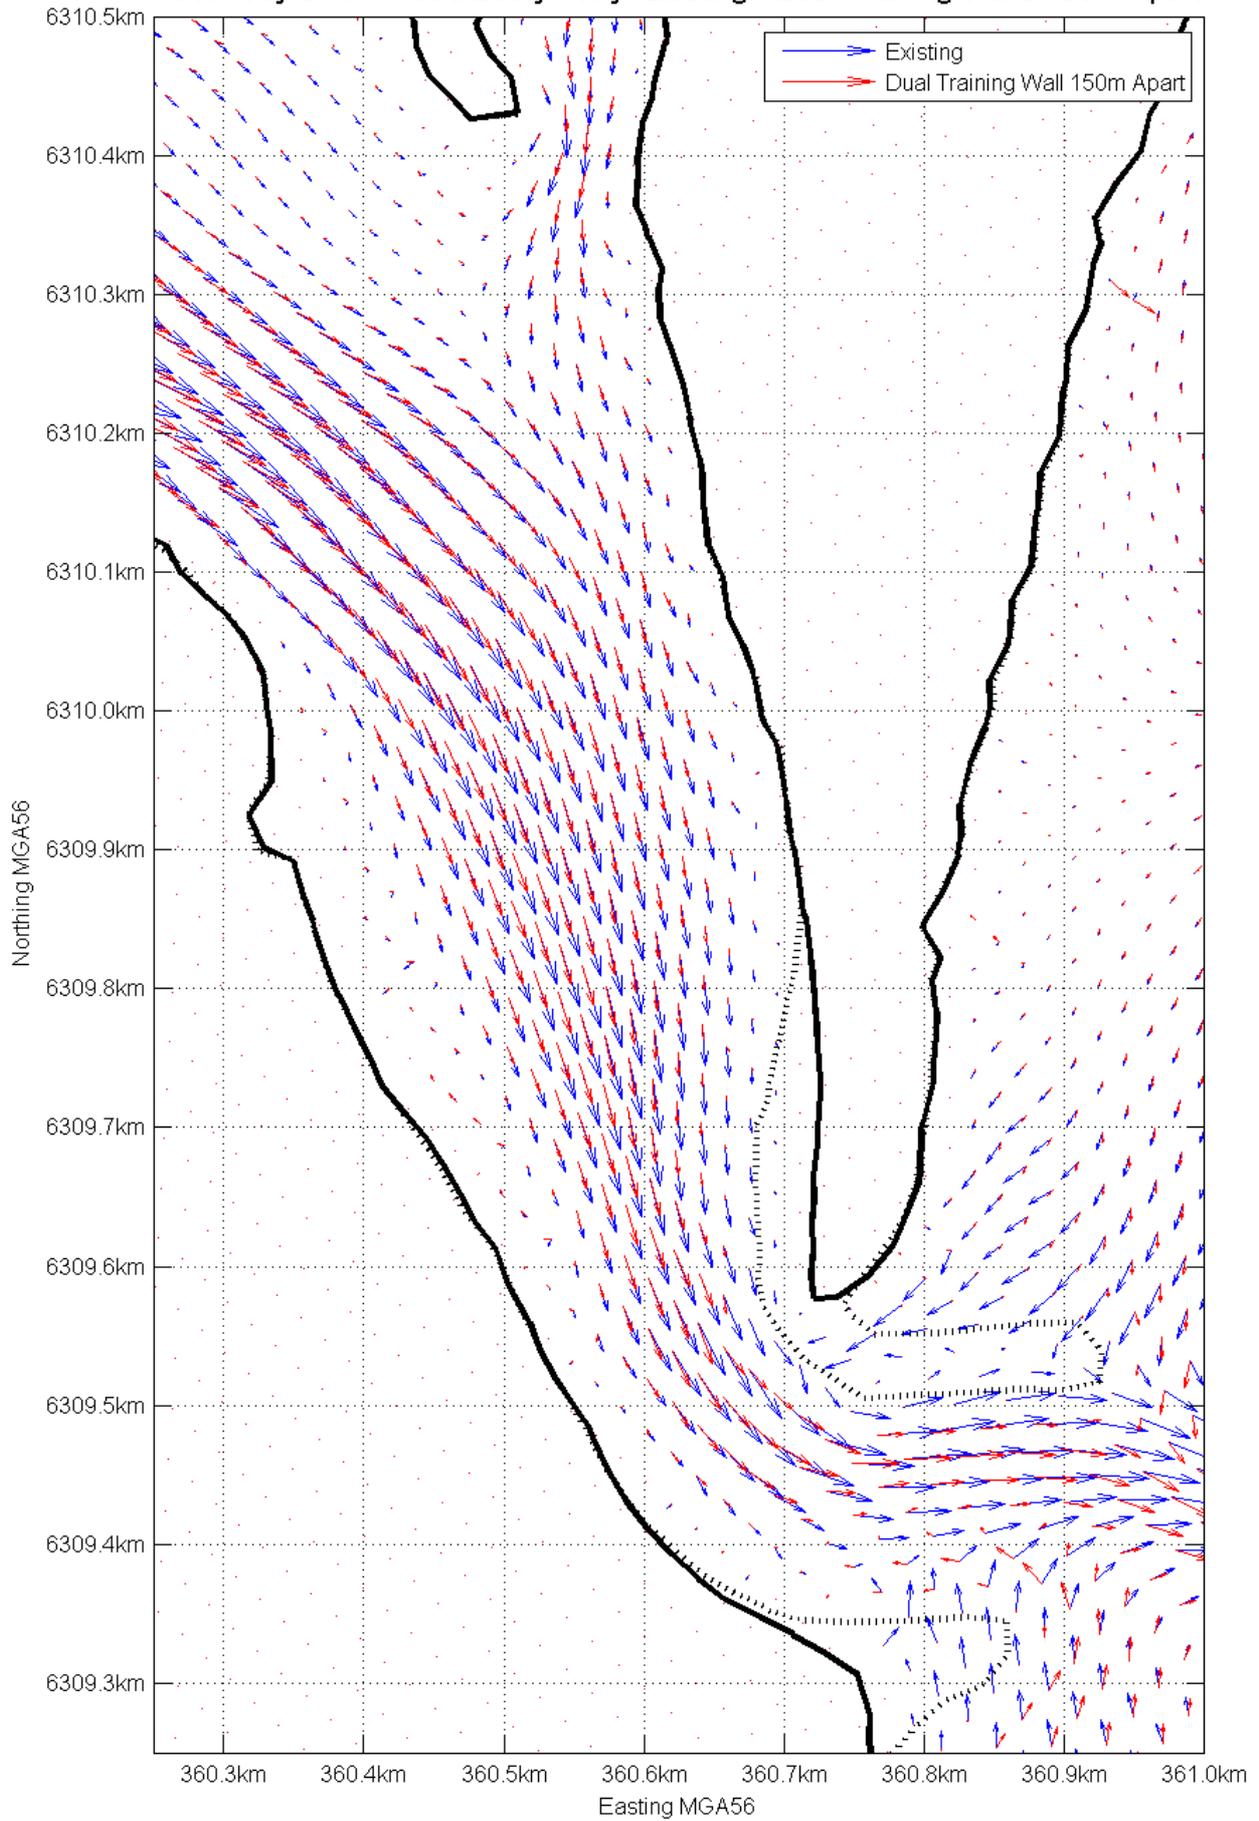
Entrance Channel Ebb Current Vectors - 2 Months after Breakout
Post 100yrs ARI Flood Bathymetry: Existing - Dual Training Walls 150m Apart

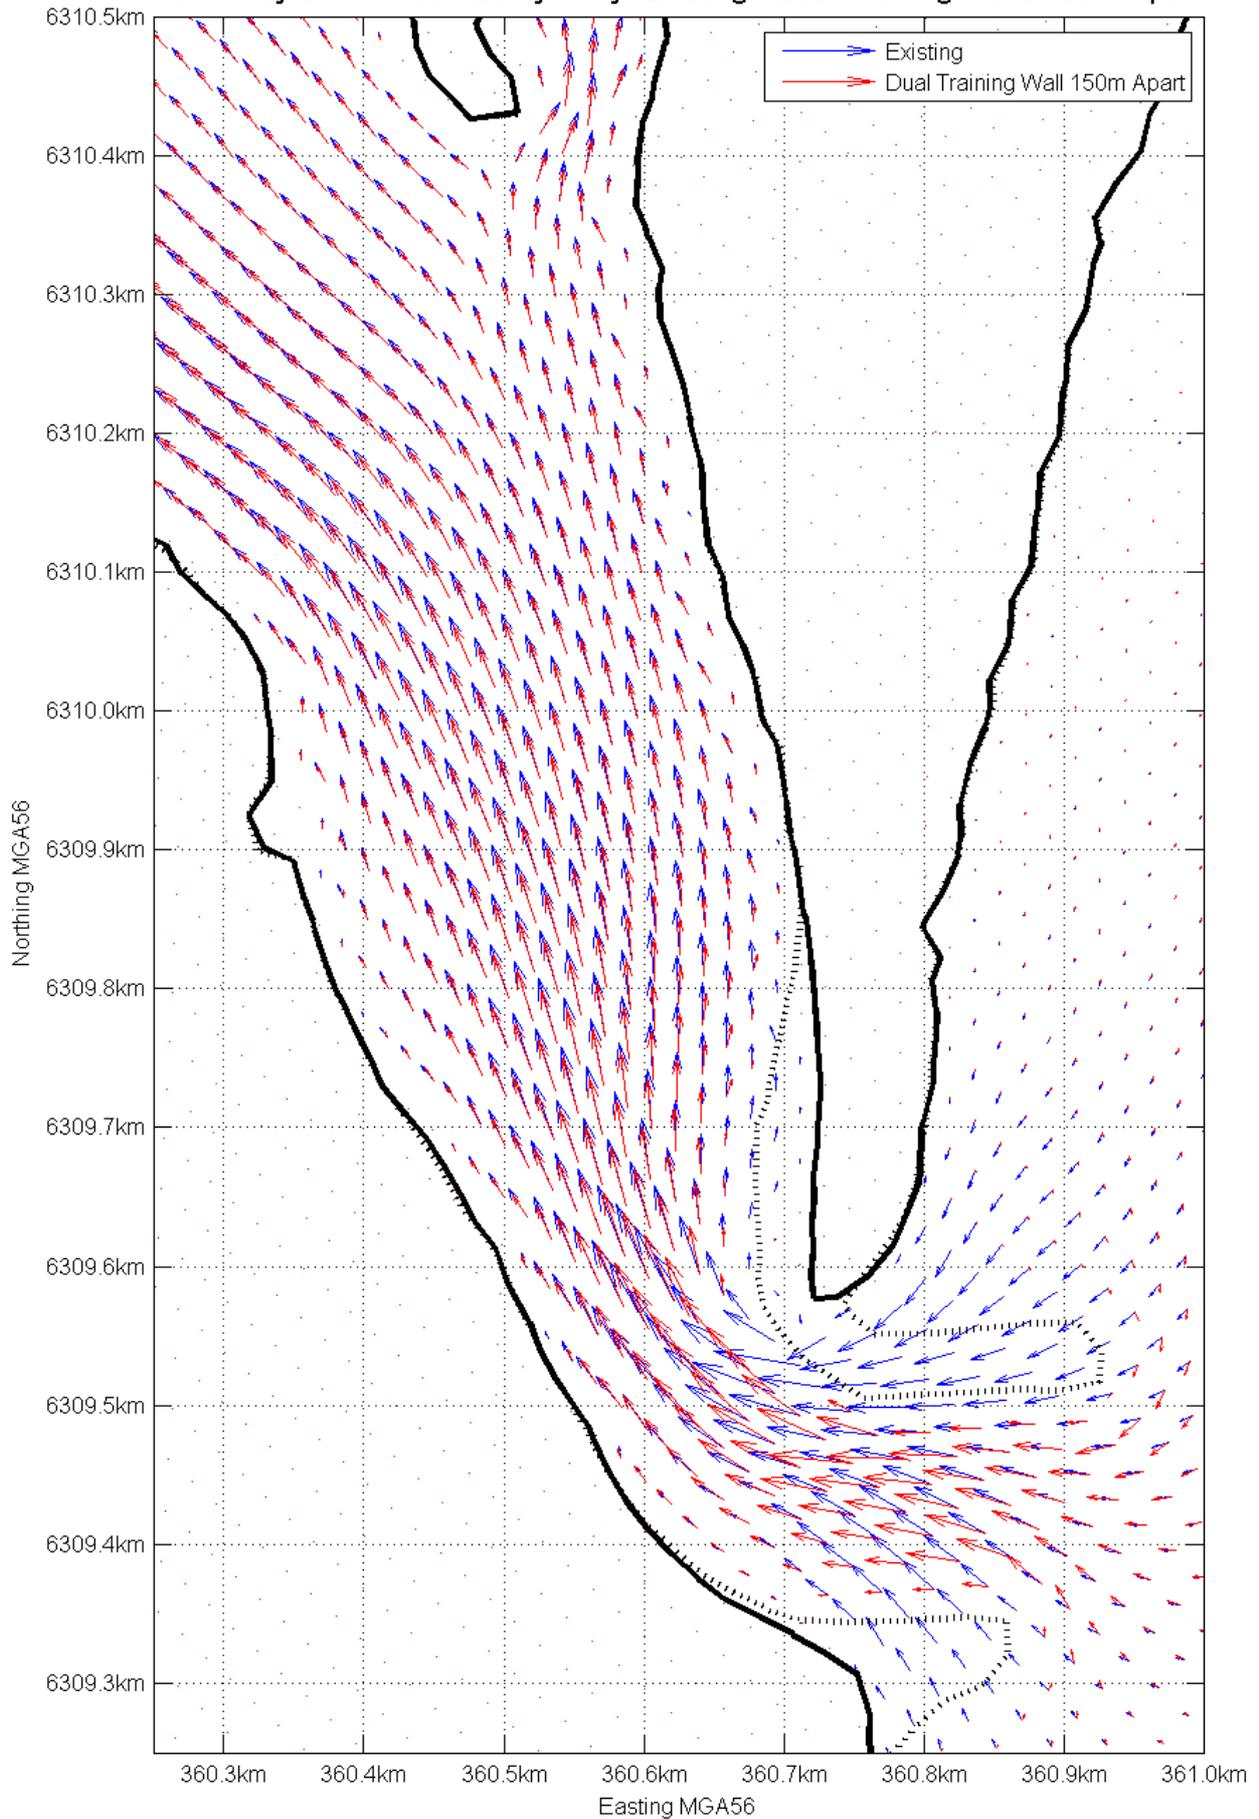
Entrance Channel Flood Current Vectors - 2 Months after Breakout
Post 100yrs ARI Flood Bathymetry: Existing - Dual Training Walls 150m Apart

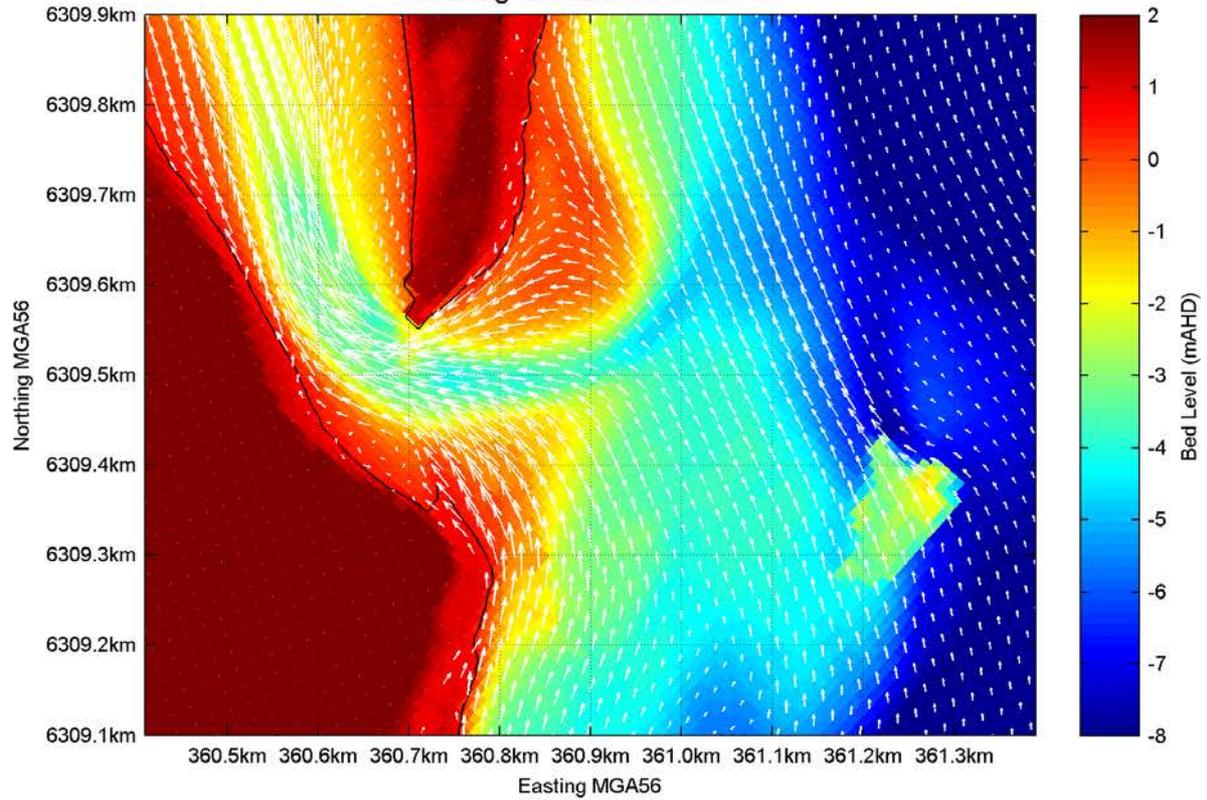
Bed Levels and Velocity Vectors
 100yrsARI Catchment Event - 19 June 2007
 Existing Entrance Condition

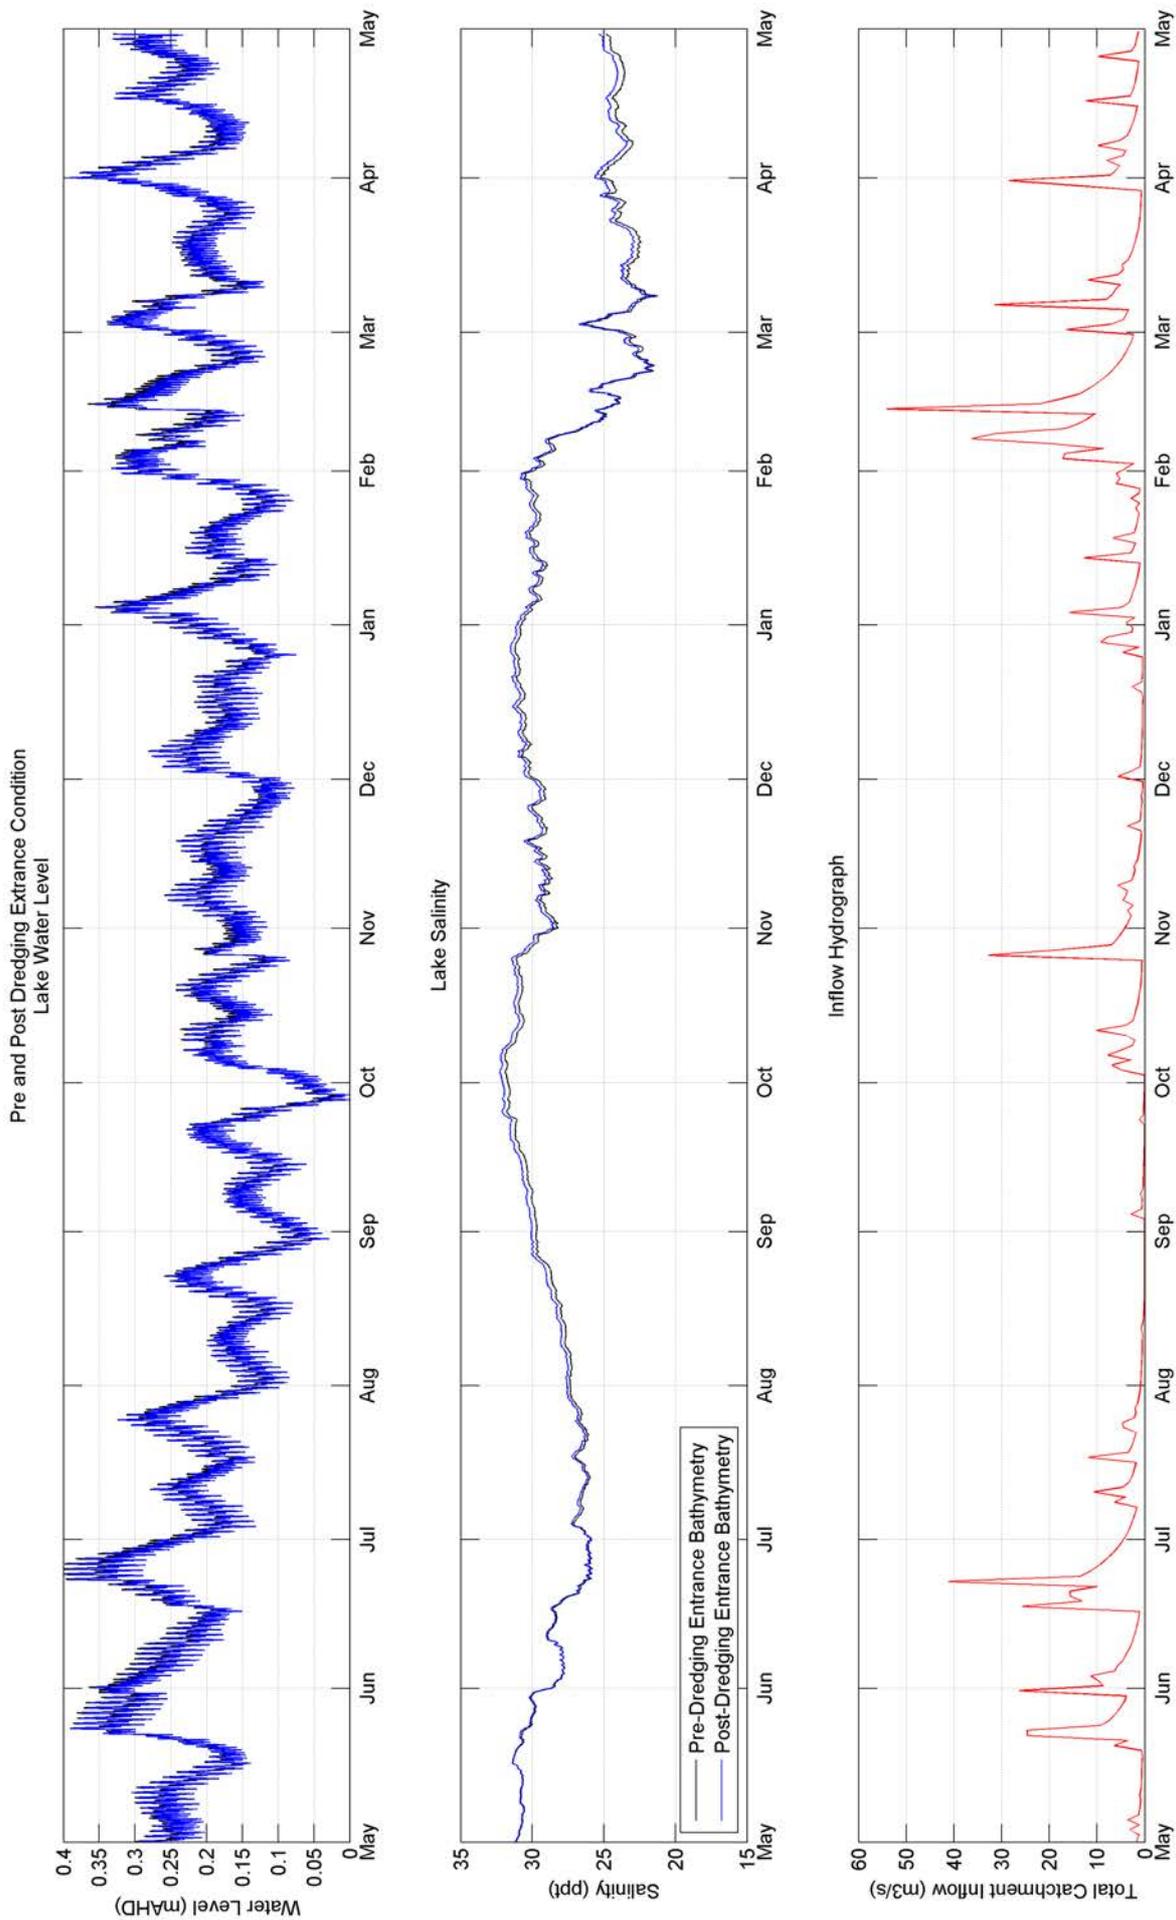
Figure 7.2

Tuggerah Lakes – The Entrance Morphodynamic Modelling
 Annual Timeseries of Water Level and Salinity
 Pre and Post Dredging Entrance Bathymetry

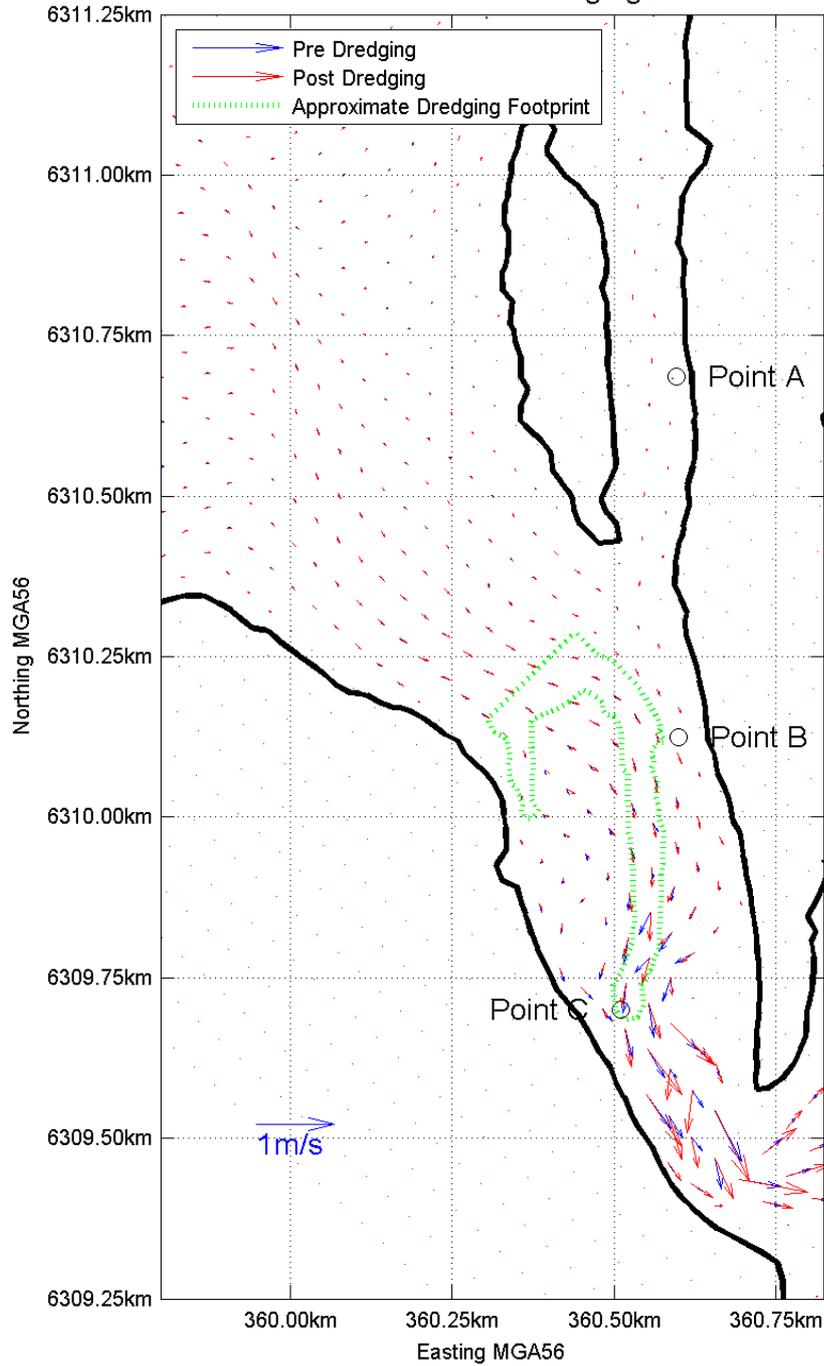
Entrance Channel Current Vector Comparison Pre and Post Dredging

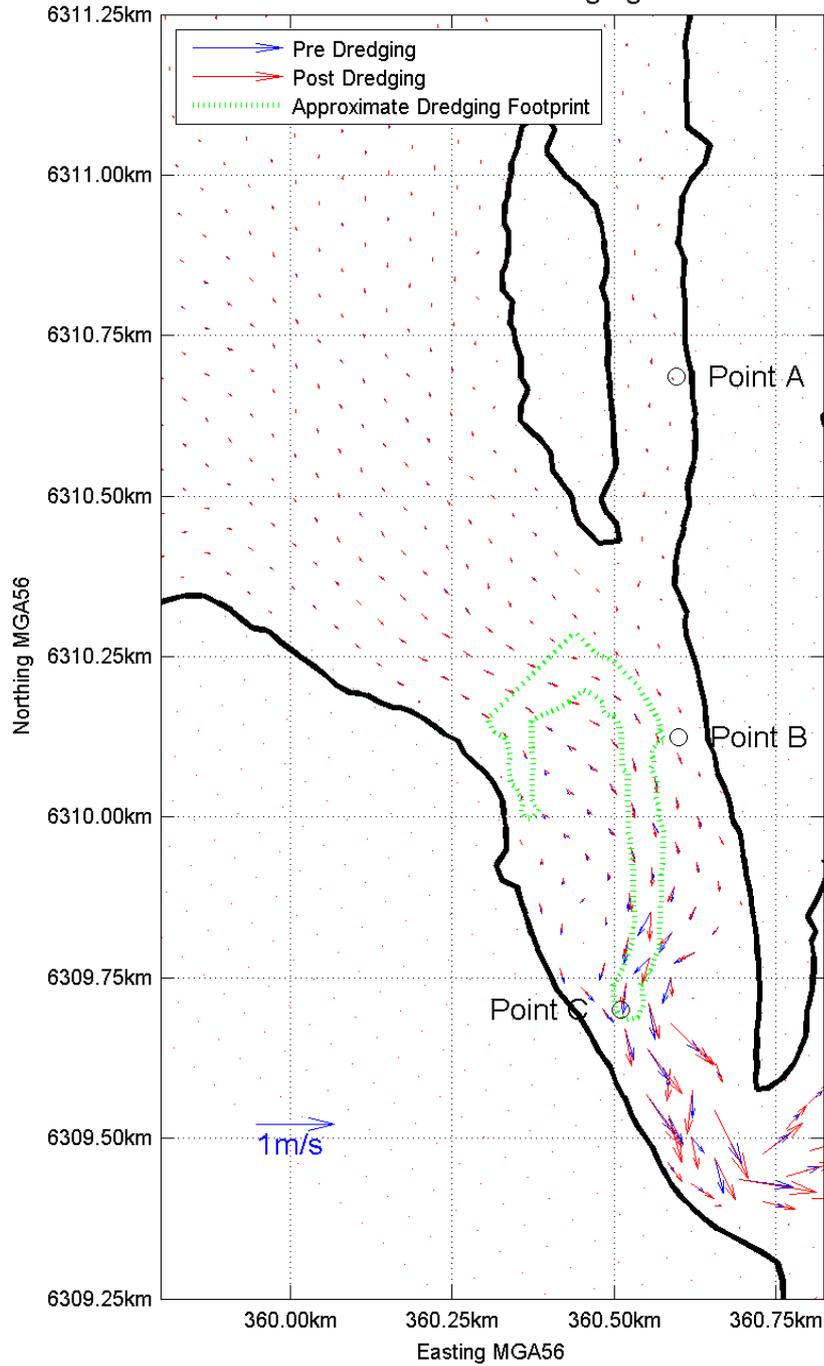
Entrance Channel Current Vector Comparison Pre and Post Dredging

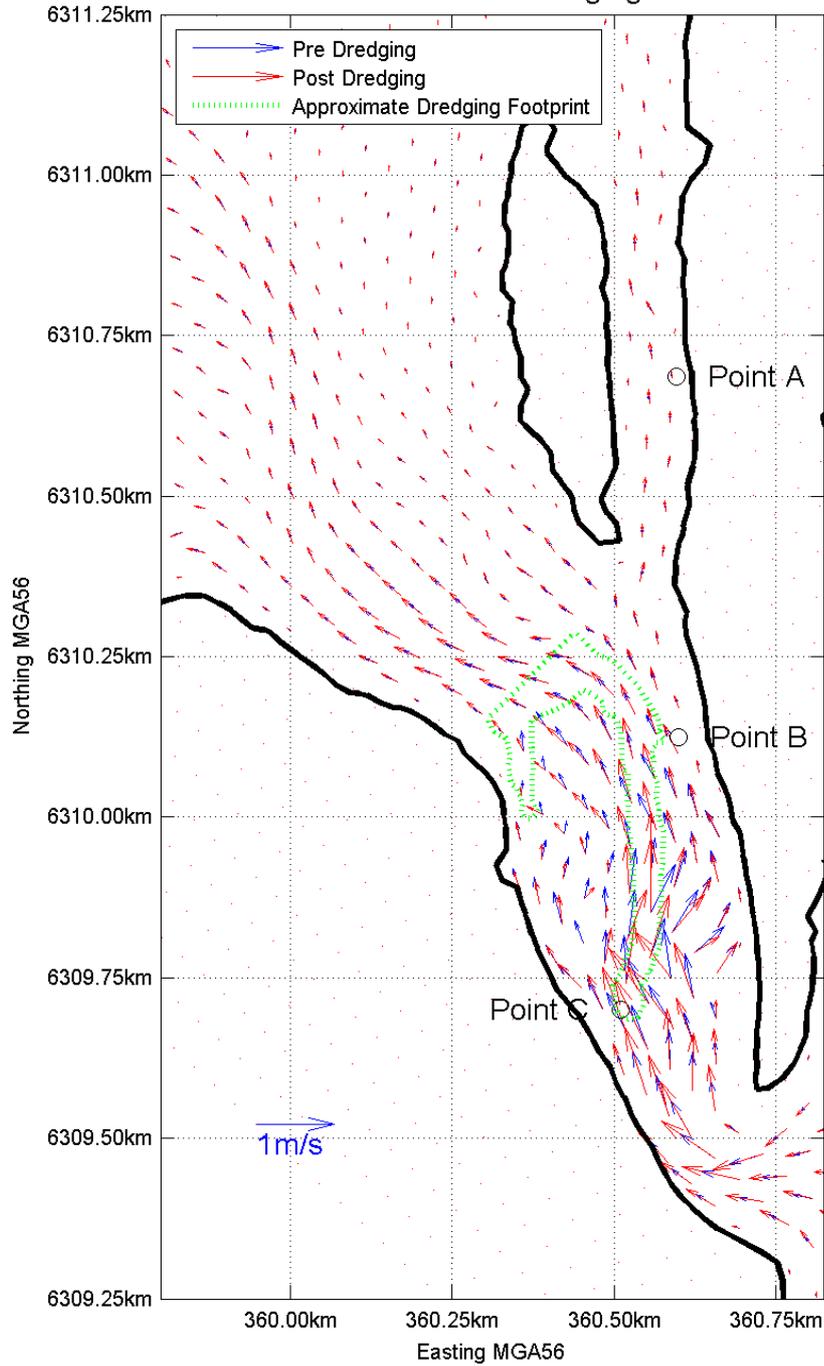
Entrance Channel Current Vector Comparison Pre and Post Dredging

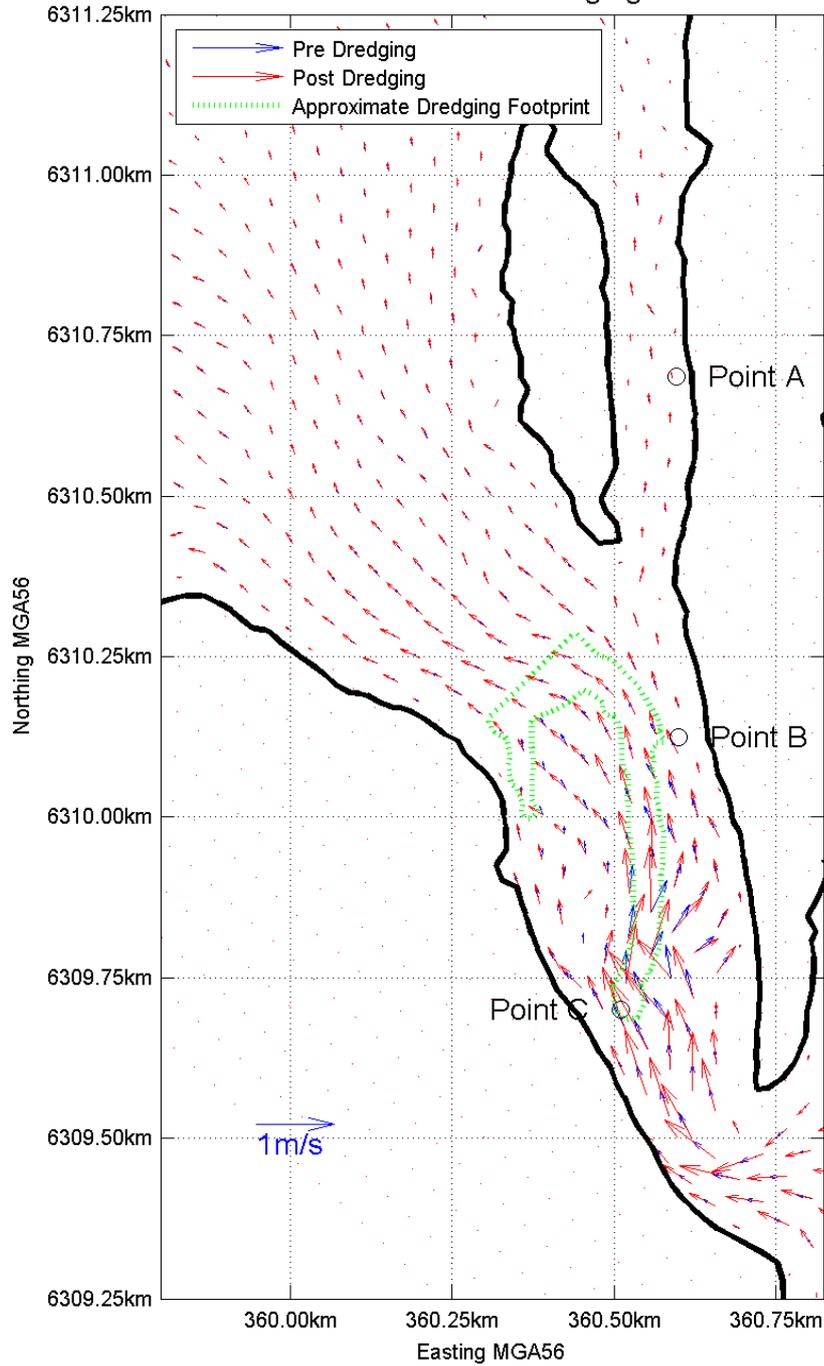
Entrance Channel Current Vector Comparison Pre and Post Dredging

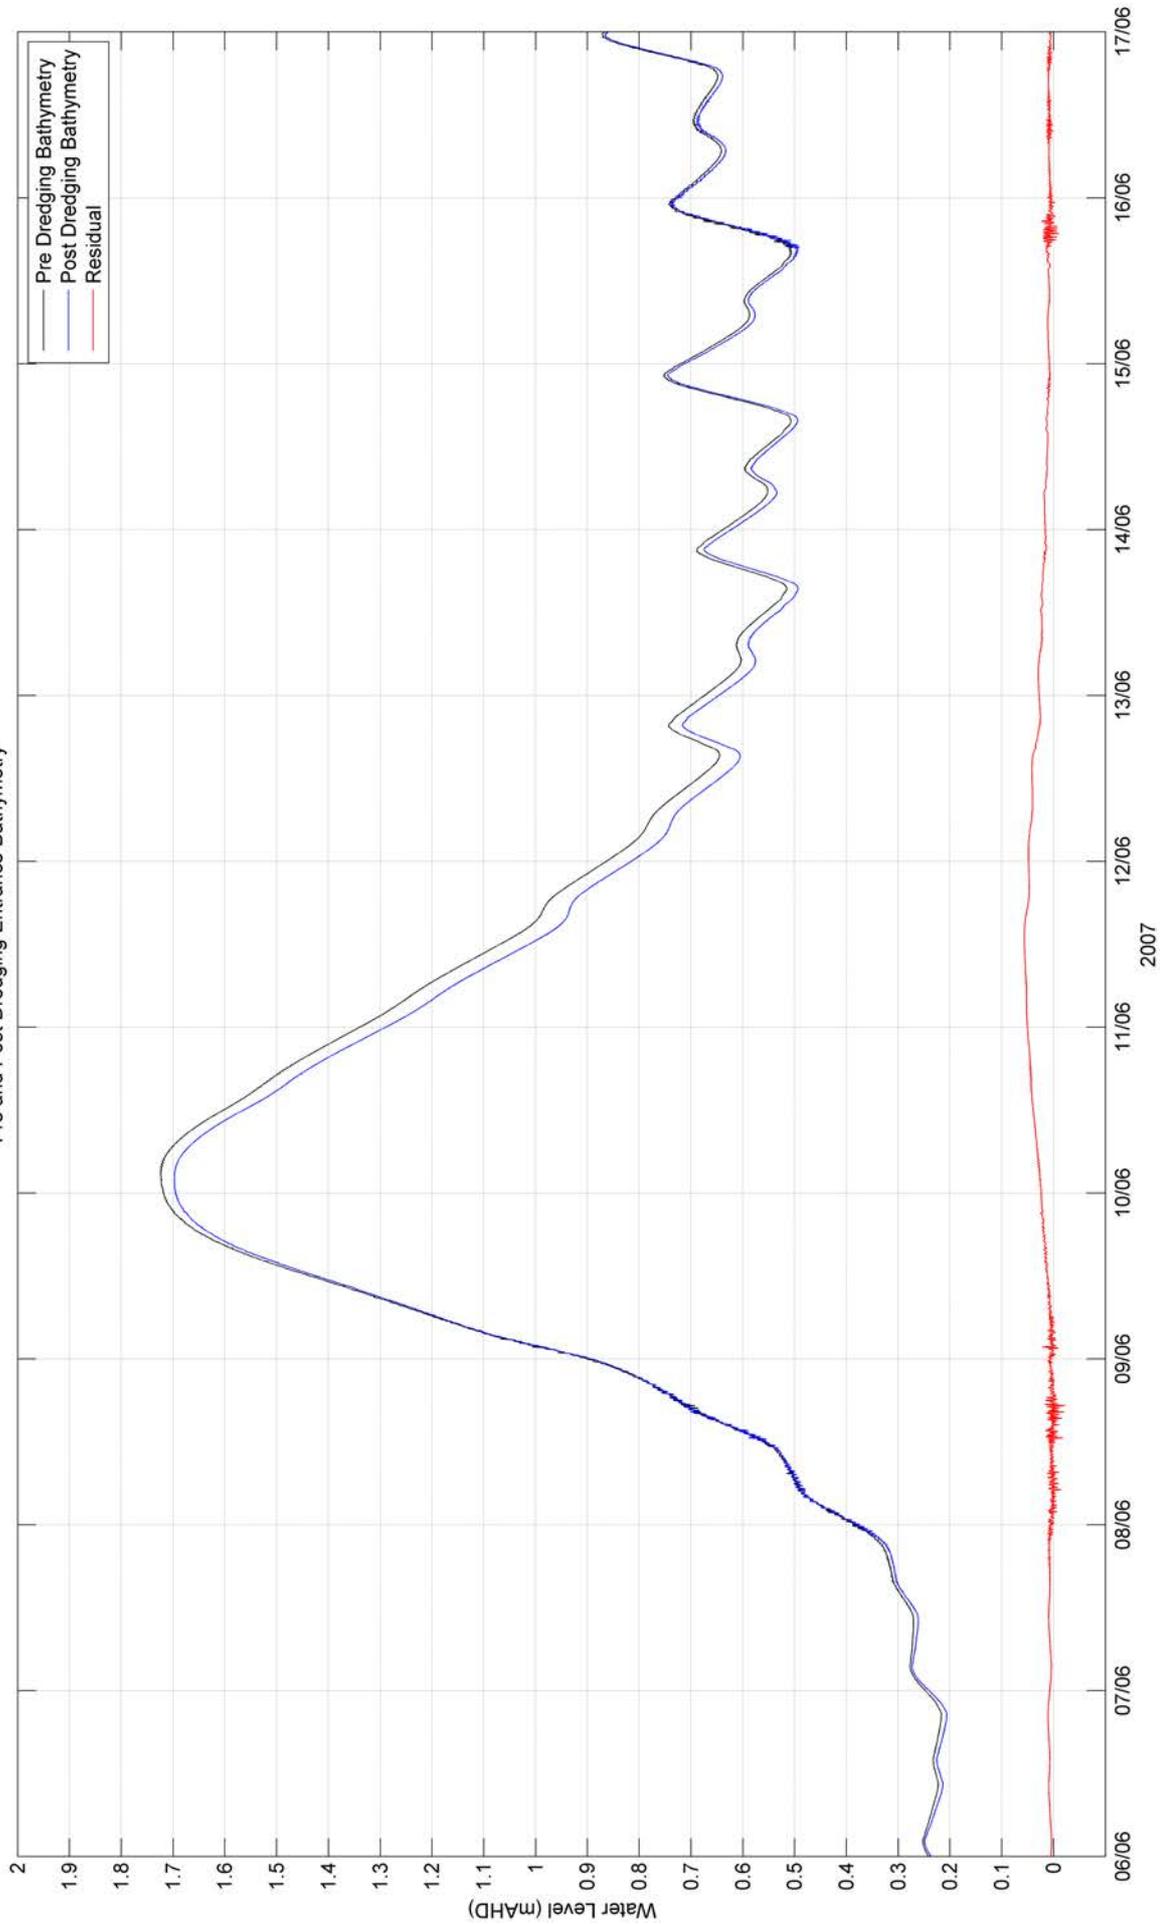
June 2007 Flood Event: Water Levels at Long Jetty
Pre and Post Dredging Entrance Bathymetry
