Long Jetty Waterwatch Data Review

2010-2015

An independent review of community data undertaken by
Wyong Shire Council's Waterways and Coastal Team

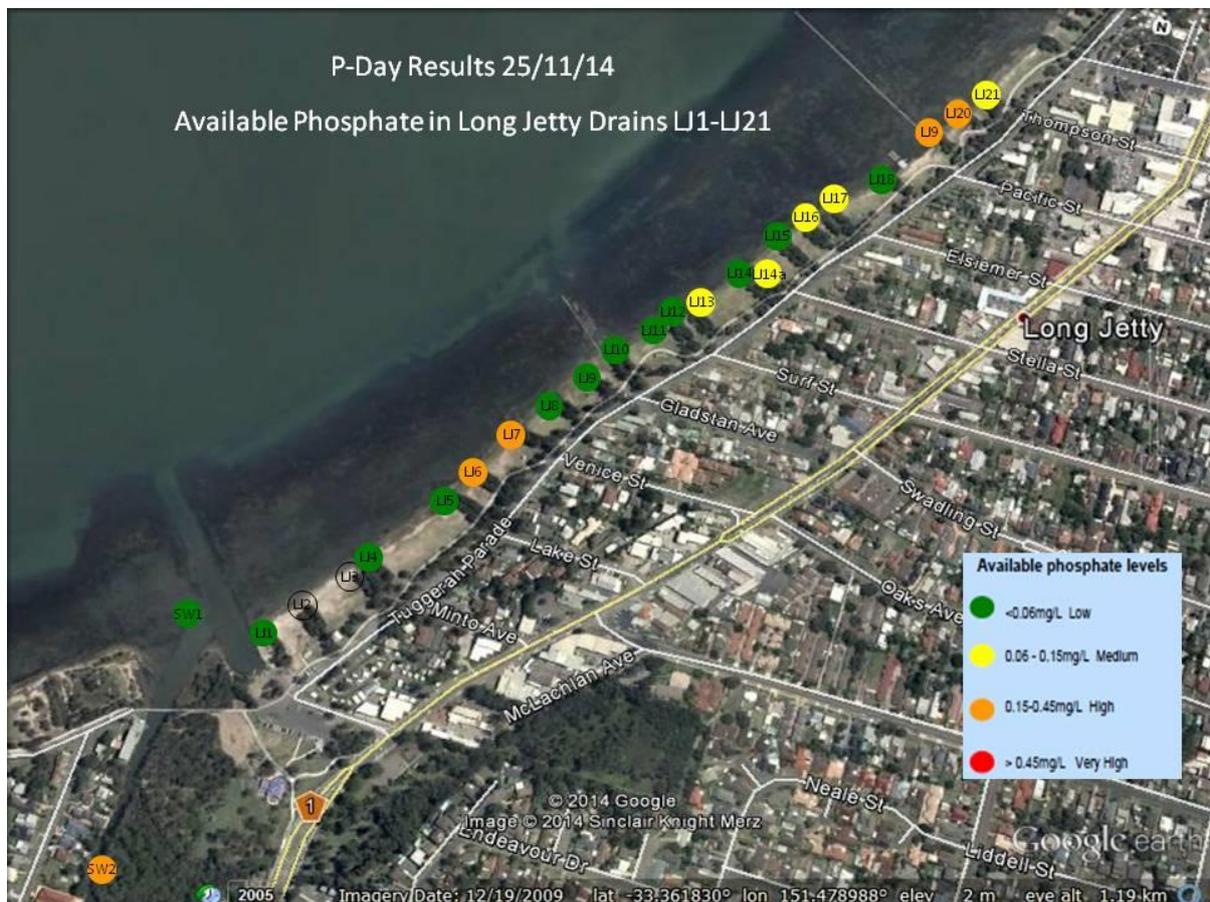
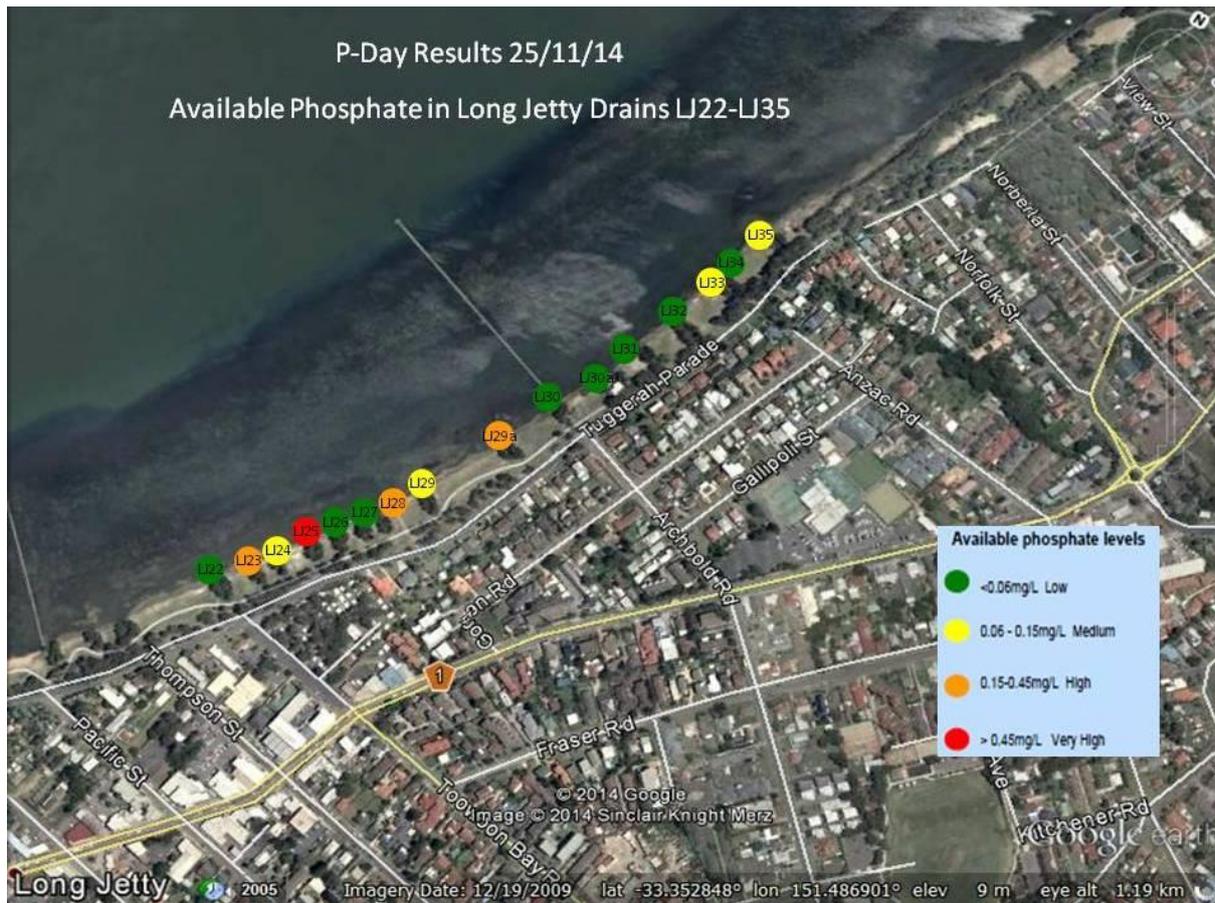
Drain numbering system

The aerial images below show the drain identification system used by the group to identify individual drains.

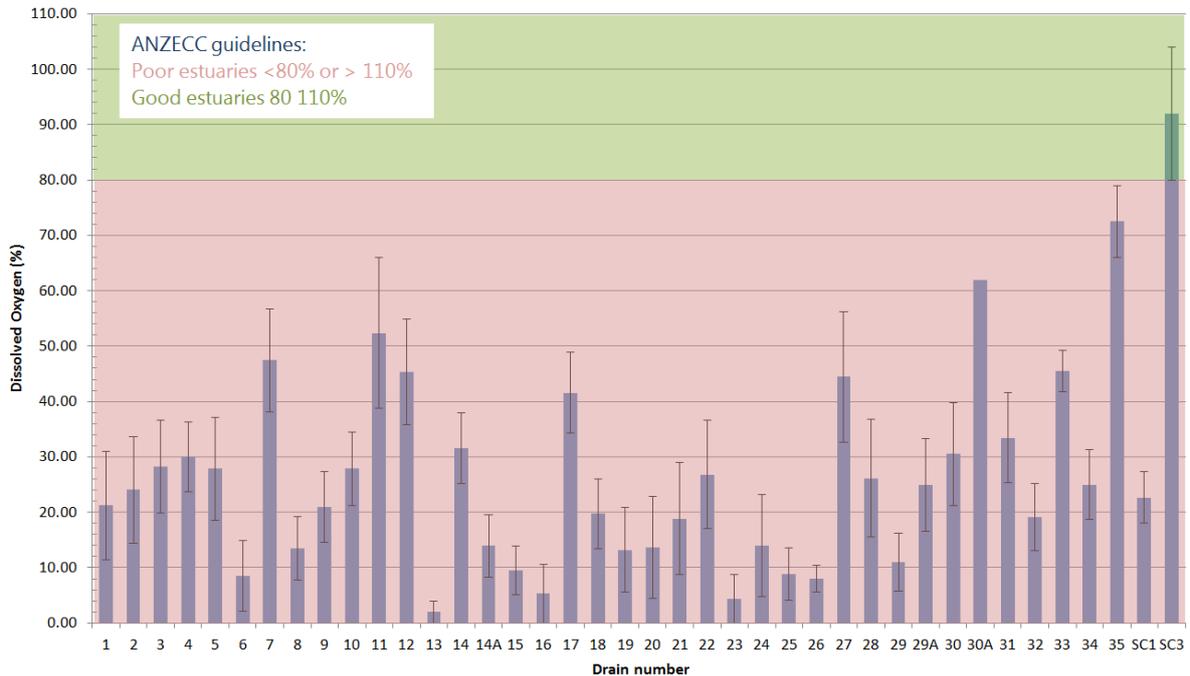
Long Jetty Waterwatch (2010-15) Average Dissolved Oxygen

The following graph shows the average DO at each drain over the 6 years of sampling. The green area indicates the range of values expected from a healthy estuary. Hyper- or hypo-saturation can be an indicator of an ecological imbalance within the system and a risk factor for aquatic fauna.

All sites except SC3 (upstream of the Central Coast Highway on Saltwater Creek) recorded values below the ANZECC trigger value of 80%. It is likely that this is a result of pooling stagnant water and could be an indicator of excessive aquatic plant growth.

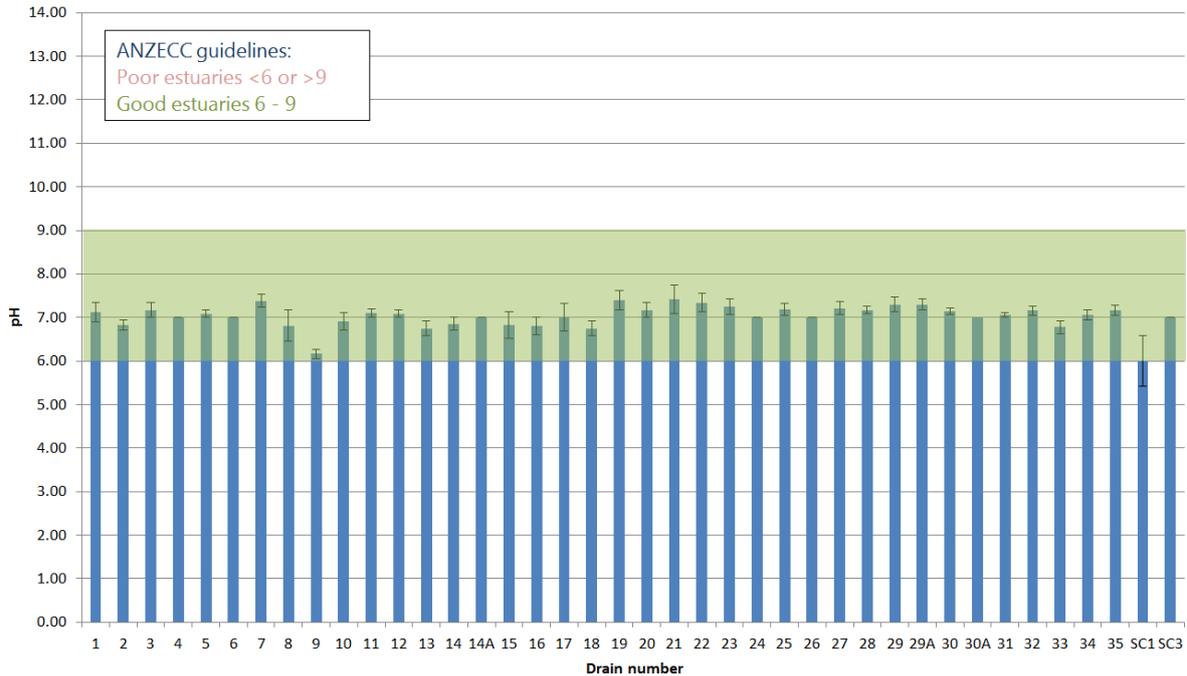
Long Jetty Waterwatch (2010-15) Average pH

The following graph shows the average pH at each drain over the 6 years of sampling. The green area indicates the range of values expected from a healthy estuary. Water that is too acidic or too basic can seriously impact the ecology of the waterway.

All sites except SC1 (the mouth of Saltwater Creek) fell within the ANZECC guidelines for healthy estuaries. SC1 has a very large catchment and is likely to have been influenced by the lower pH of freshwater flowing through this site. A pH level below 6 would be cause for further investigation and should be monitored by the group in upcoming sampling periods.

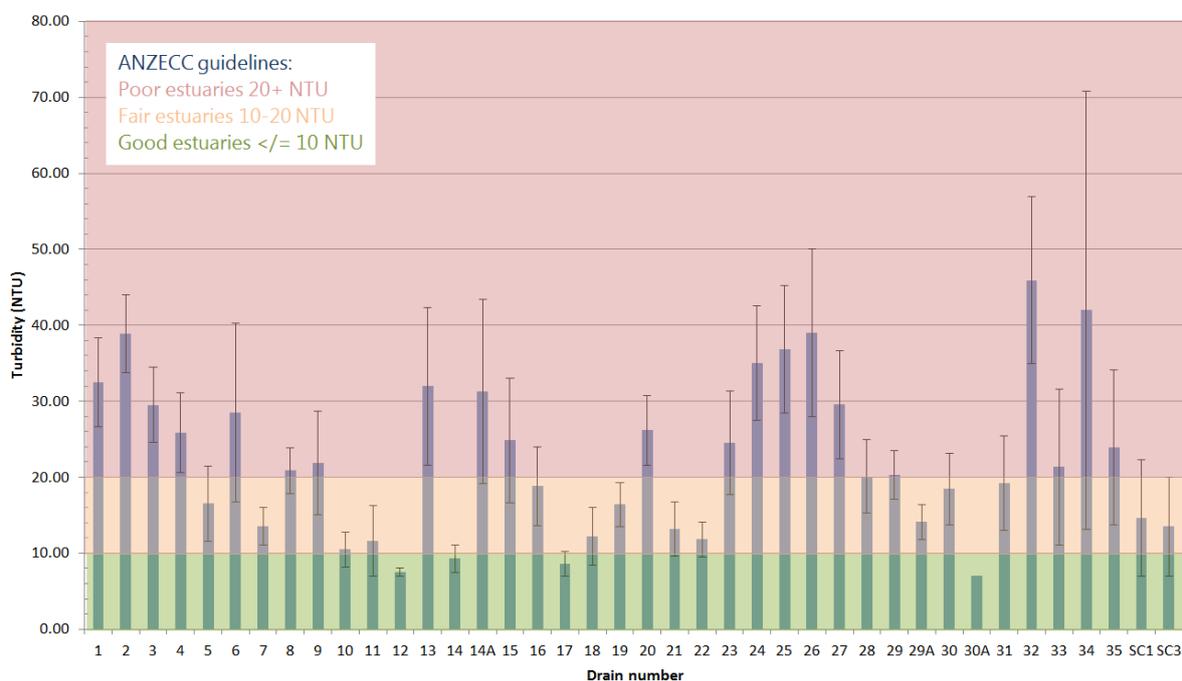
Long Jetty Waterwatch (2010-15) Average Turbidity

The following graph shows the average turbidity at each drain over the 6 years of sampling. The green area indicates the range of values expected from a healthy estuary. The orange band shows the values that represent fair quality and the red band is considered poor quality water within an estuary.

Few sites can be considered healthy based on average turbidity. Sites 12, 14, 17 and 30A are the only sites which fall within the healthy range for estuaries. These sites also exhibit lower levels of available phosphorus as shown in the next section of the report and therefore represent the best quality inputs along the Long Jetty foreshore. All other sites can be considered fair to poor in terms of turbidity and further investigation is recommended.

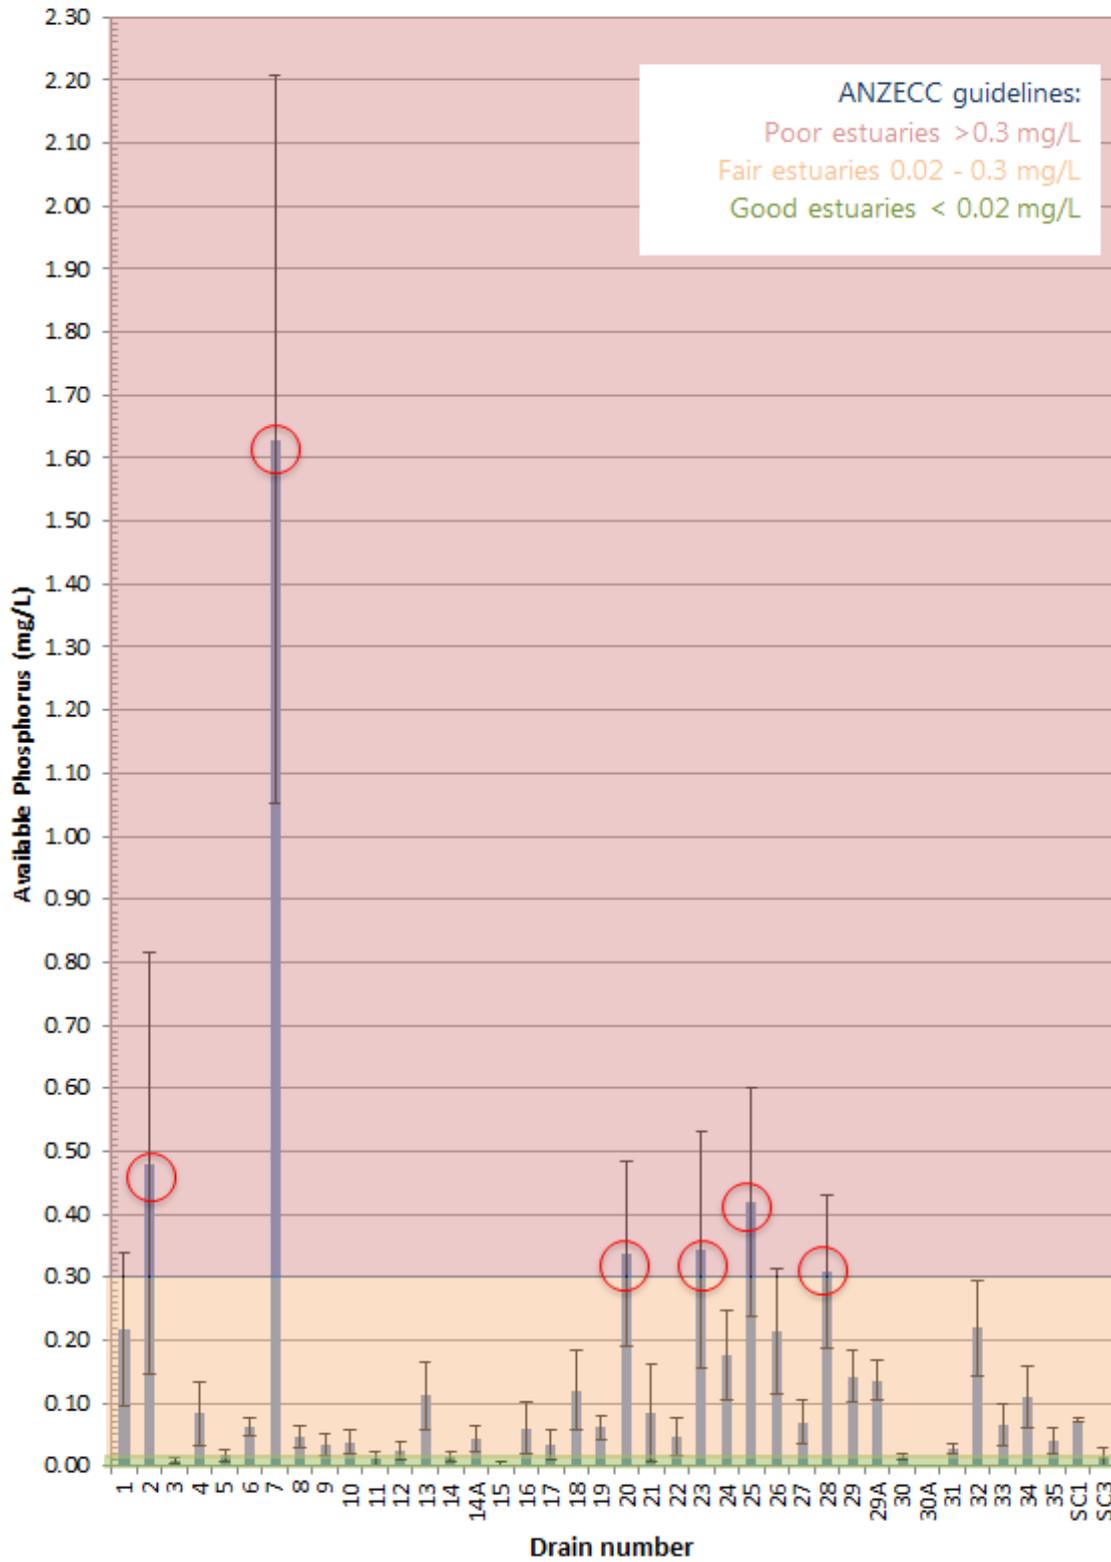
Long Jetty Waterwatch (2010-15) Average Available Phosphorus

The following graph shows the average available phosphorus at each drain over the 6 years of sampling. The narrow green band indicates the range of values expected from a healthy estuary (less than 0.02mg/L). The orange band shows the values found in a fair condition estuary and the red band shows poor quality results.

Six of the 40 sites recorded average available phosphorus levels greater than 0.3mg/L which represent poor results. These sites include 7, 2, 25, 23, 20 and 28 respectively. Site 7 has performed

consistently badly over the six years of testing. The site has been tested 21 times and has scored a good rating 9% of the time, a fair rating 29% of the time and a poor rating 62% of the time. This coupled with fair turbidity ratings makes site 7 the worst performing site along with those listed above. Further investigation is encouraged to try to reduce pollutant inputs at the source and improve water quality entering the vulnerable Long Jetty nearshore zone.
