Tuggerah Lakes Black Ooze

Removal investigations and feasibility study

Prepared for
Wyong Shire Council

31 July 2015

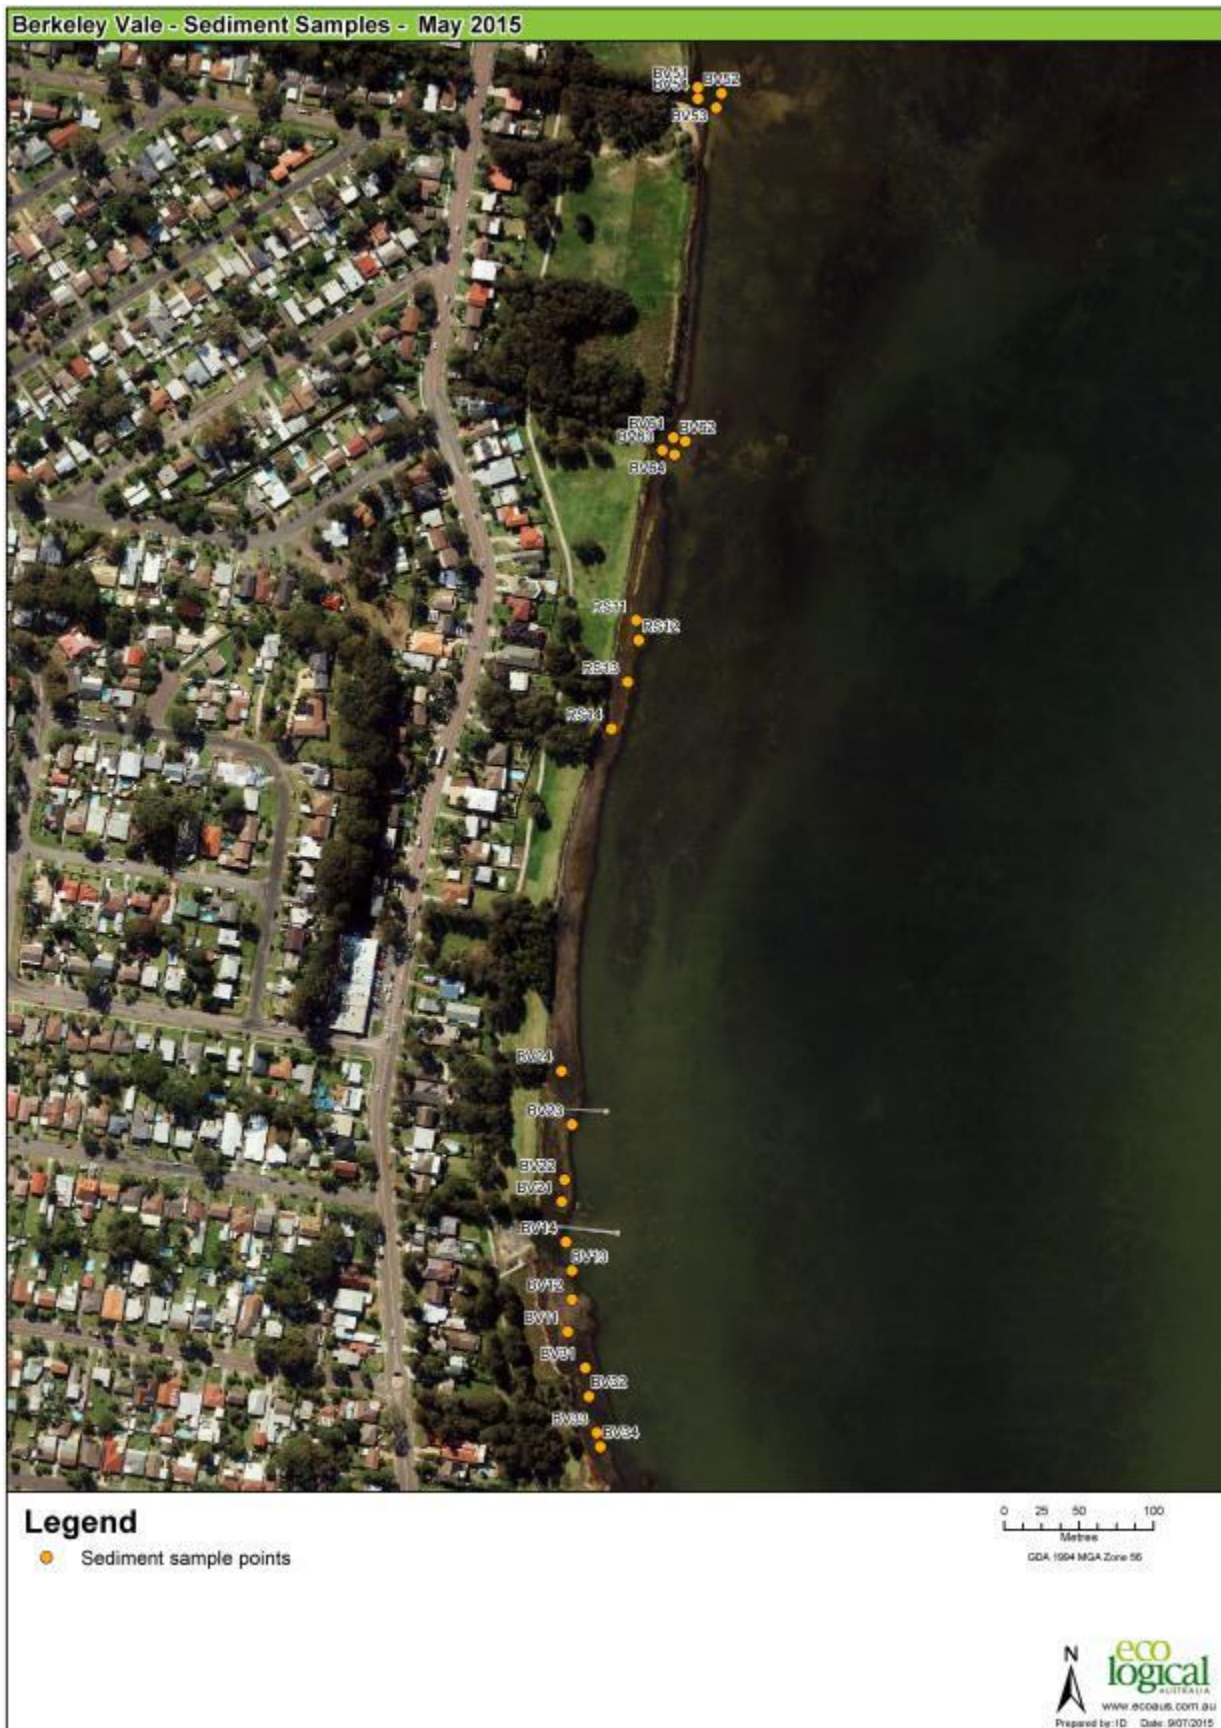
Figure 1: Sediment sample locations (Map 1)

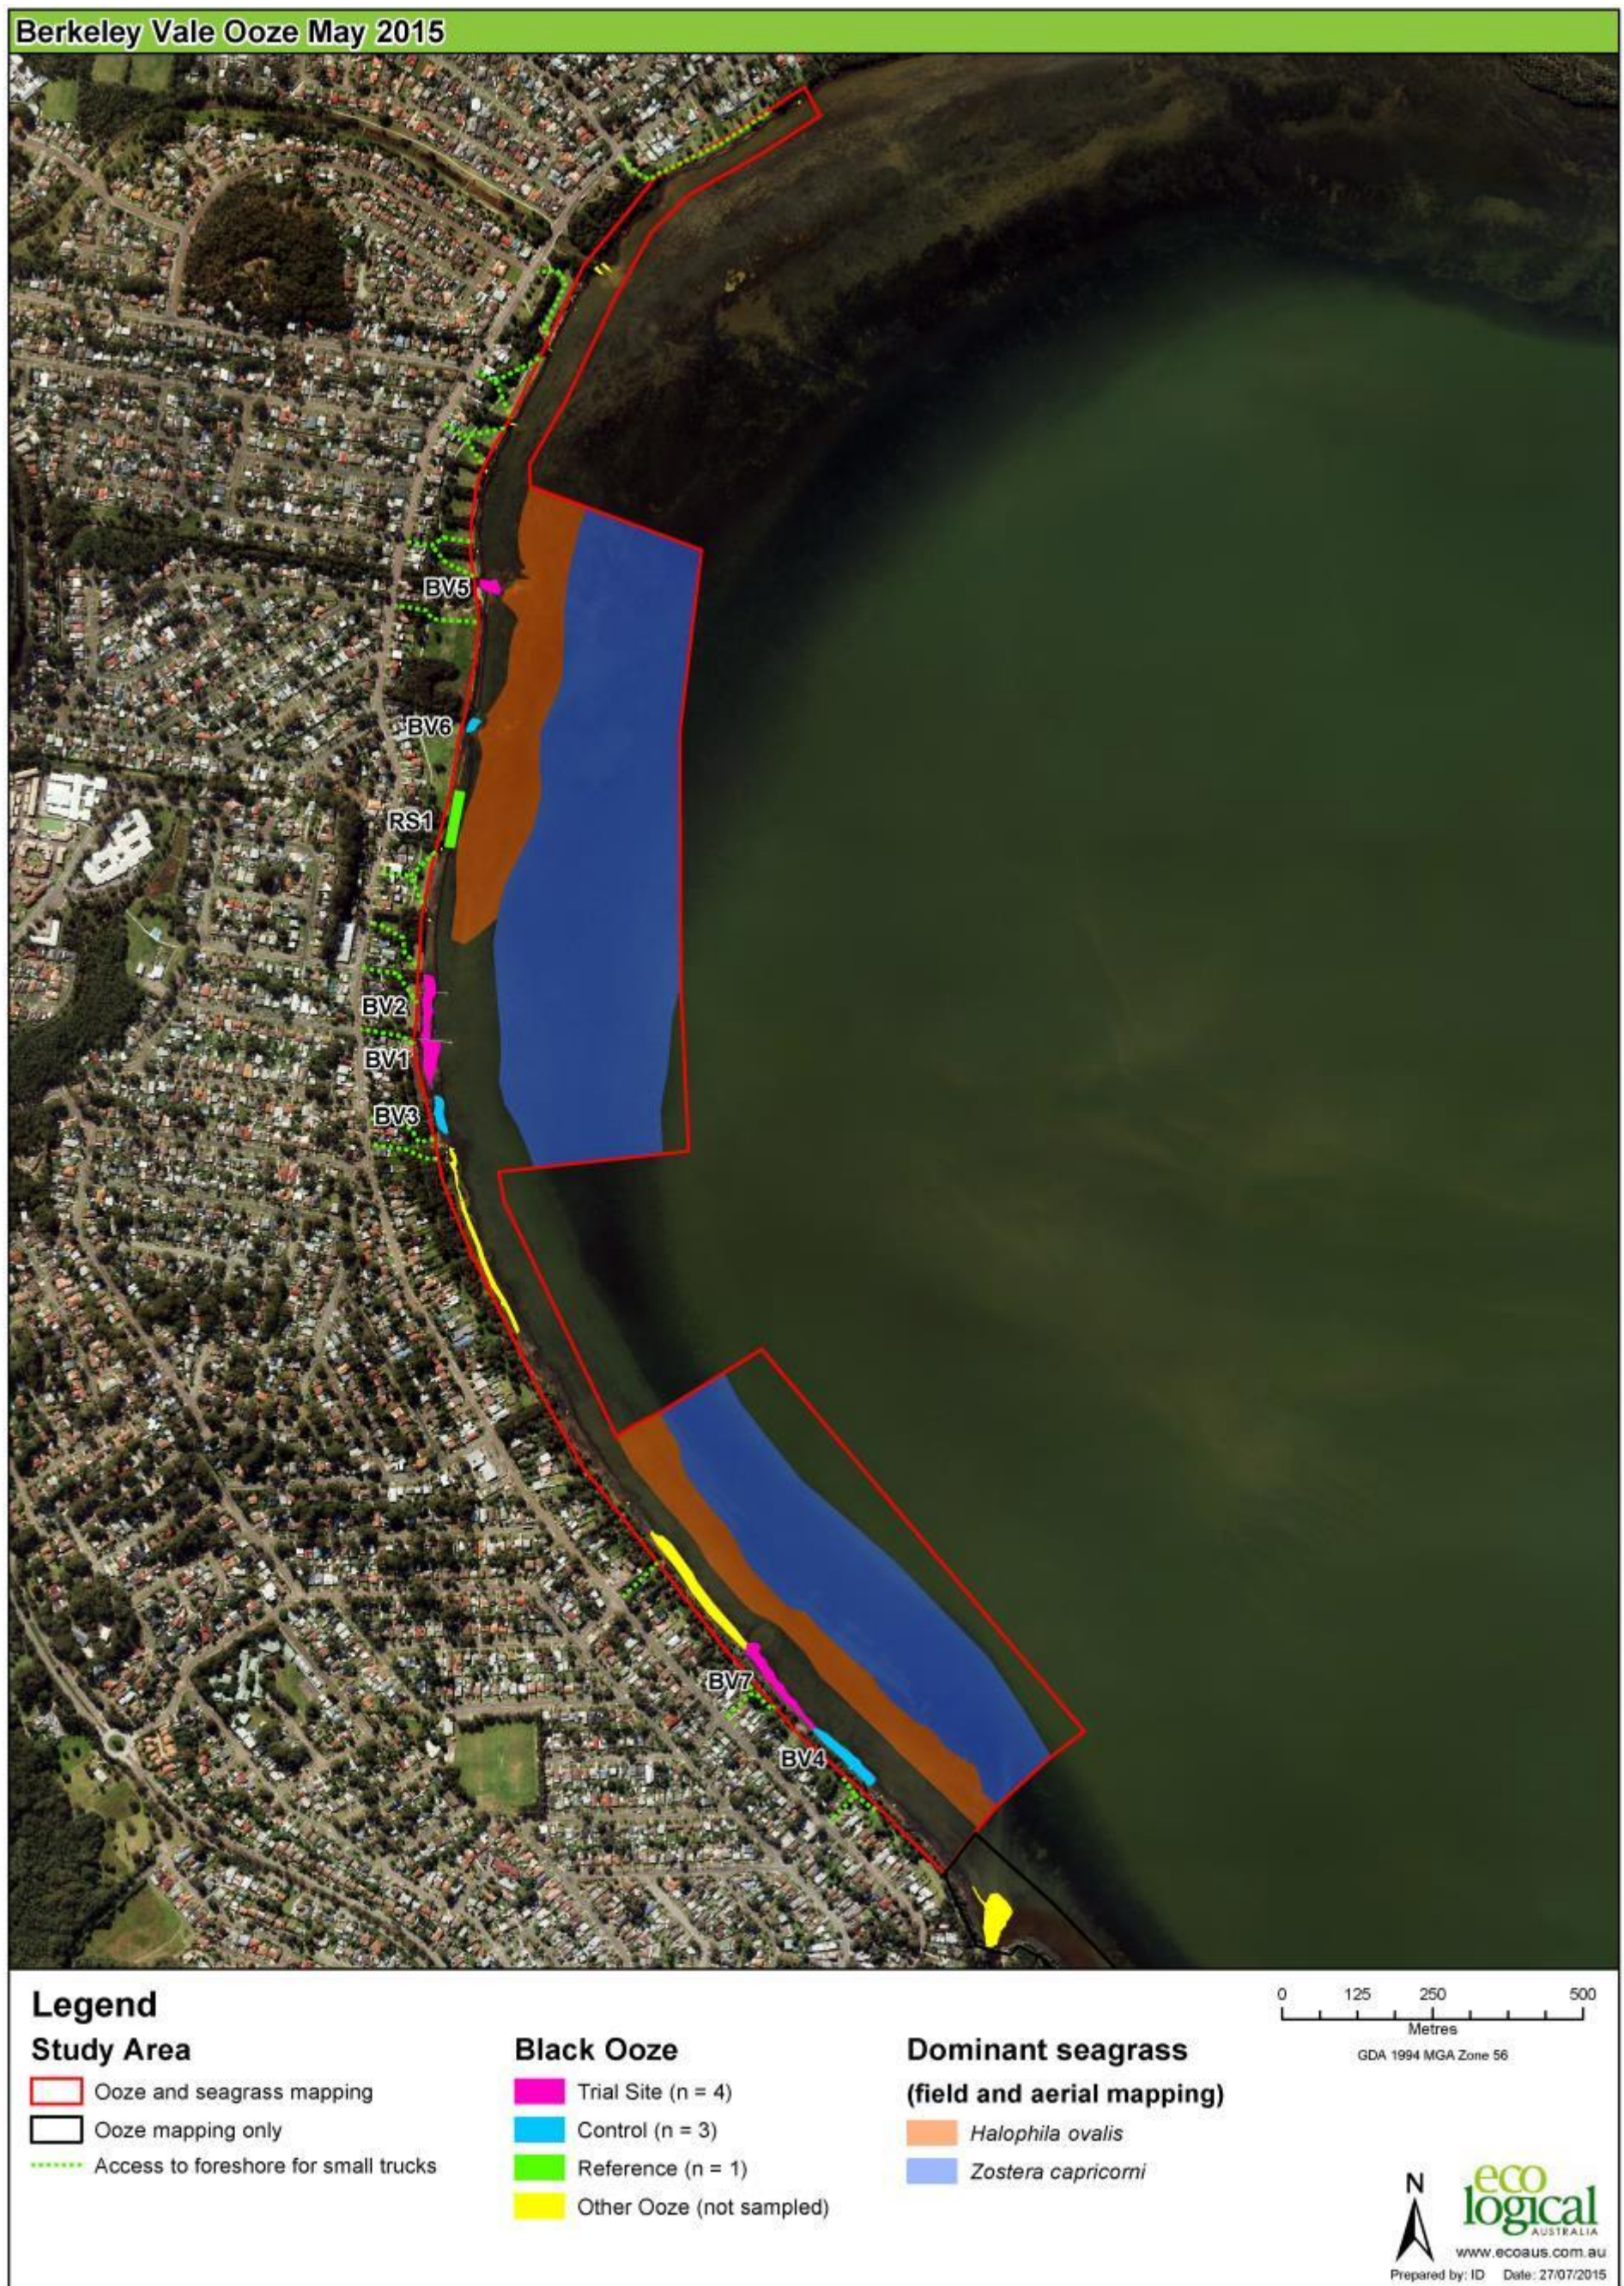
Figure 3: Map of ooze sites, extent, seagrass and accessibility in Berkeley Vale

Details of seagrass condition and approximate extent are shown in **Table 4** and **Figure 3**.

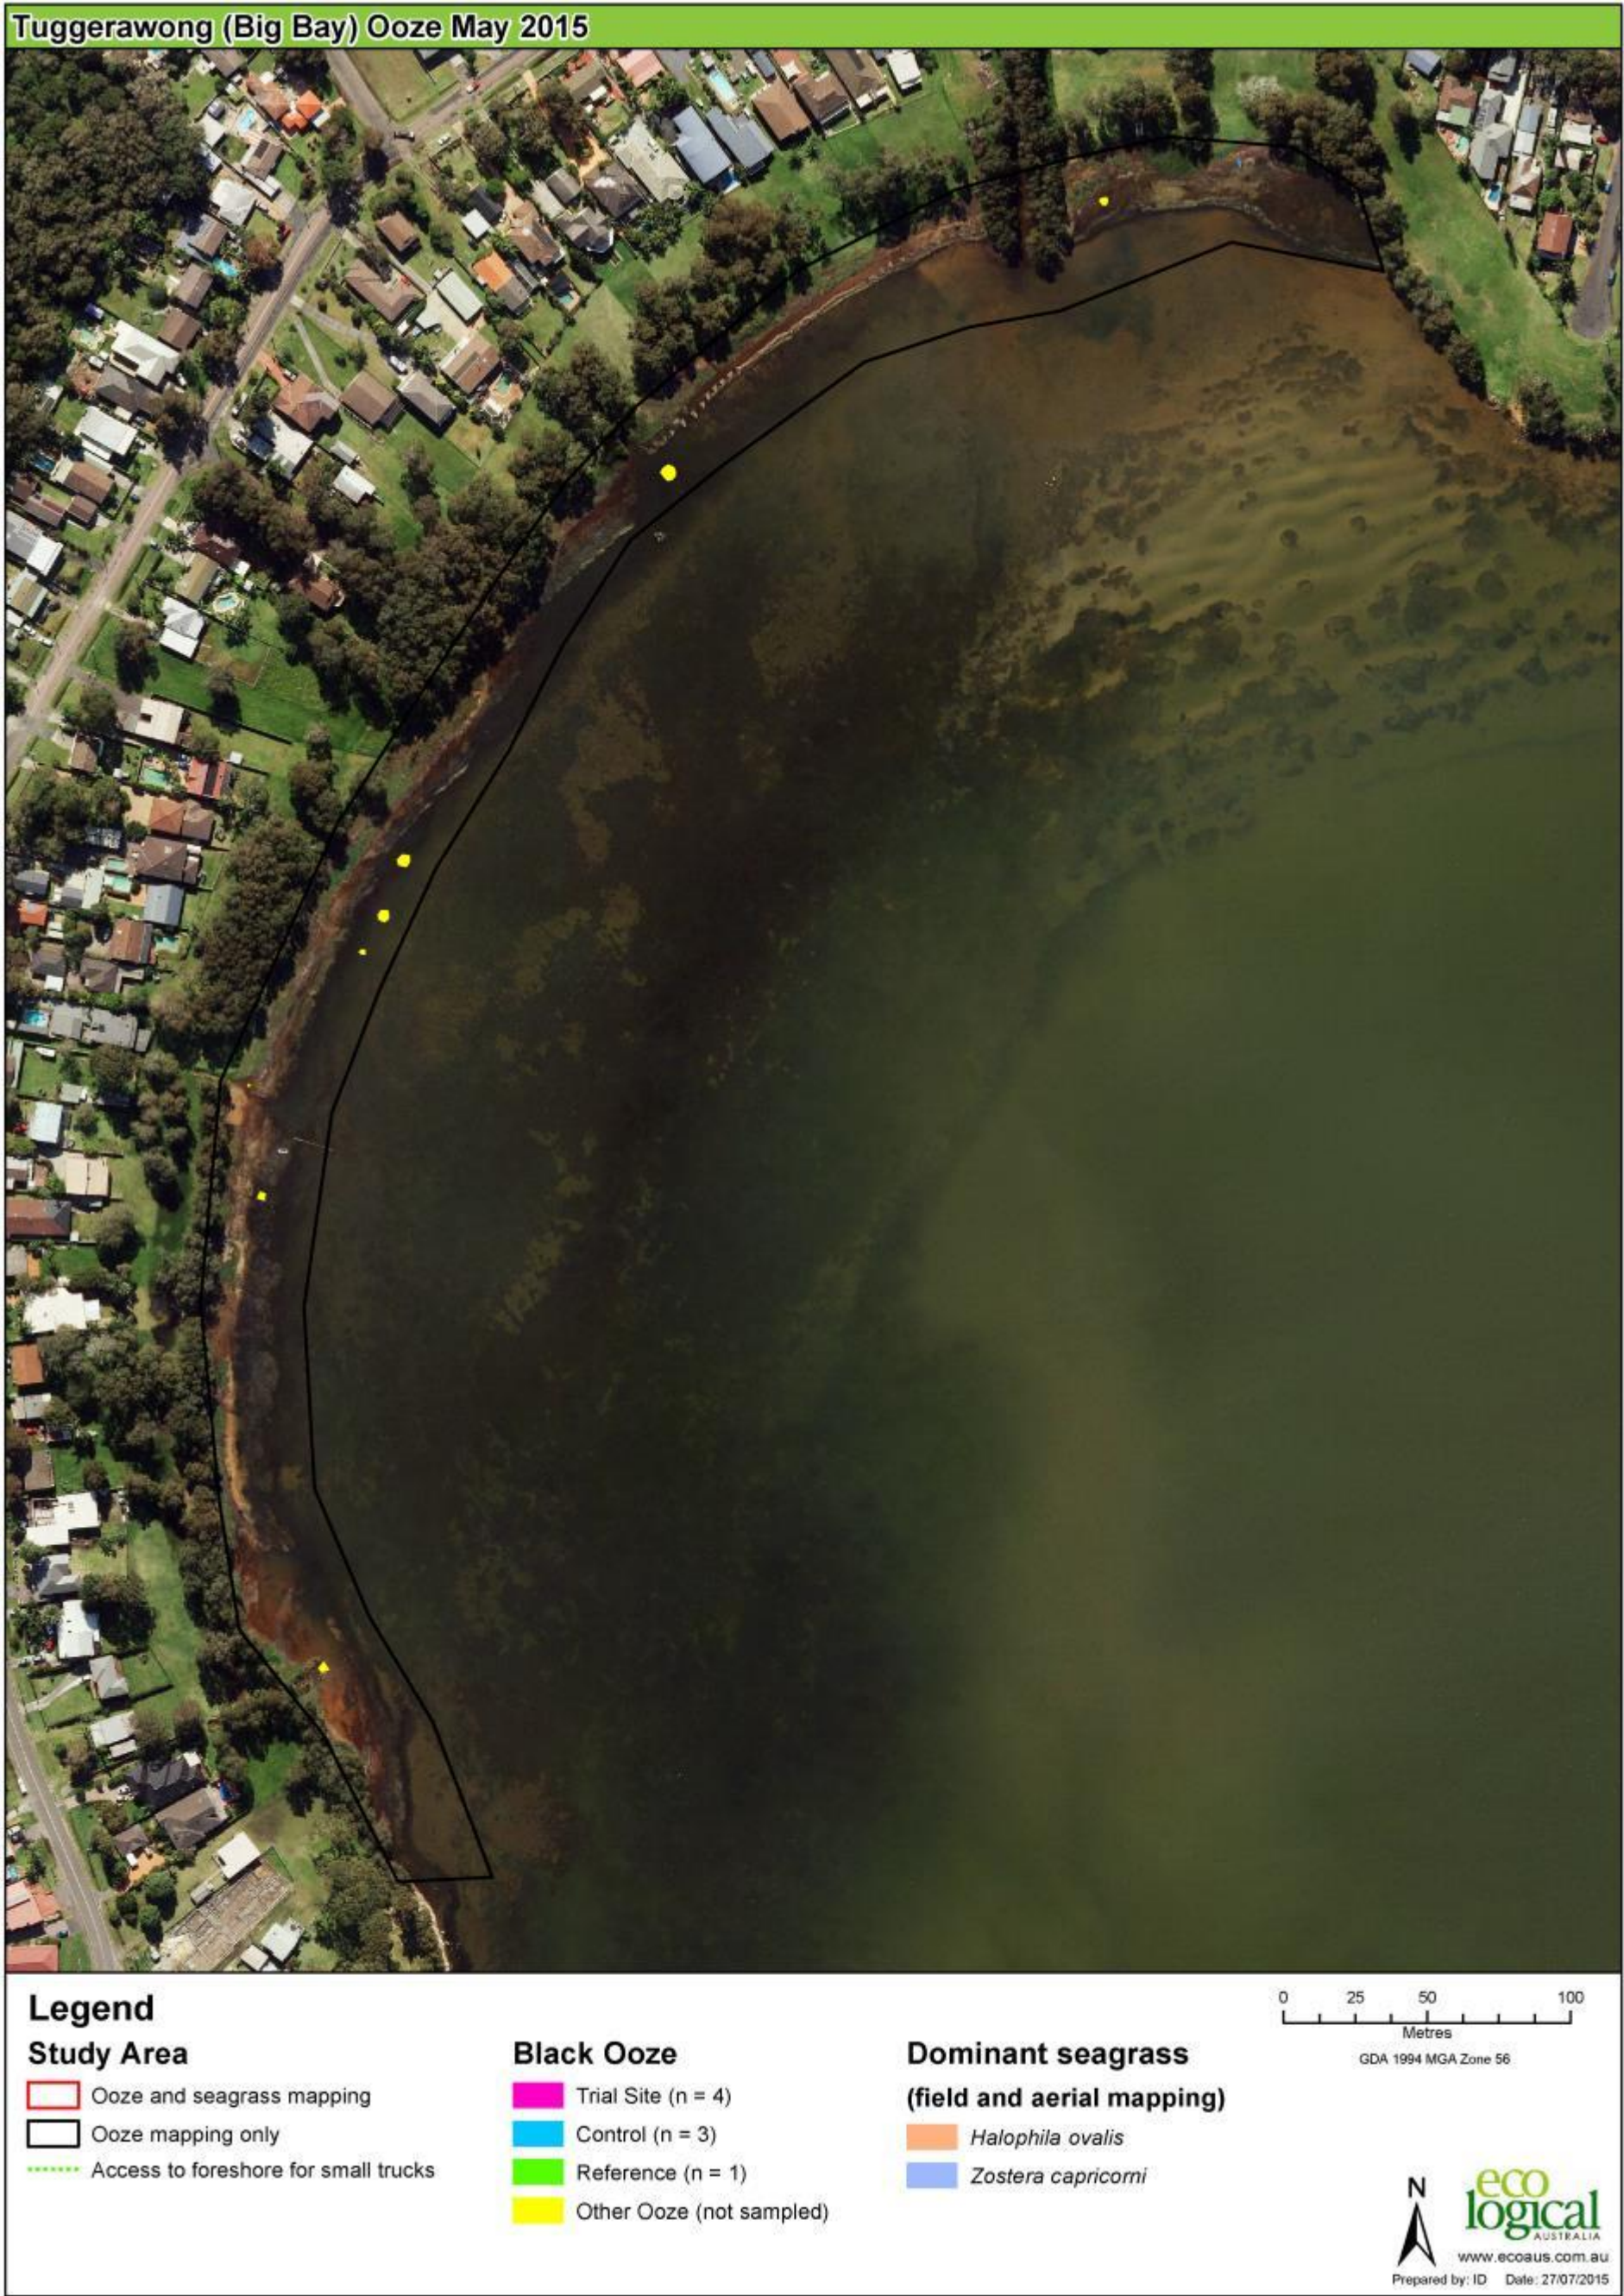
Figure 4: Map of ooze extent in Tuggerawong (Big Bay).

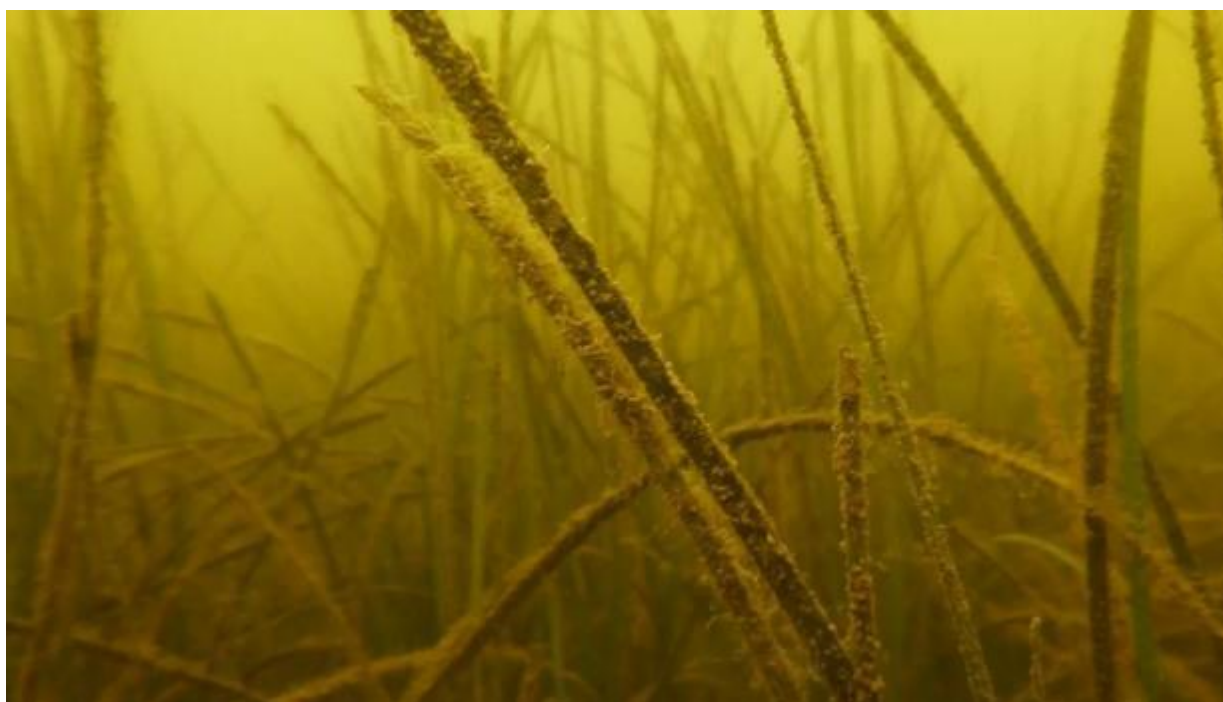
Figure 8: Typical condition of *Zostera capricorni* with tall leaves (20-40 cm), moderate density with some epiphyte growth

Z. capricorni was abundant in deeper water, possibly more sheltered from wave disturbance and associated turbidity. A close inspection of *Z. capricorni* in shallower areas found these plants to be detached and resting on top of the sediment, a likely result of the severe storm events in the preceding month. Underwater footage of the *Z. capricorni* beds show the cover is moderately dense, with some epiphyte growth on leaves (**Figure 8**). Other areas had patches of bare sediment and uprooted plants settled to the floor.
