**REPORT**  
**TO**  
**BMT WBM PTY LTD**  
**ON**  
**GEOTECHNICAL ASSESSMENT**  
**OF**  
**EROSION HAZARD LINES**  
**ALONG THE**  
**WYONG SHORE COUNCIL FORESHORE AREAS**  
**BETWEEN CRACKNECK POINT AND**  
**HARGRAVES BEACH, NSW**

**5 April 2016**  
**Ref: 28424WRrpt**

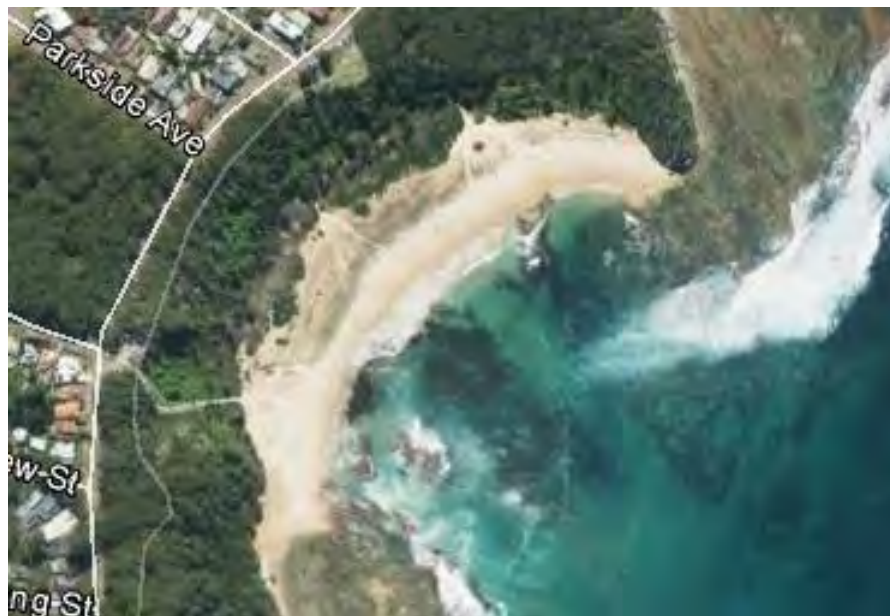
**Plate 5: Bateau Bay Site Area**

This area of the foreshore was typified by a crescent shaped bay feature (see Plate 5) immediately to the north of the Crackneck Point site area. The crest of a steep curved slope defined the seaward margin of the vegetated reserve areas and car park which lined the crest of the slope.

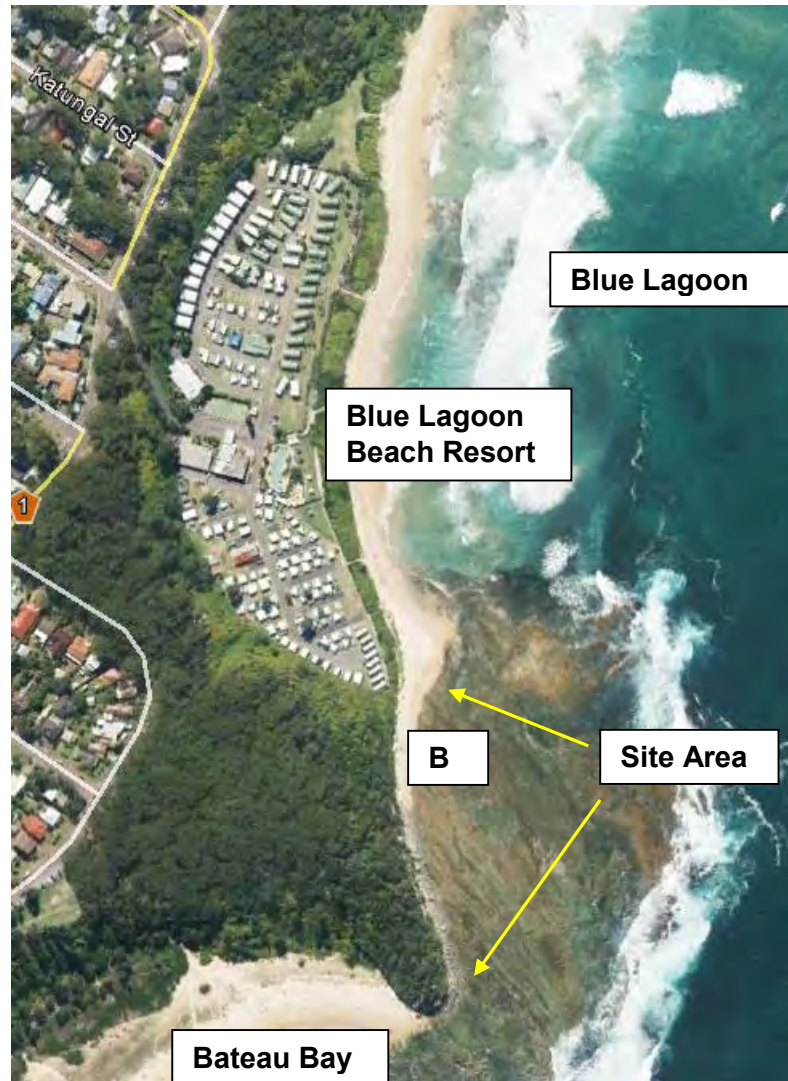
**Plate 9: Blue Lagoon Site Area**

This area of the foreshore was typified by sub-vertical cliff face which extended north from the northern end of Bateau Bay to a crescent shaped low lying area occupied by the Blue Lagoon Beach Resort (see Plate 9).

North from the southern end of Blue Lagoon, above the cliff face a steep (maximum about 45°) vegetated slope was present. North from location 'B' (see Plate 9), the cliff face was absent and the vegetated slope extended down to a 1m to 2m sub-vertical face which lined the landward margin of the beach surface. At location 'B' what appeared to be a localised small scale rock fall deposit was observed. North of location 'B', to the southern boundary of the Blue Lagoon Beach Resort, the sub-vertical soil face exposed what appeared to be colluvial or residual clay soils (see Plate

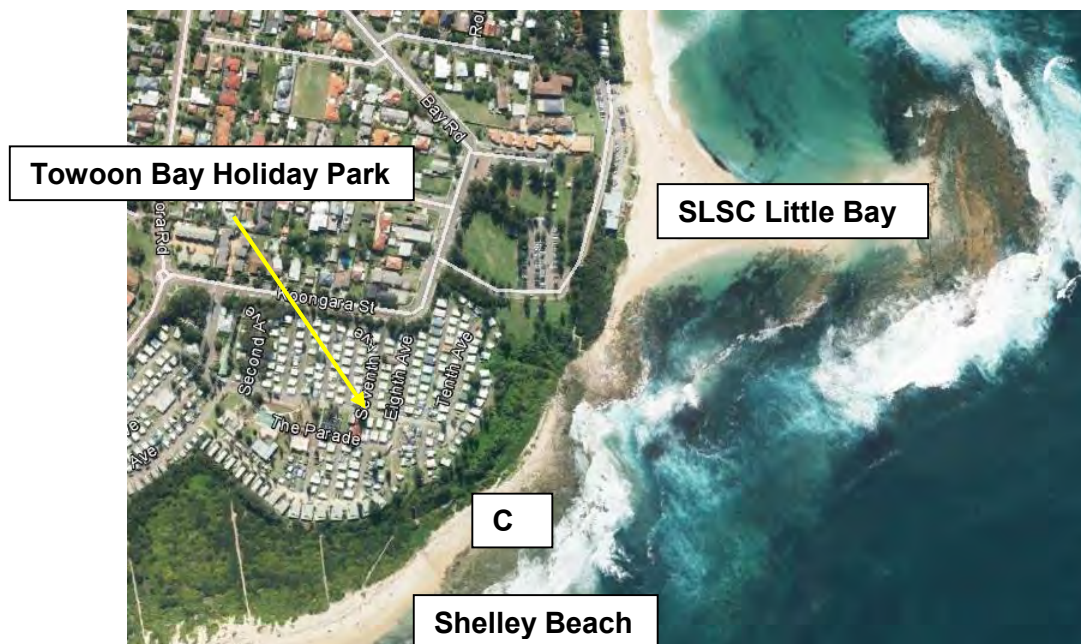
**Plate 12: Shelley Beach Site Area**

This area of the foreshore was located over the northern end of Shelley Beach and extended north to the Surf Life Saving Club (SLSC) at Little Bay (see Plate 12).

To the north and south of location 'C' the crest of the slope was lined by Towoon Bay Holiday Park (see Plate 12).

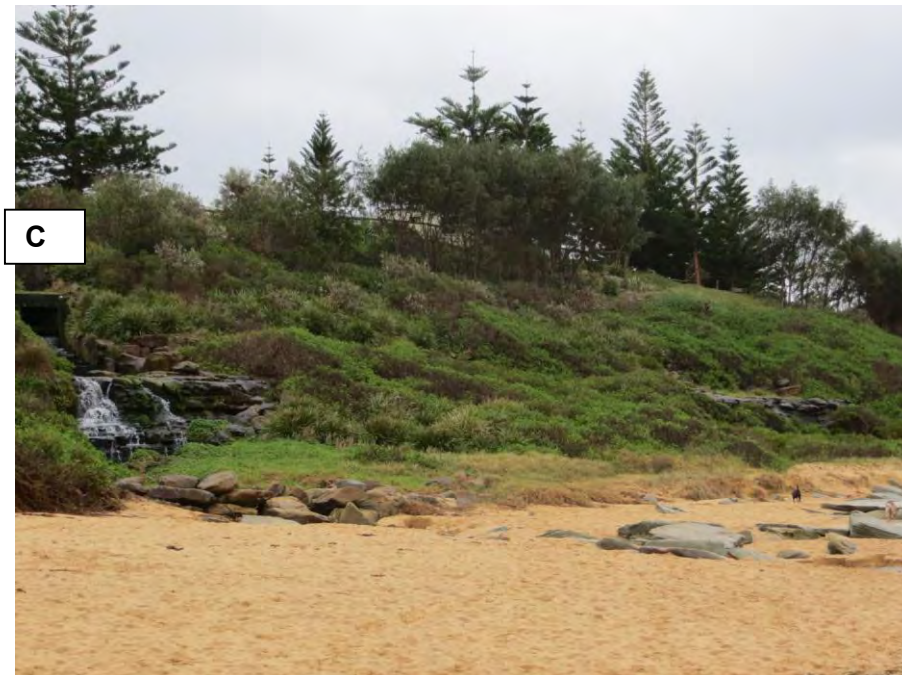
**Plate 14: Below Towoon Bay Holiday Park at Location 'C'**

The sandstone bedrock face was generally overgrown and only intermittently exposed southwards to location 'C' where a stormwater culvert discharged down the stepped bedrock profile (see Plate 14). Thin claystone bands were evident in the sandstone bedrock. Sub-vertical joint planes were evident in the bedrock and typically orientated at approximately 020°, 110° and 045°.

The toe of the northern portion of the foreshore slope was covered with numerous cobble and boulder sized sandstone blocks. To the south, the number of sandstone cobbles and boulders reduced and the wave cut platform had a thin sand covering (see Plate 14).

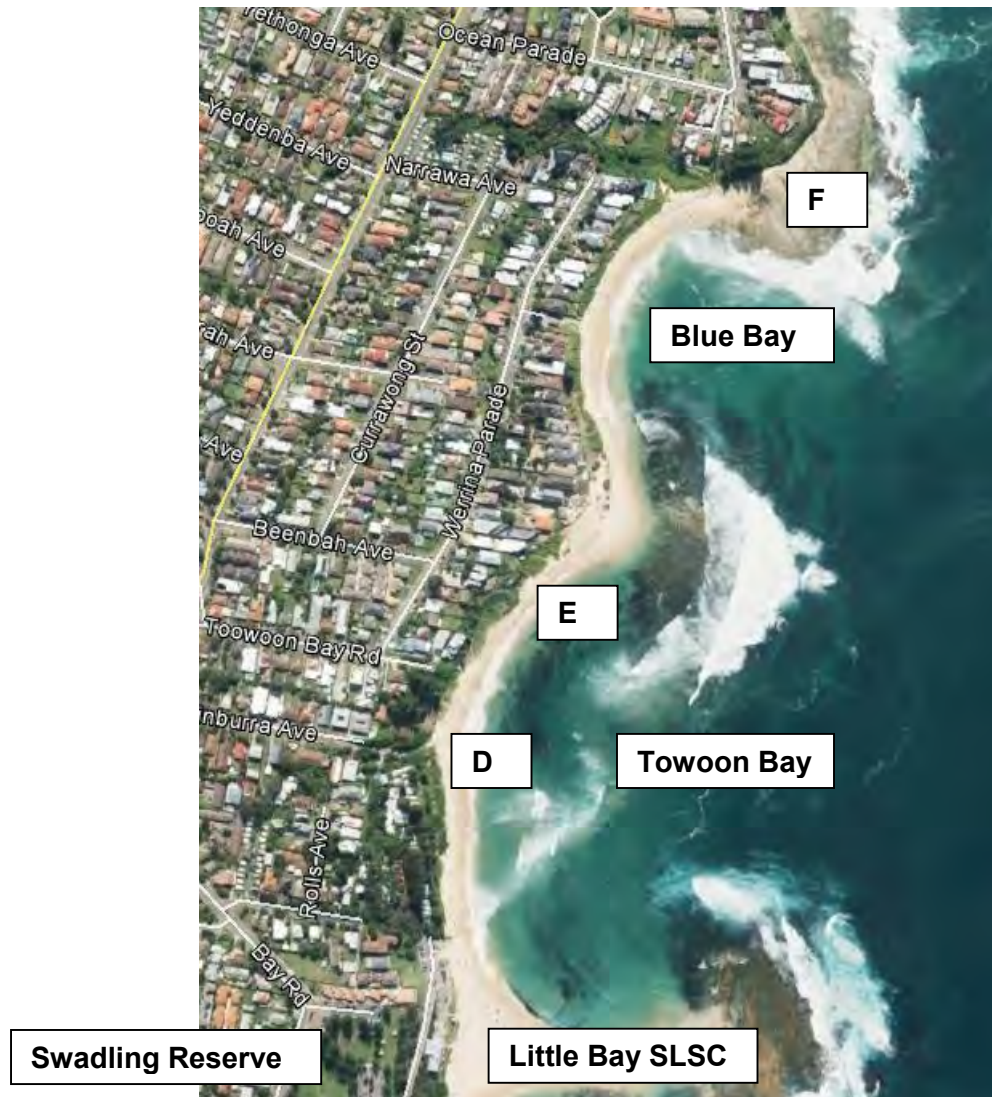
**Plate 15: Towoon Bay and Blue Bay Site Area**

North from the Little Bay SLSC, this portion of the foreshore generally comprised moderately steep vegetated sand dunes. The rear yards of private residences typically occupied the upper portions of the sand dune slopes. Two bays formed this portion of the foreshore; Towoon Bay and Blue Bay (see Plate 15) and a small headland feature separated the two bays.

- At the Ocean Parade Headland, adjacent to Location 'F' on Plate 15, (Patonga Claystone) SCE found there was no measurable recession over the 21 year interval appropriate to the aerial photographs being considered and the 1985 orthophoto map. We consider this is consistent with site observations during our walk over survey as there was no evidence of recent instability other than the presence of small isolated detached blocks at the toe of the cliff face.

- Comparison of the 1941 and 1976 aerial photograph and the 2015 ‘Google Earth’ imagery at the Swadling Reserve and Ocean Parade headlands at Towoon Bay (see Plate 15) indicates little if any discernible recession. There also appears to have been an appreciable increase in vegetative cover at Swadling Reserve.

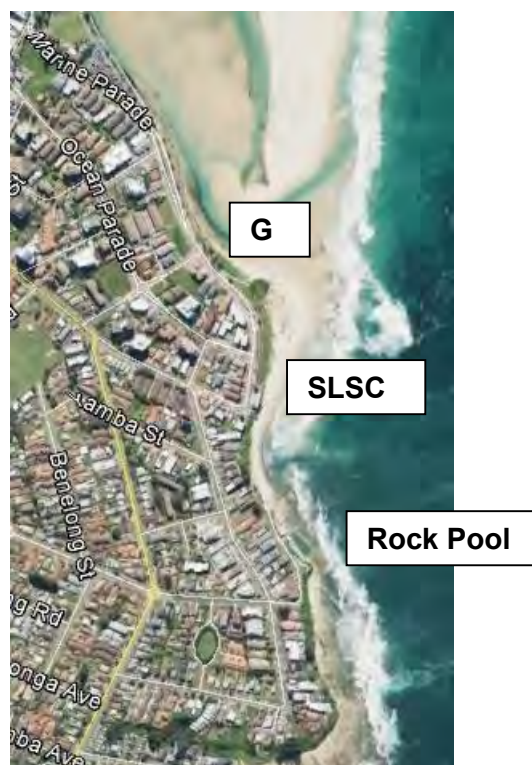
**Plate 19: The Entrance Site Area**

The site area extended north from the rock pool to the Marine Parade foreshore area (see Plate 19).

A sandstone cliff face was present to the south of the rock pool which was located over the northern end of the wave cut platform (see Plate 19). The cliff face reached a maximum height of about 6m immediately to the south of the rock pool then reduced in height to the north of the rock pool and was not observed north of the SLSC. However, historical photographs from 1974 indicated that a cliff face (approximately 3m to 4m high) was present immediately below and to the north of the SLSC and had been eroded by severe coastal erosion.

Sand dune slopes extended from the northern end of the SLSC to about location 'G' (see Plate 19) where a maximum 1m high sandstone bedrock face was noted at the toe of the grass surfaced moderately steep concave slope (see Plate 21).

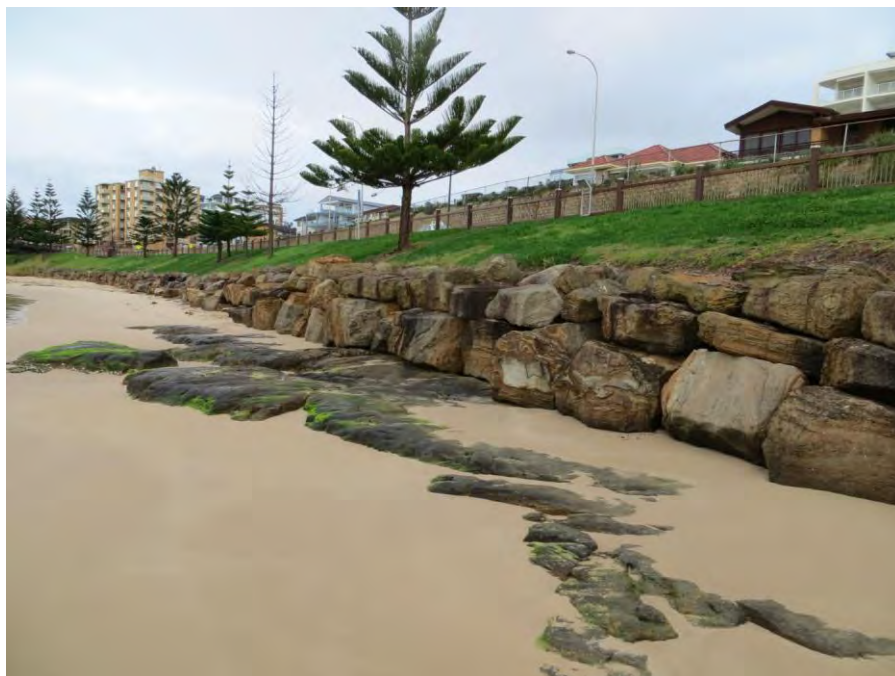
**Plate 22: Sandstone Boulder Wall Below Marine Parade**

To the north-west of location 'G' the foreshore essentially comprised a sandstone boulder wall (maximum height about 2m) which lined the toe of a moderately steep grass surfaced slope which extended down from the northern side of Marine Parade. The boulder wall was founded on the wave cut platform which exposed sandstone bedrock (see Plate 22).

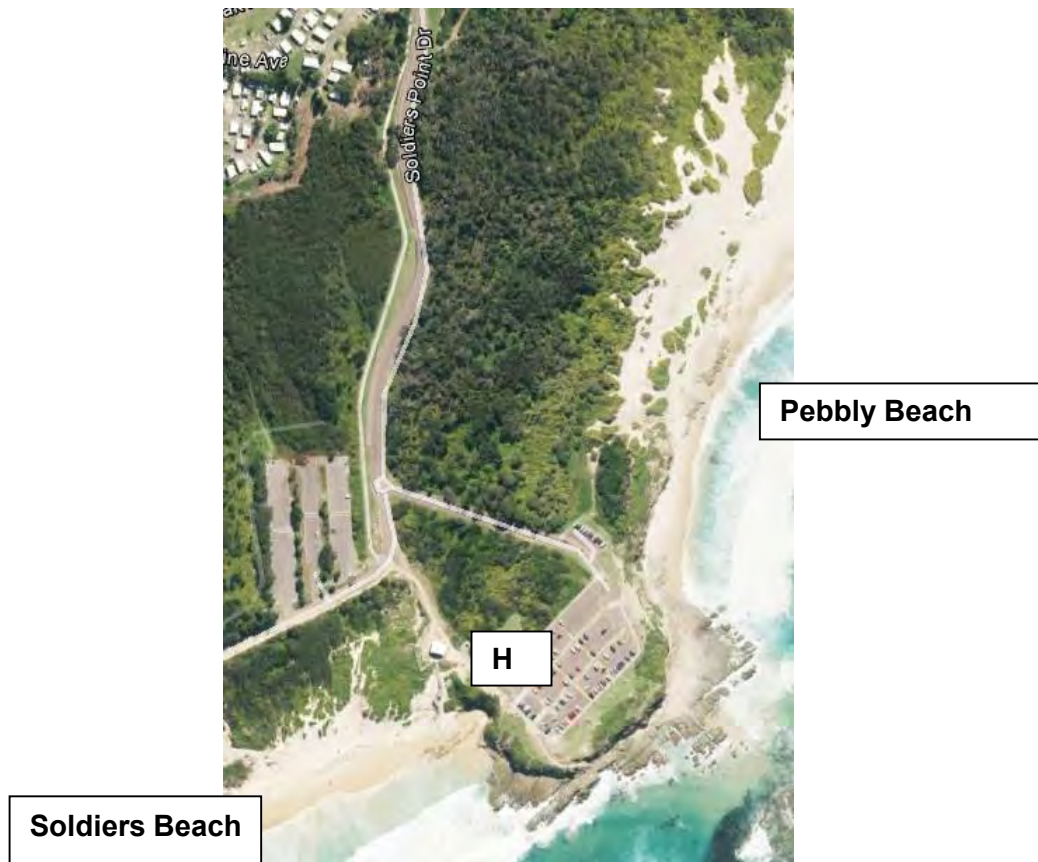
**Plate 23: Soldiers Beach site area**

The site area included the headland which marks the boundary between Soldiers Beach to the south-west, and Pebbly Beach to the north (see Plate 23).

present (see Plate 25). The cliff line (in plan) was characterised by a small arcuate area which probably represents the old back scarp of the landslide (see Plate 23).

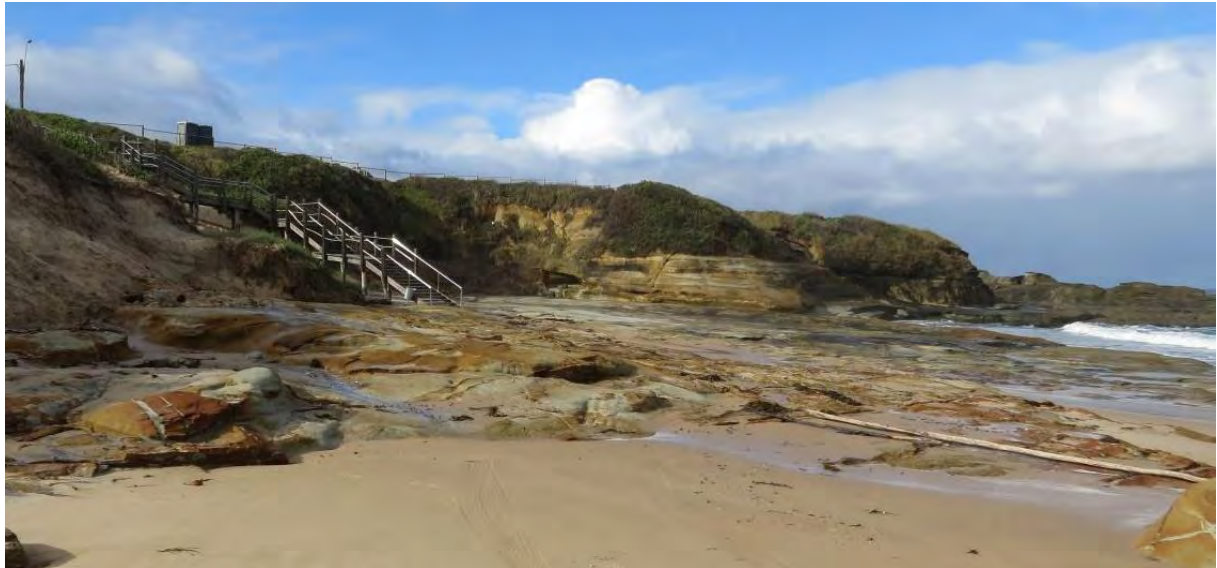
**Plate 24: Soldiers Beach headland (looking north-east)**

The headland cliff face exposed interbedded sandstone, claystone and conglomerates of the Munmorah Conglomerate and ranged between maximum heights of about 6m (south-western side) and 10m (north-eastern side). A wave cut platform lined the base of the cliff face (see Plates 23 and 24).

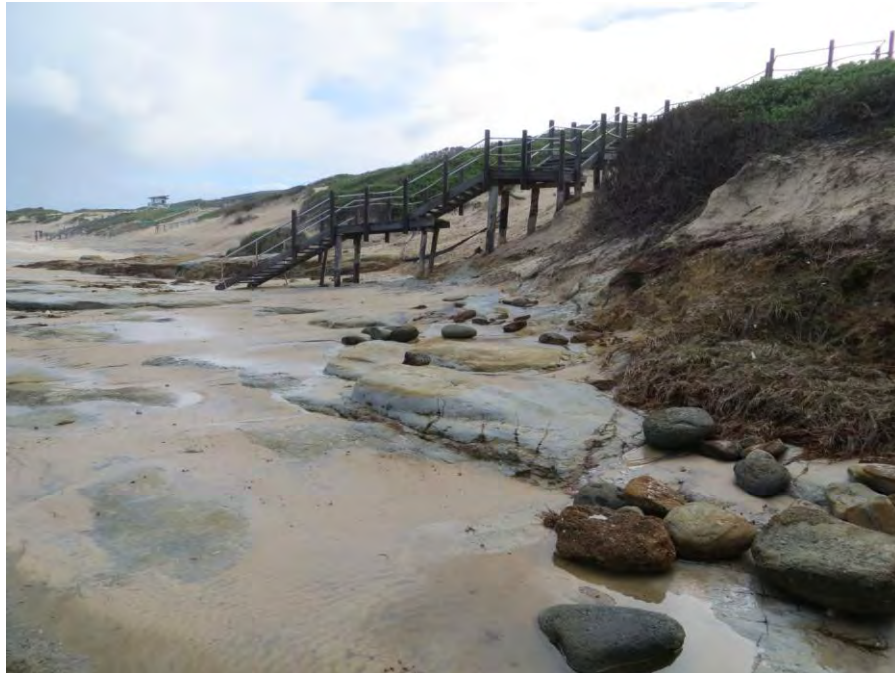
**Plate 26: Bedrock face and sand dune slope (looking south-west)**

From the slope area around the timber stepped access, the bedrock face was typically about 1m high with a moderately steep (maximum 27°) sand dune slope above.

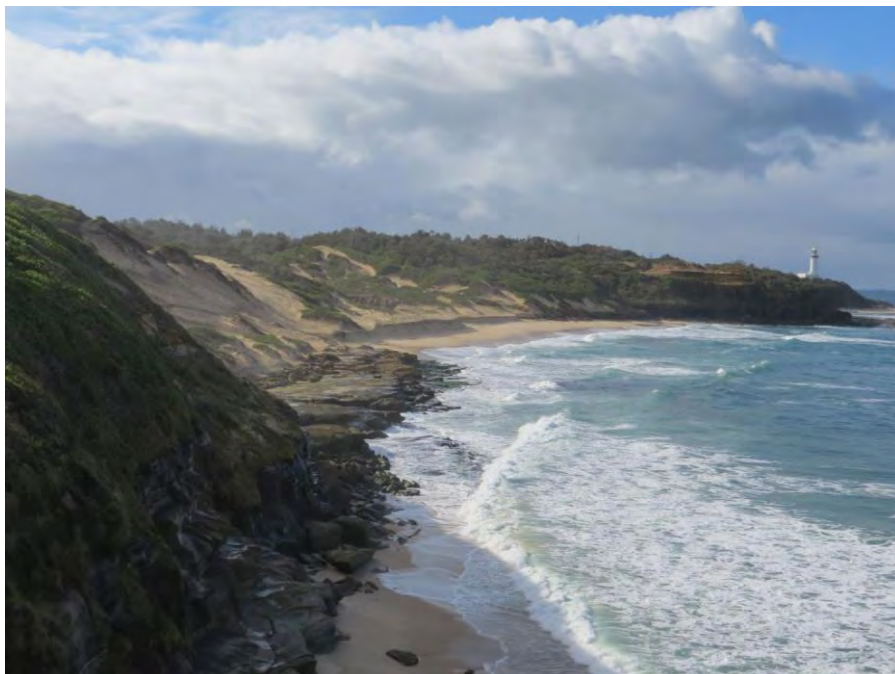
**Plate 27: Cliff face, looking north to Pebbly Beach**

The landward (western) side of the beach was lined by a steep (maximum  $35^\circ$ ) sand dune slope which extended to a maximum height of about 30m above the beach surface (see Plate 27). The lower portion of the sand dune slope had a stepped profile with a lower  $15^\circ$  to sub-vertical section about 2m maximum height at the toe (see Plate 29).

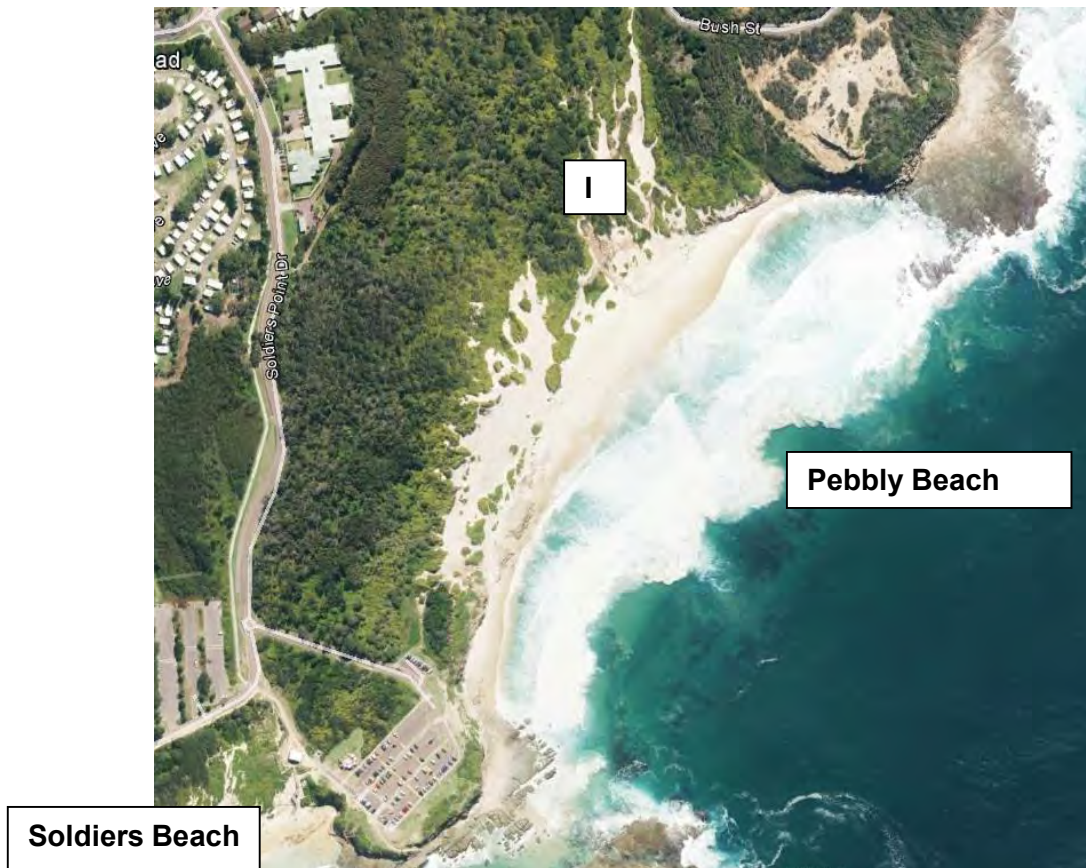
**Plate 28: Pebbly Beach site area**

The site area included the beach between the headlands at the southern end (Soldiers Beach) and north-eastern end of the site (see Plate 28).

Over the northern portion of the sand dune slope (location 'I') a creek line discharged at the landward side of the beach (see Plates 28 and 30). The creek sides exposed sandstone and

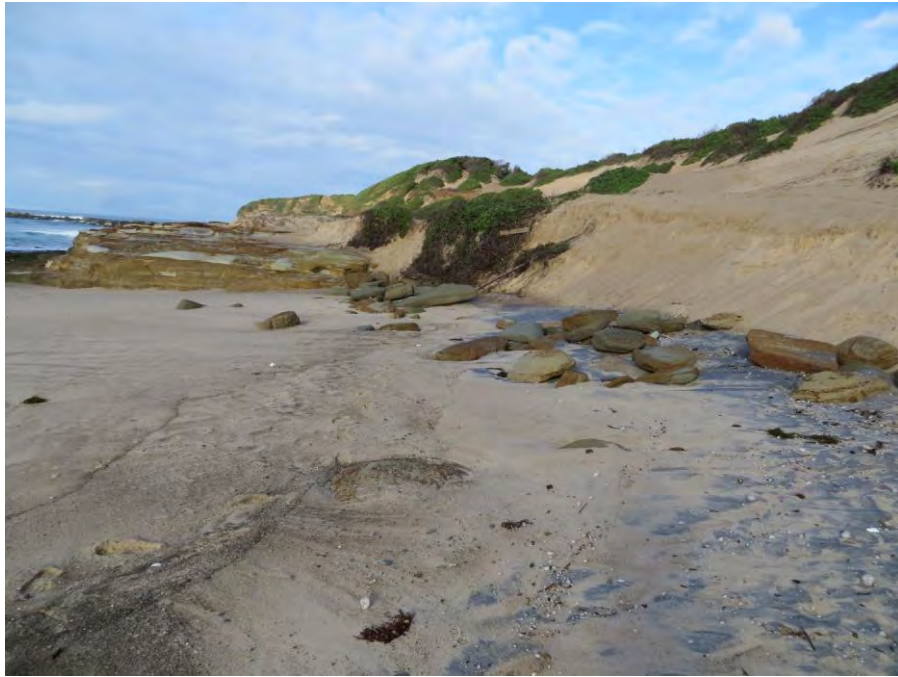
**Plate 29: Southern portion of Pebbly Beach**

The southern portion of the beach area comprised a stepped sandstone and conglomerate bedrock surface corresponding to the Munmorah Conglomerate, with vertical faces of maximum 2m height (see Plates 29 and 30).

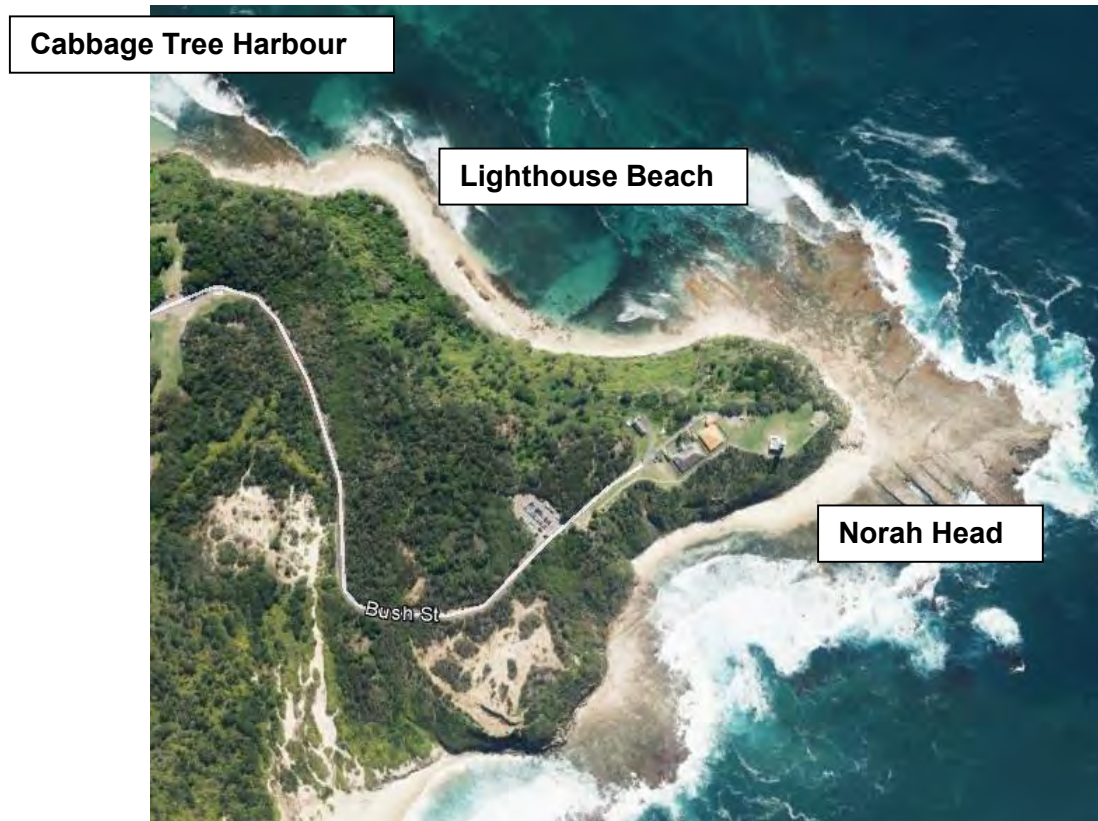
**Plate 34: Norah Head and Lighthouse Beach site area**

The site area included the cliff face which extended north-east from Pebbly Beach around the headland and west along Lighthouse Beach to the rock pool at the eastern end of Cabbage Tree Harbour (see Plate 34).

The cliff face exposed interbedded sandstone, claystone and conglomerates of the Tuggerah Formation (with Munmorah Conglomerate possibly exposed in places at the base of the cliff) and ranged between maximum heights of about 10m (south-western side) and 6m (north-eastern end of the headland, below the lighthouse). A wave cut platform assessed to comprise the Munmorah Conglomerate lined the base of the cliff face (see Plate 34).

The Lighthouse Beach site area extended west from the cliff face headland at Norah Head (see Plate 34). The foreshore area essentially comprised a moderately steep (maximum approximately 30°) vegetated slope which extended down to the beach. Towards the western end of the beach occasional short lengths of sandstone cliff face were exposed along the vegetated slope and a sandstone bedrock wave cut platform was present (see Plate 37). The sandstone has been assessed to correspond to the Tuggerah Formation.

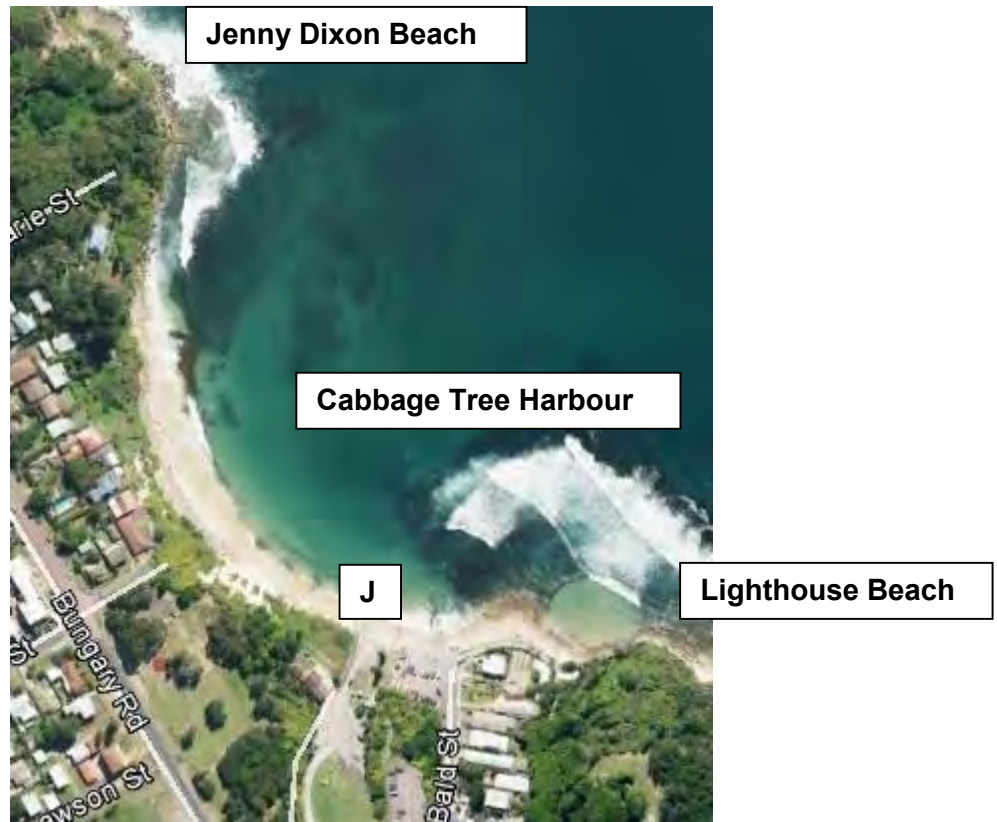
**Plate 38: Cabbage Tree Harbour site area**

The site area included the section of foreshore which extended west, then north, from Lighthouse Beach to the headland at the northern end of the bay which marks the southern end of Jenny Dixon Beach (see Plate 38).

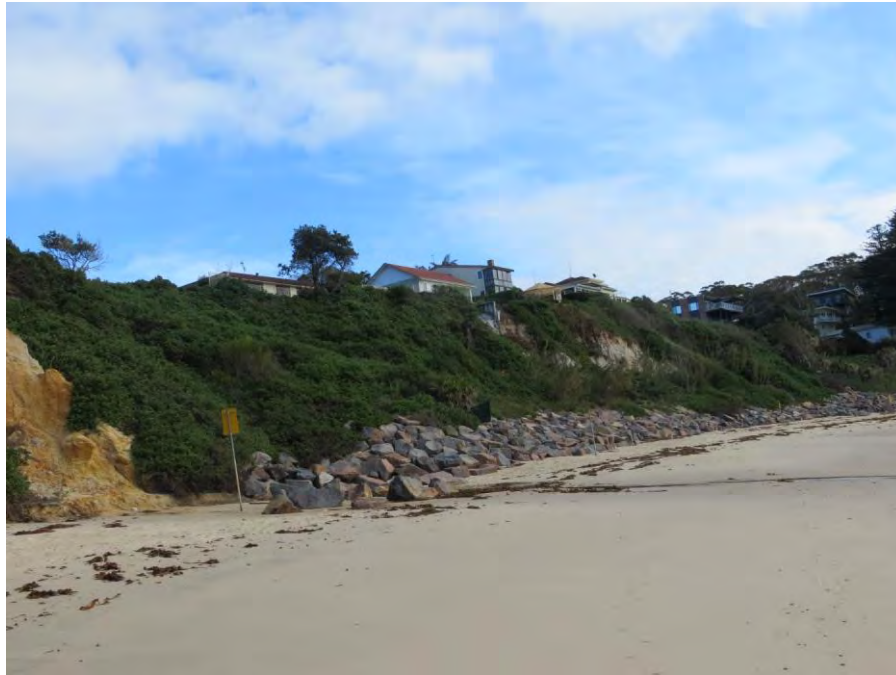
**Plate 41: North-Western end of Cabbage Tree Harbour**

West of the sub-vertical sand face, a grass surfaced concave slope extended down from the rear yards of residences along Bungary Road. Igneous boulder 'rip-rap' erosion protection had been placed along the toe of the slope (see Plates 40 and 41). The upper portion of the slope was typically sub-vertical and exposed light grey and light brown sands.

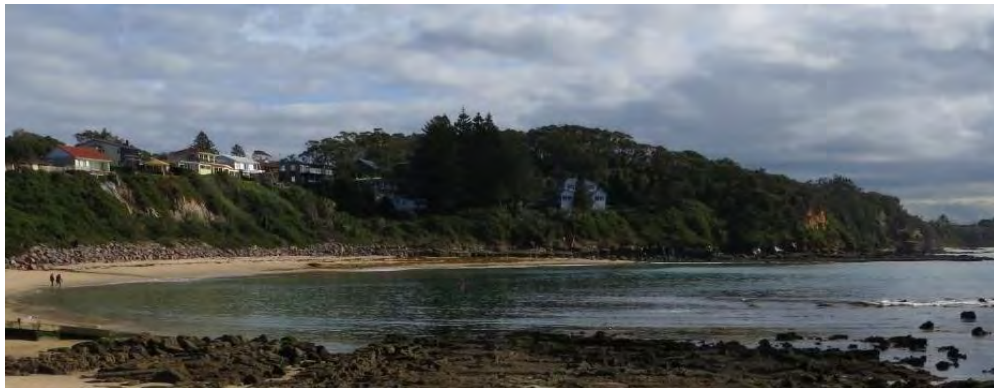
**Plate 42: Cliff Face at the western end of Cabbage Tree Harbour**

The vegetated sand slopes extended north to the sandstone bedrock cliff face forming the southern side of the headland which marked the southern end of Jenny Dixon Beach. The cliff face increased in height to a maximum of about 15m at the headland with a steep vegetated slope above the cliff face. Traces of orange brown sandstone faces were evident over the cliff face (see Plates 42 and 43) which may represent areas of more recent cliff face rock falls.

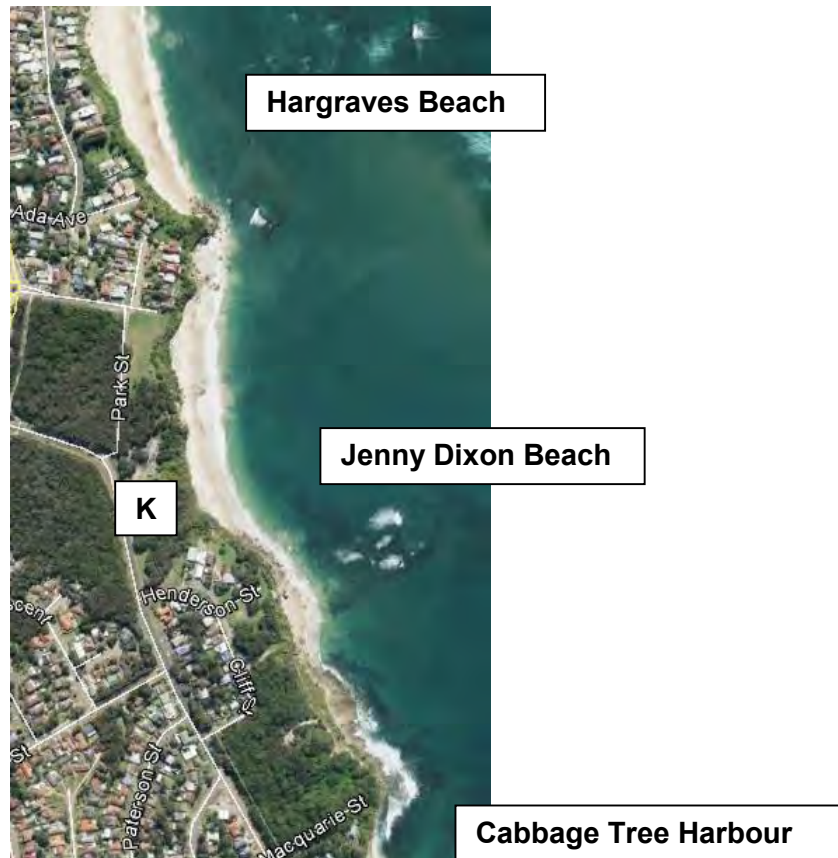
**Plate 44: Norah Head and Lighthouse Beach site area**

The site area included the cliff face which extended north from the headland at the northern end of Cabbage Tree Harbour to the headland separating Jenny Dixon Beach from Hargraves Beach to the north (see Plate 44).

The site area included the cliff face which extended north from the headland at the southern end of Hargraves Beach (see Plate 44). North from the headland, the cliff face reduced in height from 20m to typically 4m to 5m, and was absent at a point approximately opposite 19 Elizabeth Drive (see Plate 48). The cliff face comprised sandstone with claystone assessed to be the Tuggerah Formation.

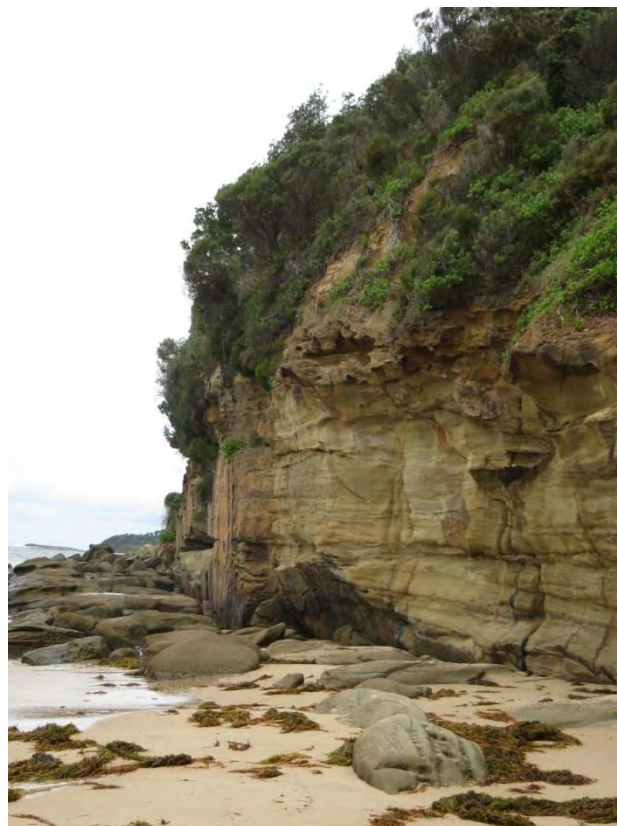
**Plate 45: Headland at southern end of Jenny Dixon Beach**

The cliff faces comprised sandstone with claystone and conglomerate bands assessed to be the Tuggerah Formation. At the southern end of the site area the headland cliff face was about 15m high and reduced in height to 4m over the central portion of the cliff face. The cliff faces were defined in places by a sub-vertical planar joints orientated at about 325°. The crest of the sub-vertical portion of cliff face was overhanging in places. A wave cut platform lined the base of the headland cliff face and 'blocky' sandstone boulders were evident on the wave cut platform (see Plate 45).

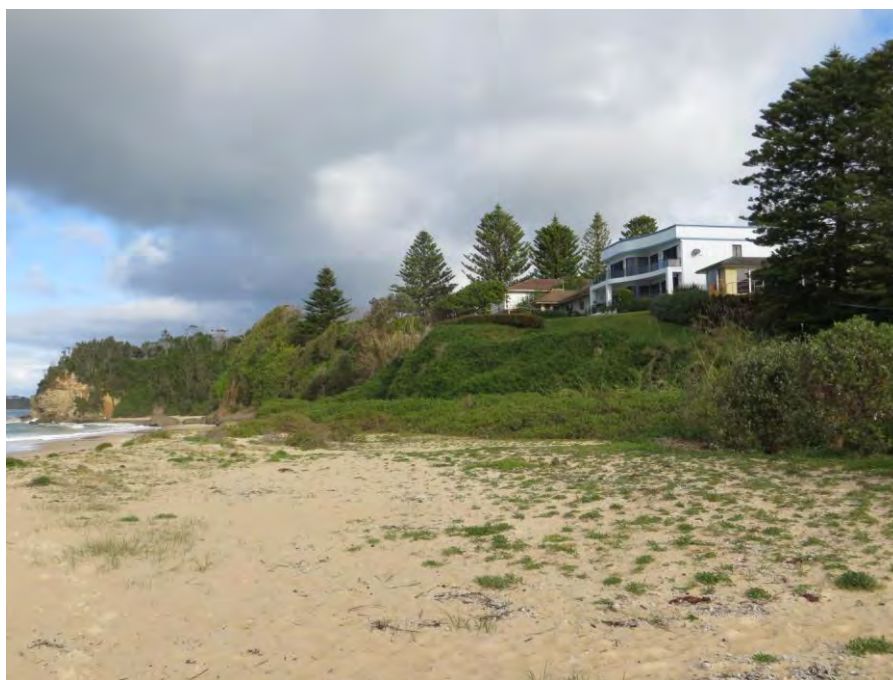
**Plate 48: Looking south to the headland at the southern end of Hargraves Beach**

The cliff face was predominantly overgrown with traces of bedrock faces evident. A localised rock fall (3m x 2m x 0.8m thick) controlled by sub-vertical planar joint orientated at about 305° was noted in a section of the 4m to 5m high portion of cliff face.

Above the sub-vertical cliff face the vegetated slope was typically steep (maximum about 45°) with traces of residual clay soils evident through the vegetation. The southern end of the overgrown sub-vertical face, which has been interpreted to comprise bedrock, was orientated approximately 280° and extended landward. To the north of the sub-vertical face the beach surface extended north.
