Review of Environmental Factors

PROJECT: **The Entrance Rock Groyne**

SITE ADDRESS: **The Entrance, NSW**

DATE: **May 2016**

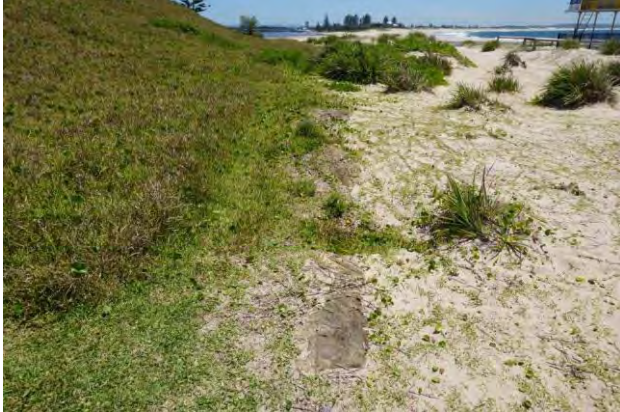
Parade) to the west.
Vegetation <i>(List vegetation type, condition, density; Advise the date of any previous clearing or fire. Note any threatened species from Section F, below).</i>	<p>Typical dune vegetation is present within the back beach portion of the site (refer photo below) comprising colonising grasses, herbs and creepers (e.g. pigface, spinifex). The majority of the footprint of the proposed groyne is beach with no vegetation present.</p>

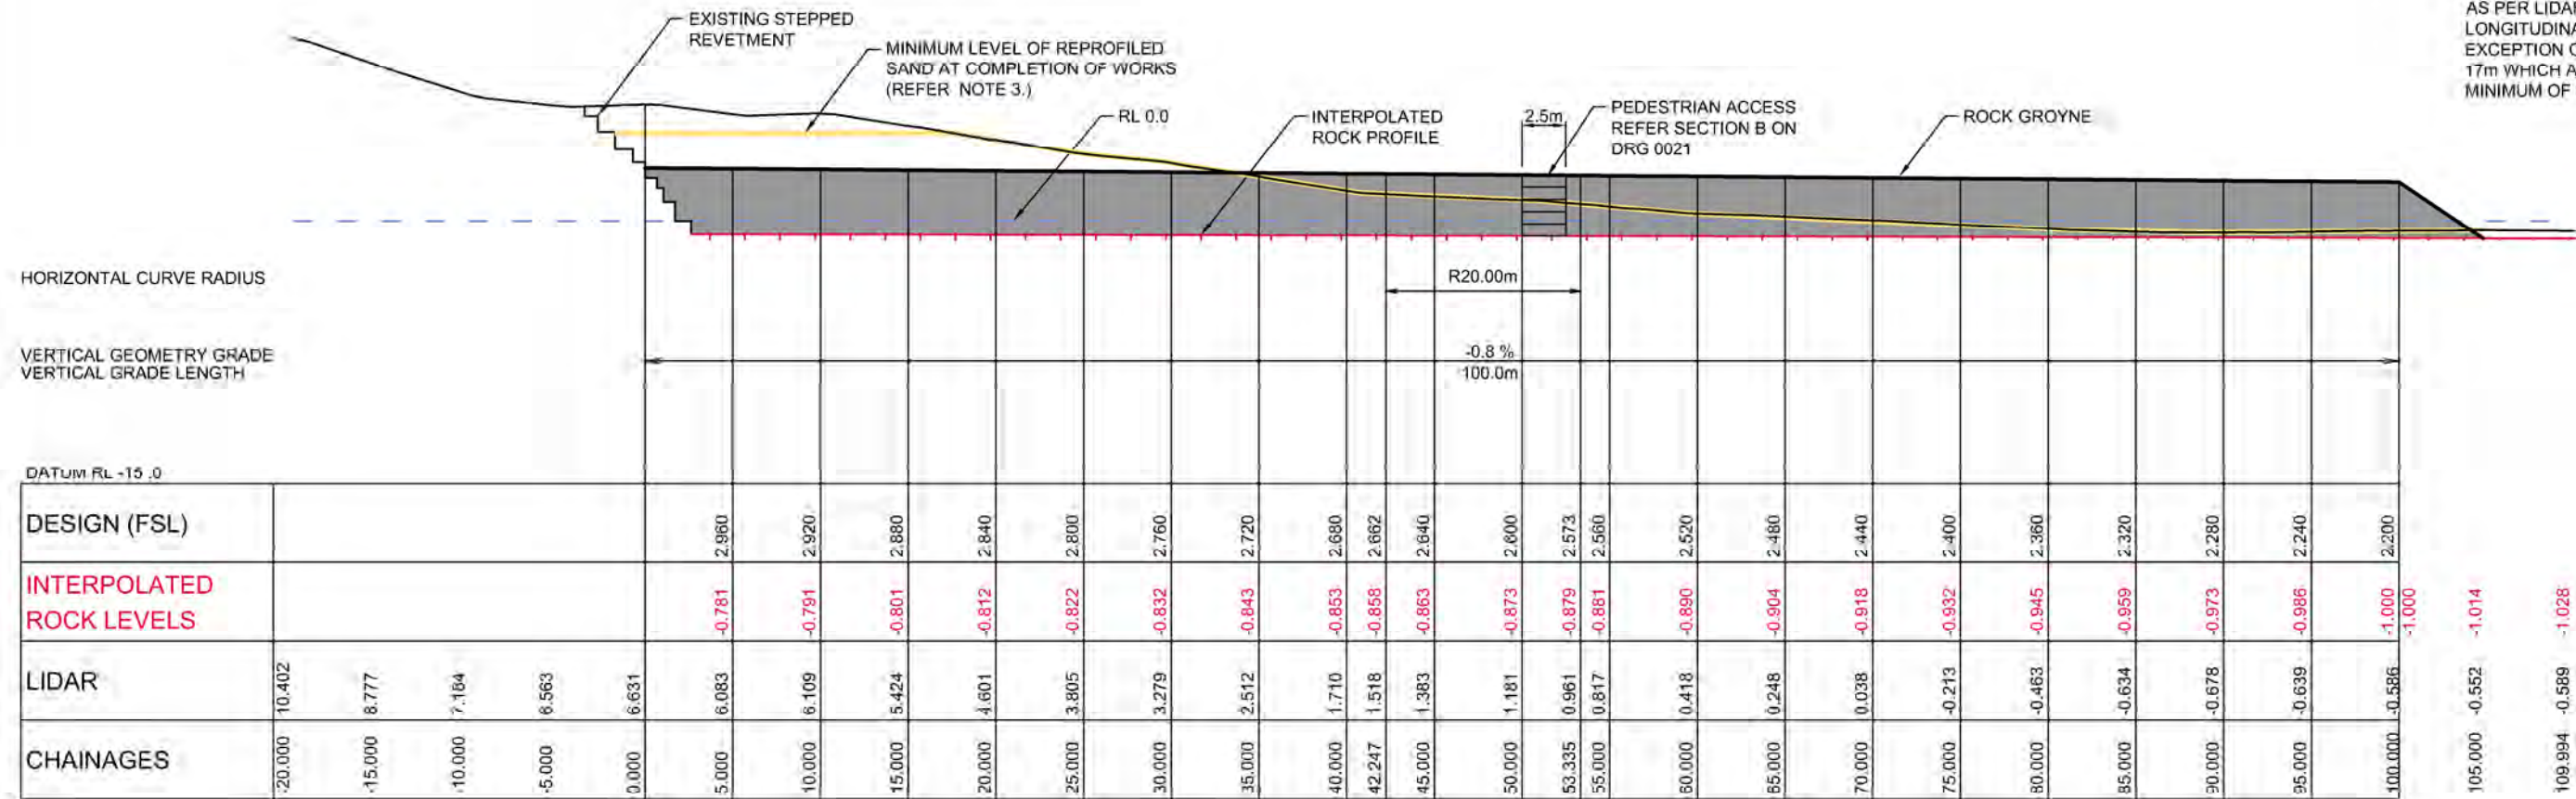
GROYNE LONGITUDINAL SECTION
1:200 (A1)

- NOTE:
- 1. ALL LEVELS ARE IN METRES RELATIVE TO AUSTRALIAN HEIGHT DATUM AHD.
 - 2. BEDROCK LEVELS AND EXISTING REVETMENT PROFILE SOURCED FROM GEOTECHNICAL INVESTIGATION REPORT BY COFFEY FEB 2016.
 - 3. REPROFIED SAND LEVELS ADJACENT TO GROYPE AT COMPLETION OF WORKS TO BE AS PER LIDAR LEVELS SHOWN IN LONGITUDINAL SECTION WITH EXCEPTION OF CHAINAGE 0m TO 17m WHICH ARE TO BE A MINIMUM OF LEVEL 5m AHD

The crest level adopted in (Cardno, 2013) was 2m AHD. As noted above, analysis of the photogrammetric profiles was undertaken to determine an 'average beach full' sand level on the beach. Local lifeguards and SLSC members who are very familiar with the beach were also consulted. The 'average beach full' profile is the level of sand that the groyne would ideally maintain on the beach and therefore dictates the structures crest level. From these assessments undertaken we have adopted a linearly varying crest level of 3m AHD at the existing revetment at the back of the beach sloping down to 2.2m AHD at the head of the structure.

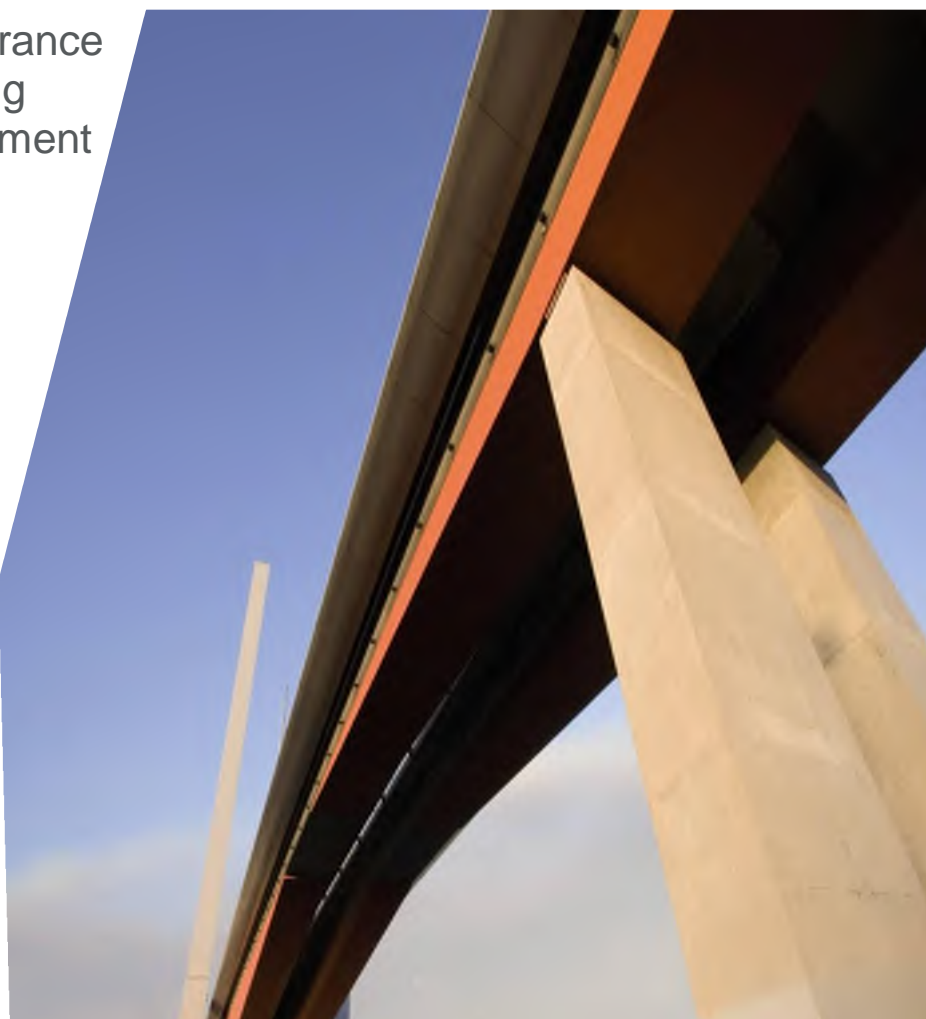
DREDGING PLAN FOR THE ENTRANCE

The following description of Wyong Council's dredging operations at The Entrance has been prepared from Worley Parsons (2009) – not verbatim.

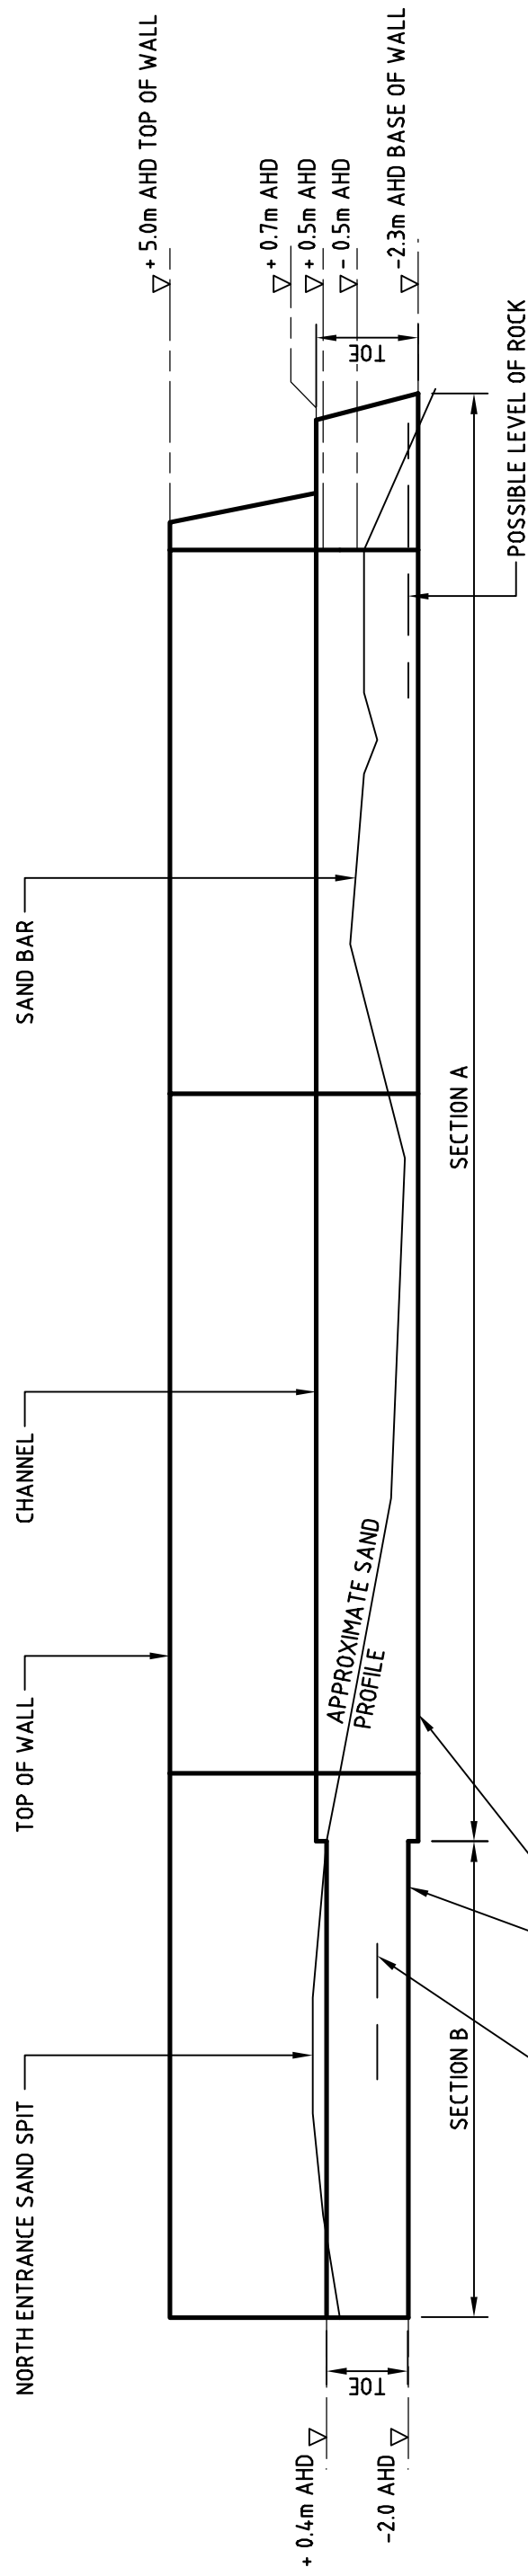
NORTHERN TRAINING WALL

SCALE 1:1000 HORIZONTAL
SCALE 1:200 VERTICAL

NOTE:
ALL WALLS AND REVETMENTS DESIGNED TO BE FOUNDED ON SAND.

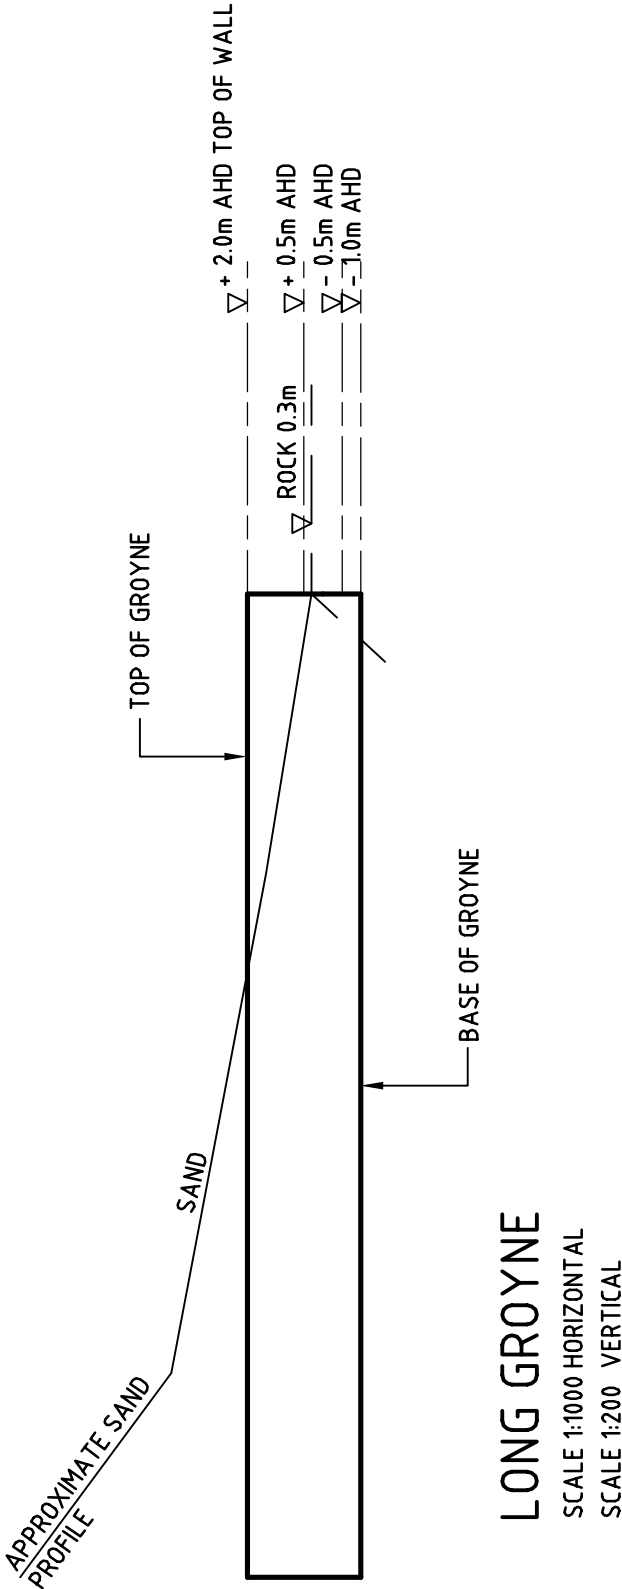
LONG GROUYNE
SCALE 1:1000 HORIZONTAL
SCALE 1:200 VERTICAL

NOTE:
ALL WALLS AND REVETMENTS DESIGNED TO BE FOUNDED ON SAND.

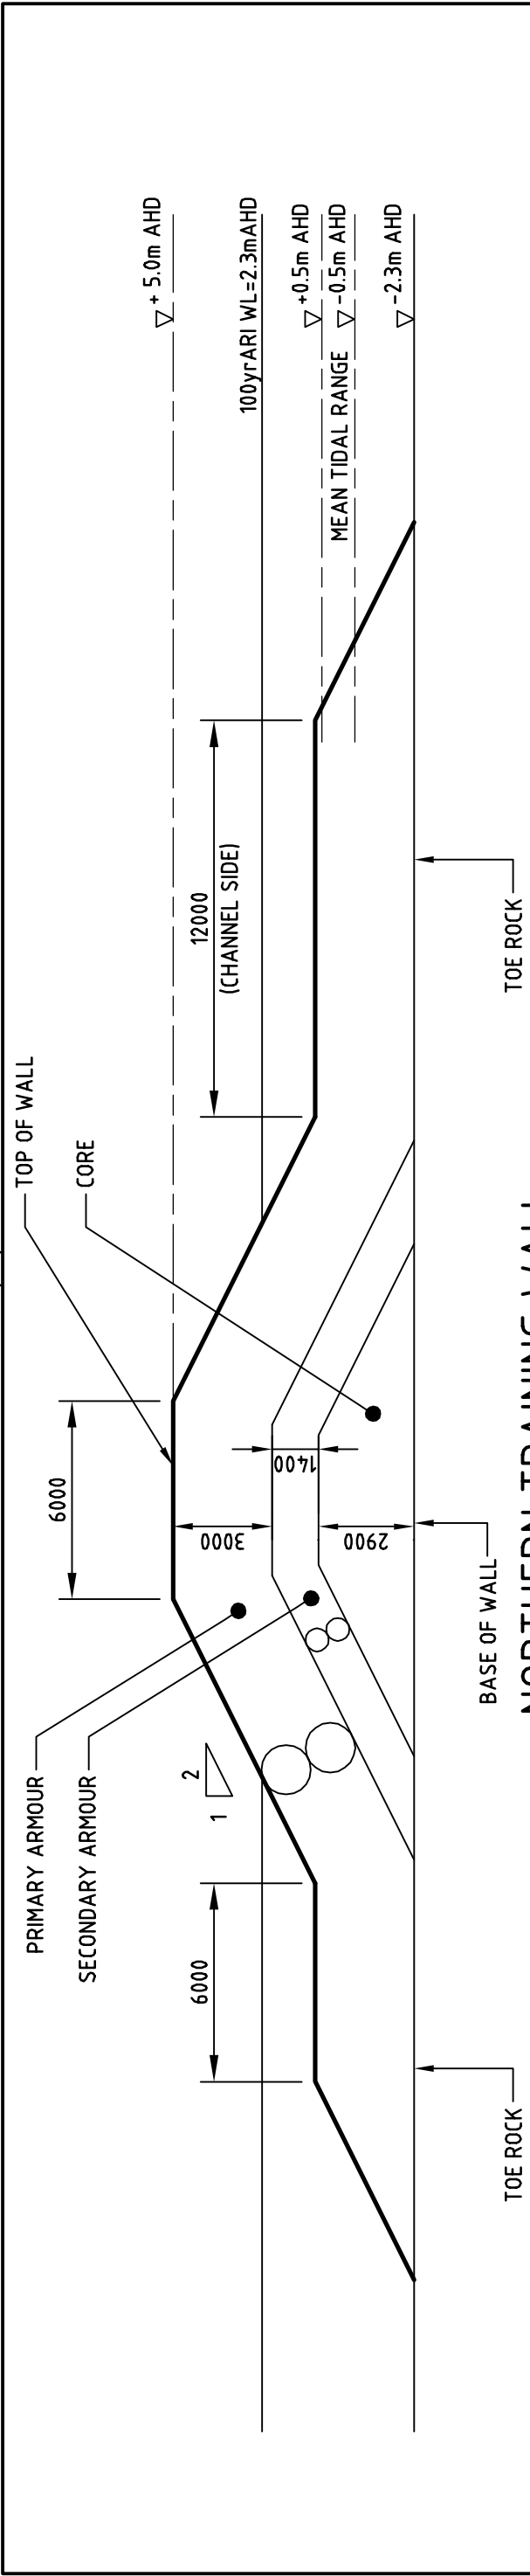
SECTION A

NOTE:
ALL WALLS AND REVETMENTS DESIGNED TO BE FOUNDED ON SAND.

NORTHERN TRAINING WALL

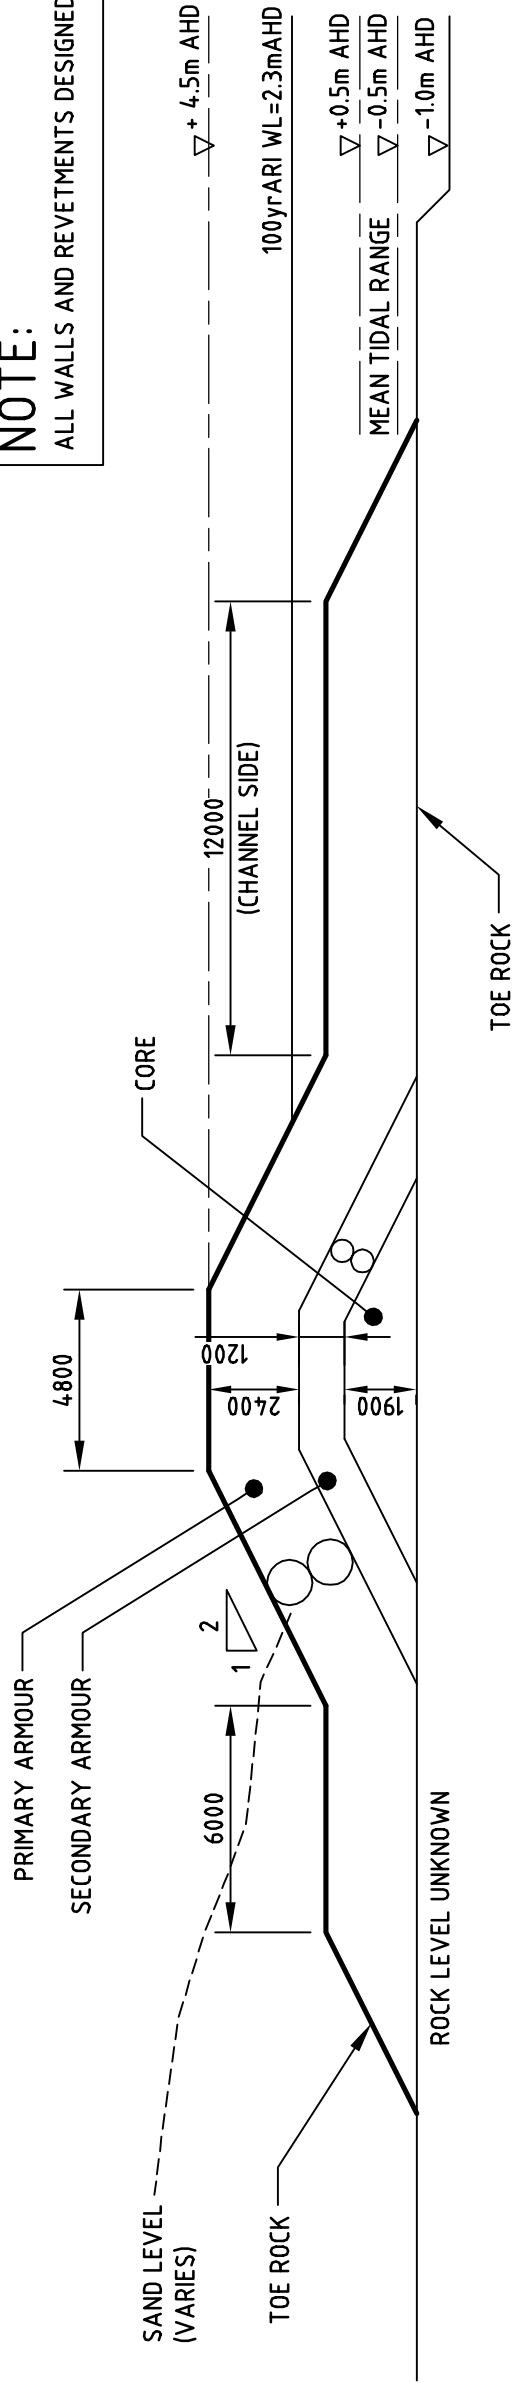
SOUTHERN TRAINING WALL			
	PRIMARY ARMOUR	SECONDARY ARMOUR	CORE
	D50	D50	D50
SECTION E	1.5m	0.7m	0.25m
SECTION F	1.2m	0.6m	0.21m

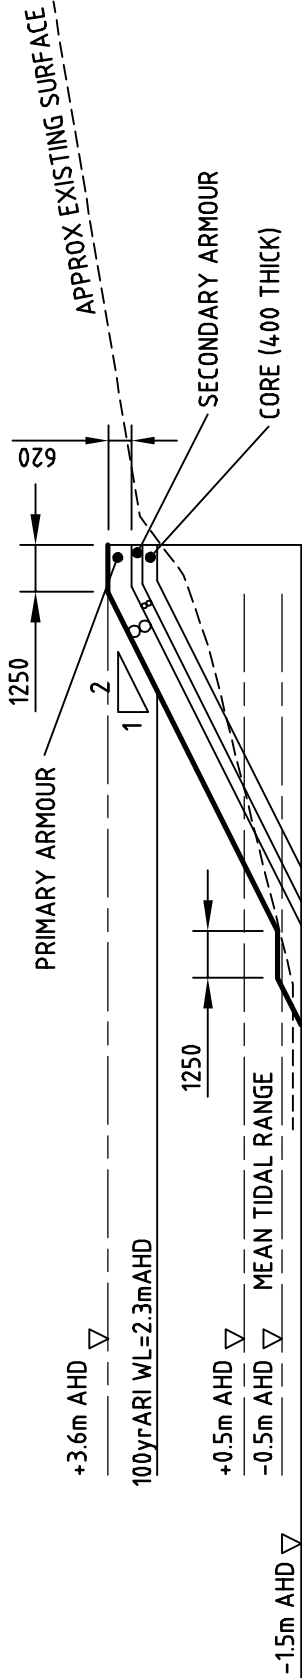
SECTION D
SCALE 1:200

- ALL WALLS AND REVETMENTS DESIGNED TO BE FOUNDED ON SAND.
- SECTION C: PROTECTION FOR NORTH ENTRANCE SAND SPIT.
- SECTION D: PROTECTION FROM SAND SPIT UP TO BRIDGE.

REVETMENT WALL
(NORTHERN TRAINING WALL)

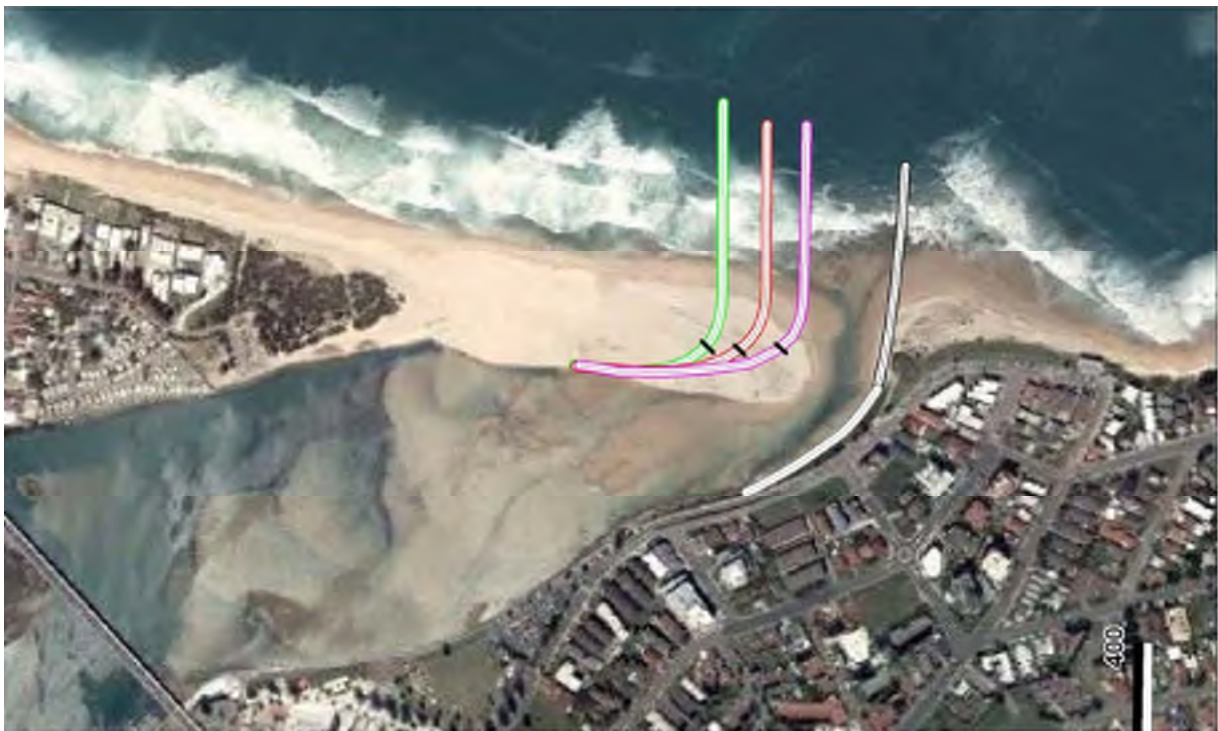
The proposed possible training walls superimposed in their approximate positions.

The building of two training walls in the vicinity of Karagi Point has been proposed as a method whereby a reasonably predictable flow/volume of water can be facilitated into and out of the lakes. Cardno have investigated a range of training wall opening widths (100m, 150m, and 200m) and 150m would be the most suitable from flooding effects and entrance

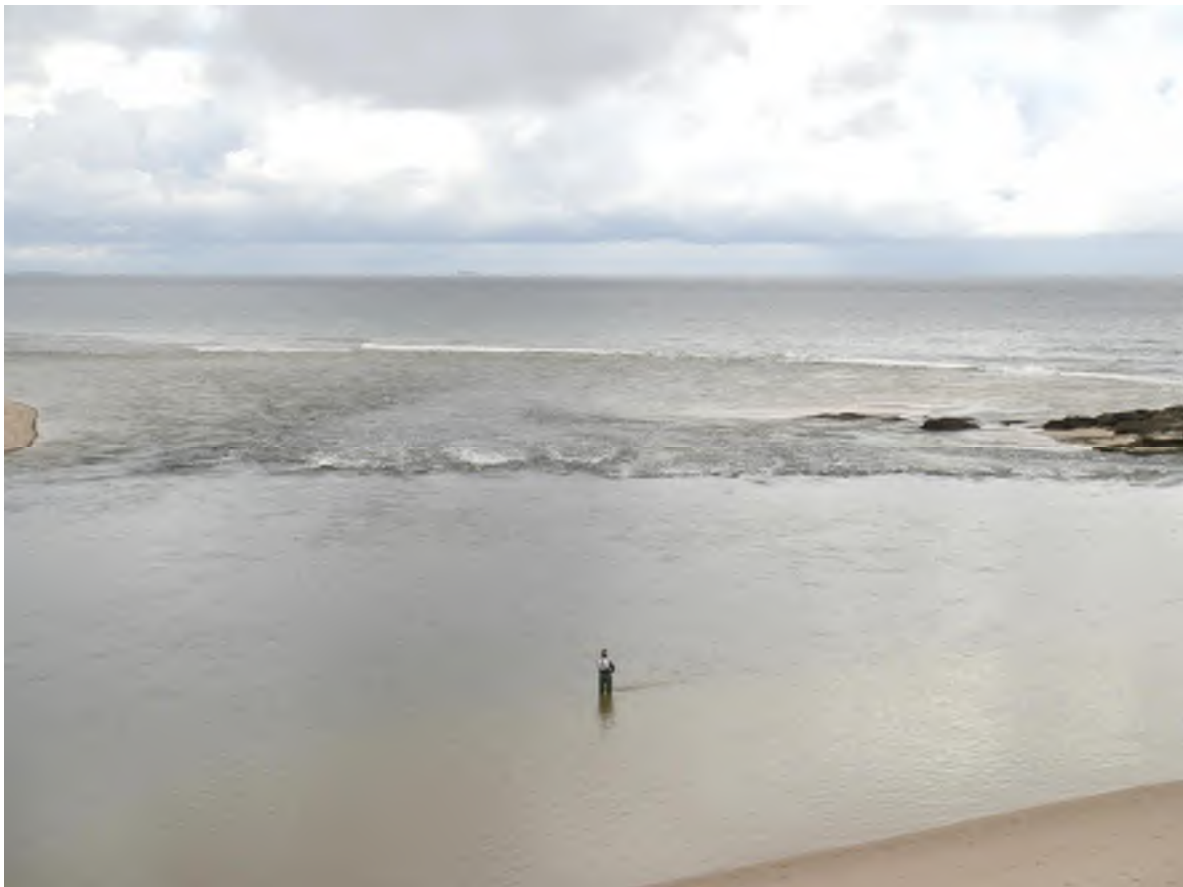
The rock shelf is evident in the foreground with the outgoing water breaking on it and the bar-way itself in the distance. This photo was taken just before low water and on an almost calm day. (Photo taken at 1415 on 9/4/13)

The base of the entry, inshore of the bar-way, is rock and at low tide has an approximate depth of 0.3m and is virtually non-navigable except by vessels such as jet skis and kayaks. The bar-way itself, the area where the outgoing water meets the sea, is also constantly

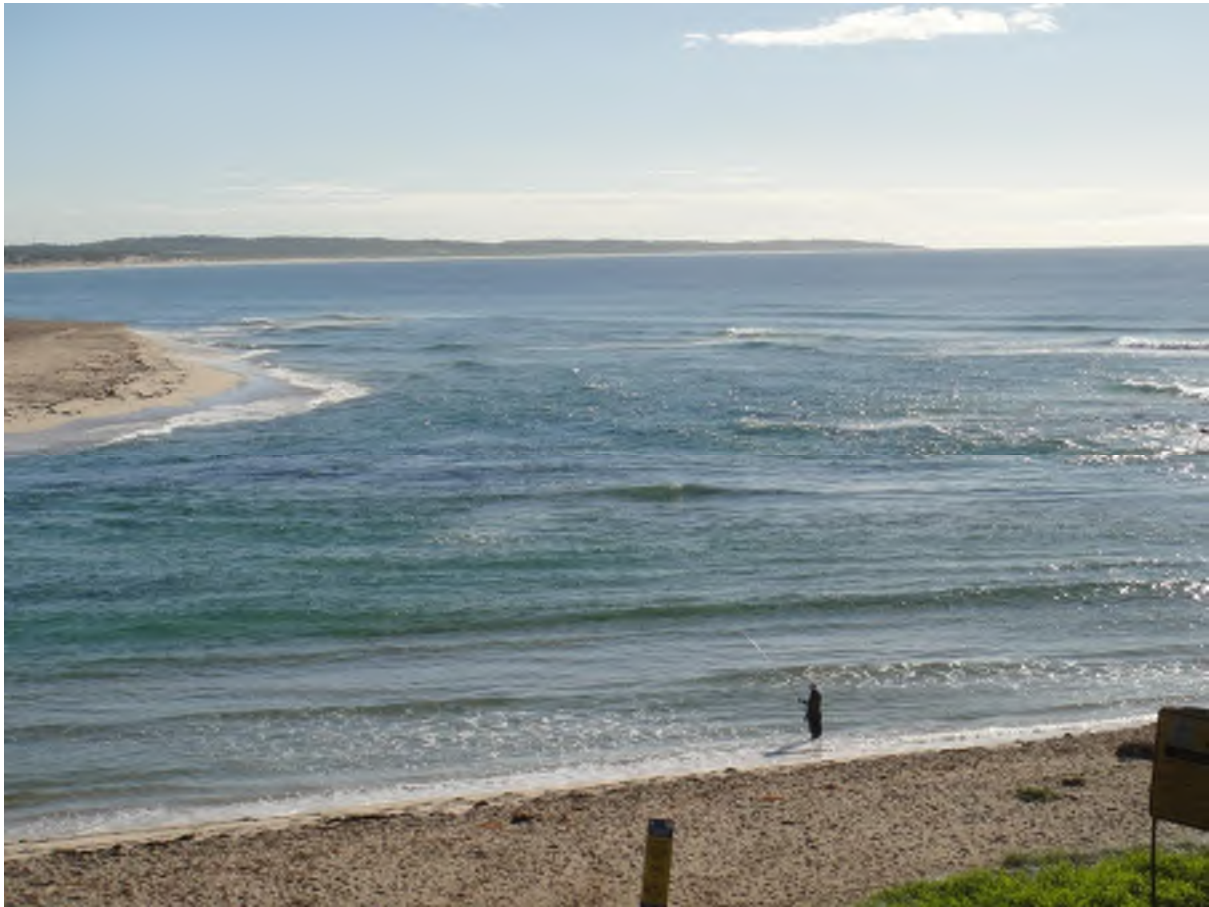
The same area at high tide. Note that the rock shelf is not evident due to the depth being approximately 1.0 to 1.5m. (Photo taken at 0815 on 10/4/13)

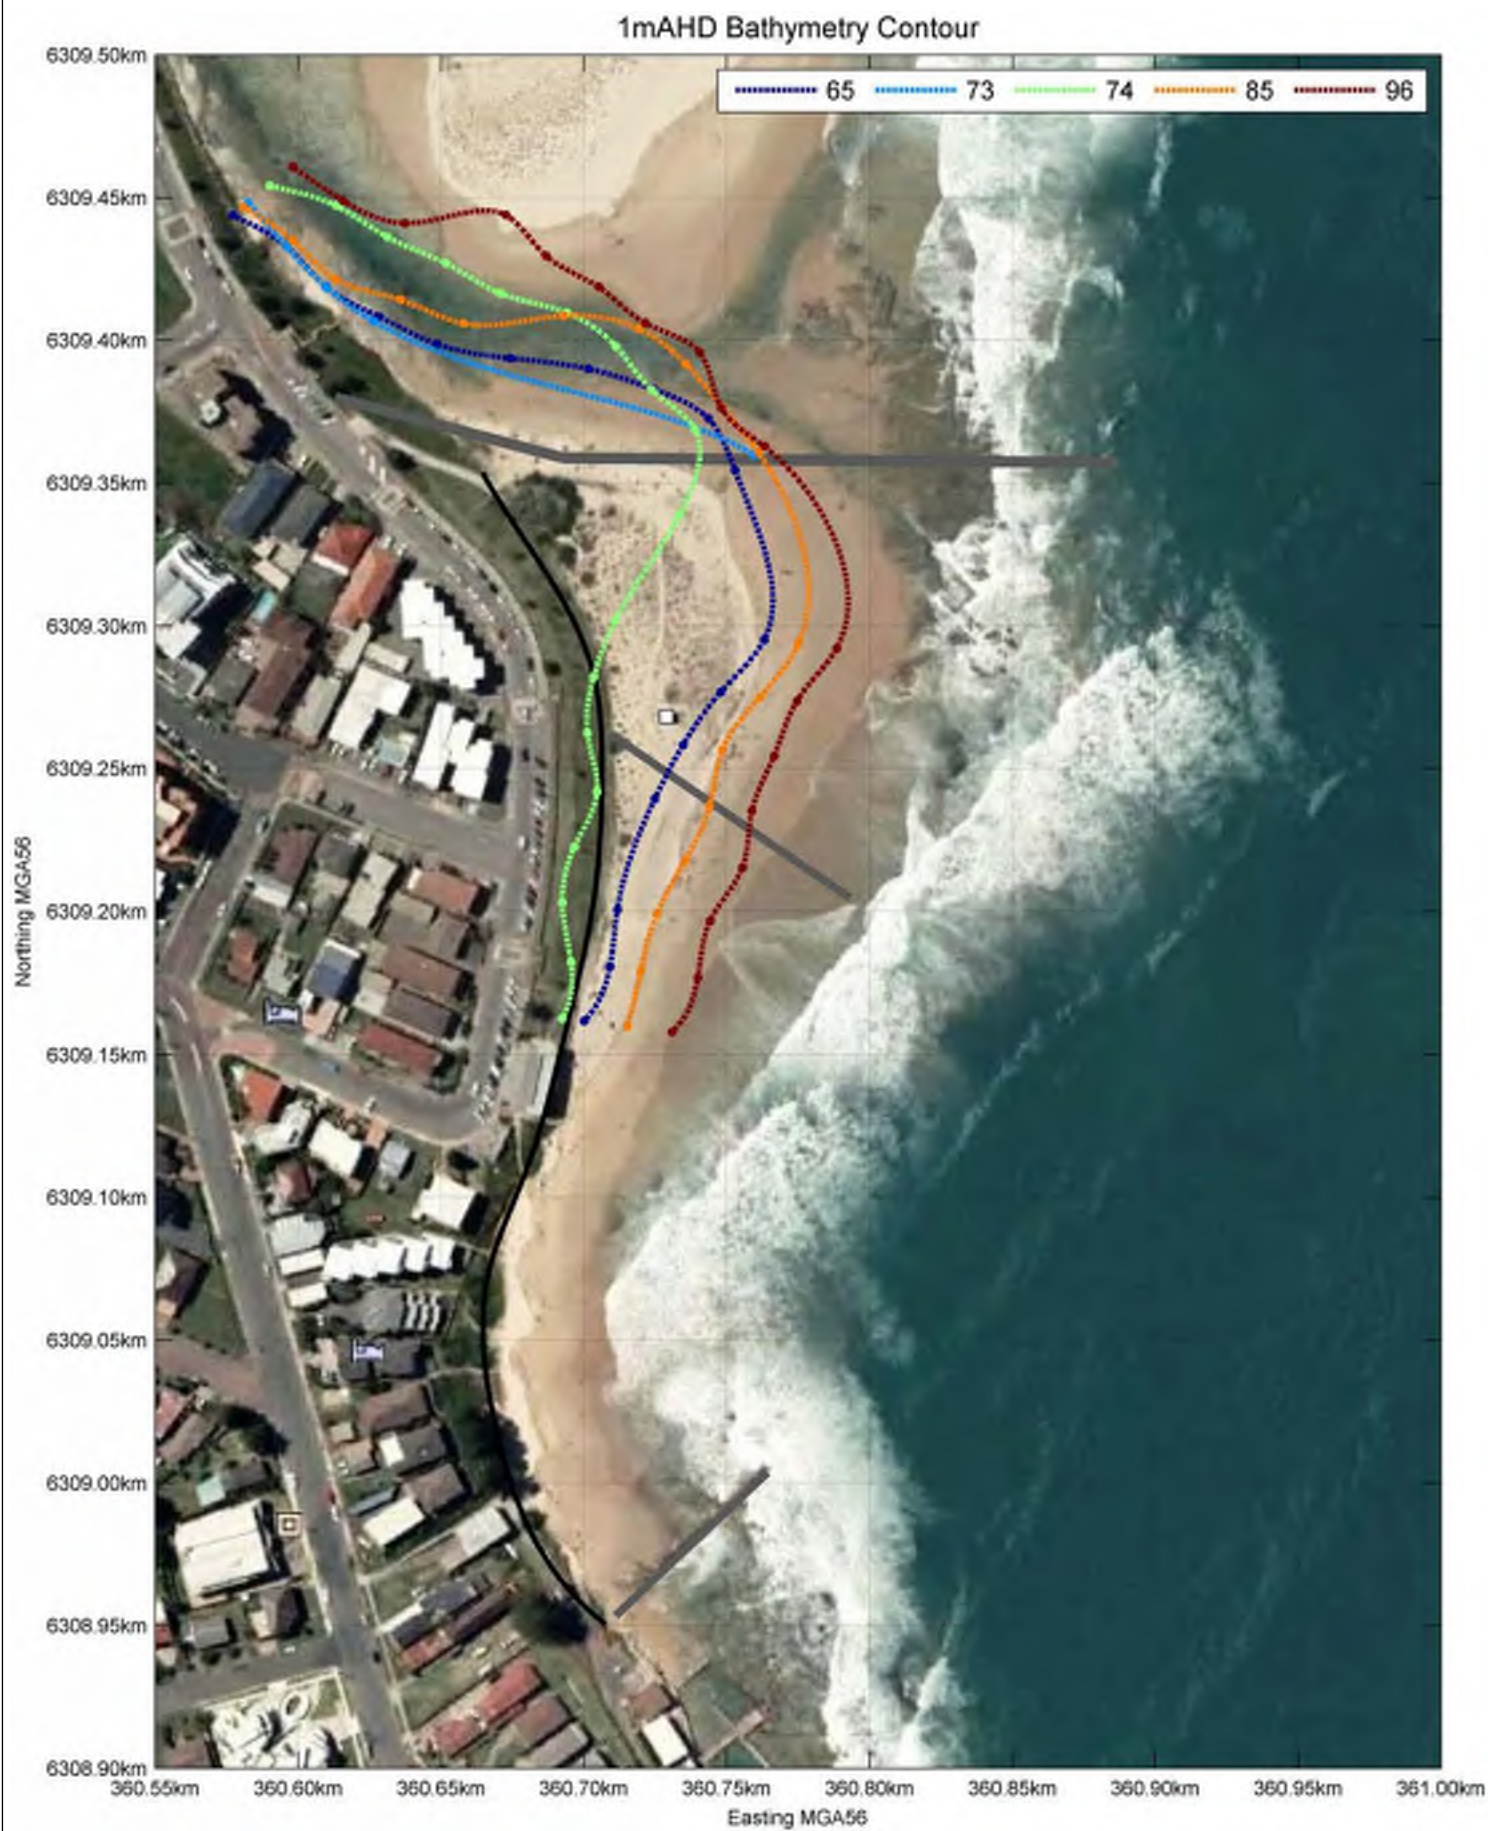
WL=0.9mAHD - $H_{s_{off}}=5m$ - $T_{p_{off}}=11.2s$ - $Dir_{off}=135^{\circ}TN$

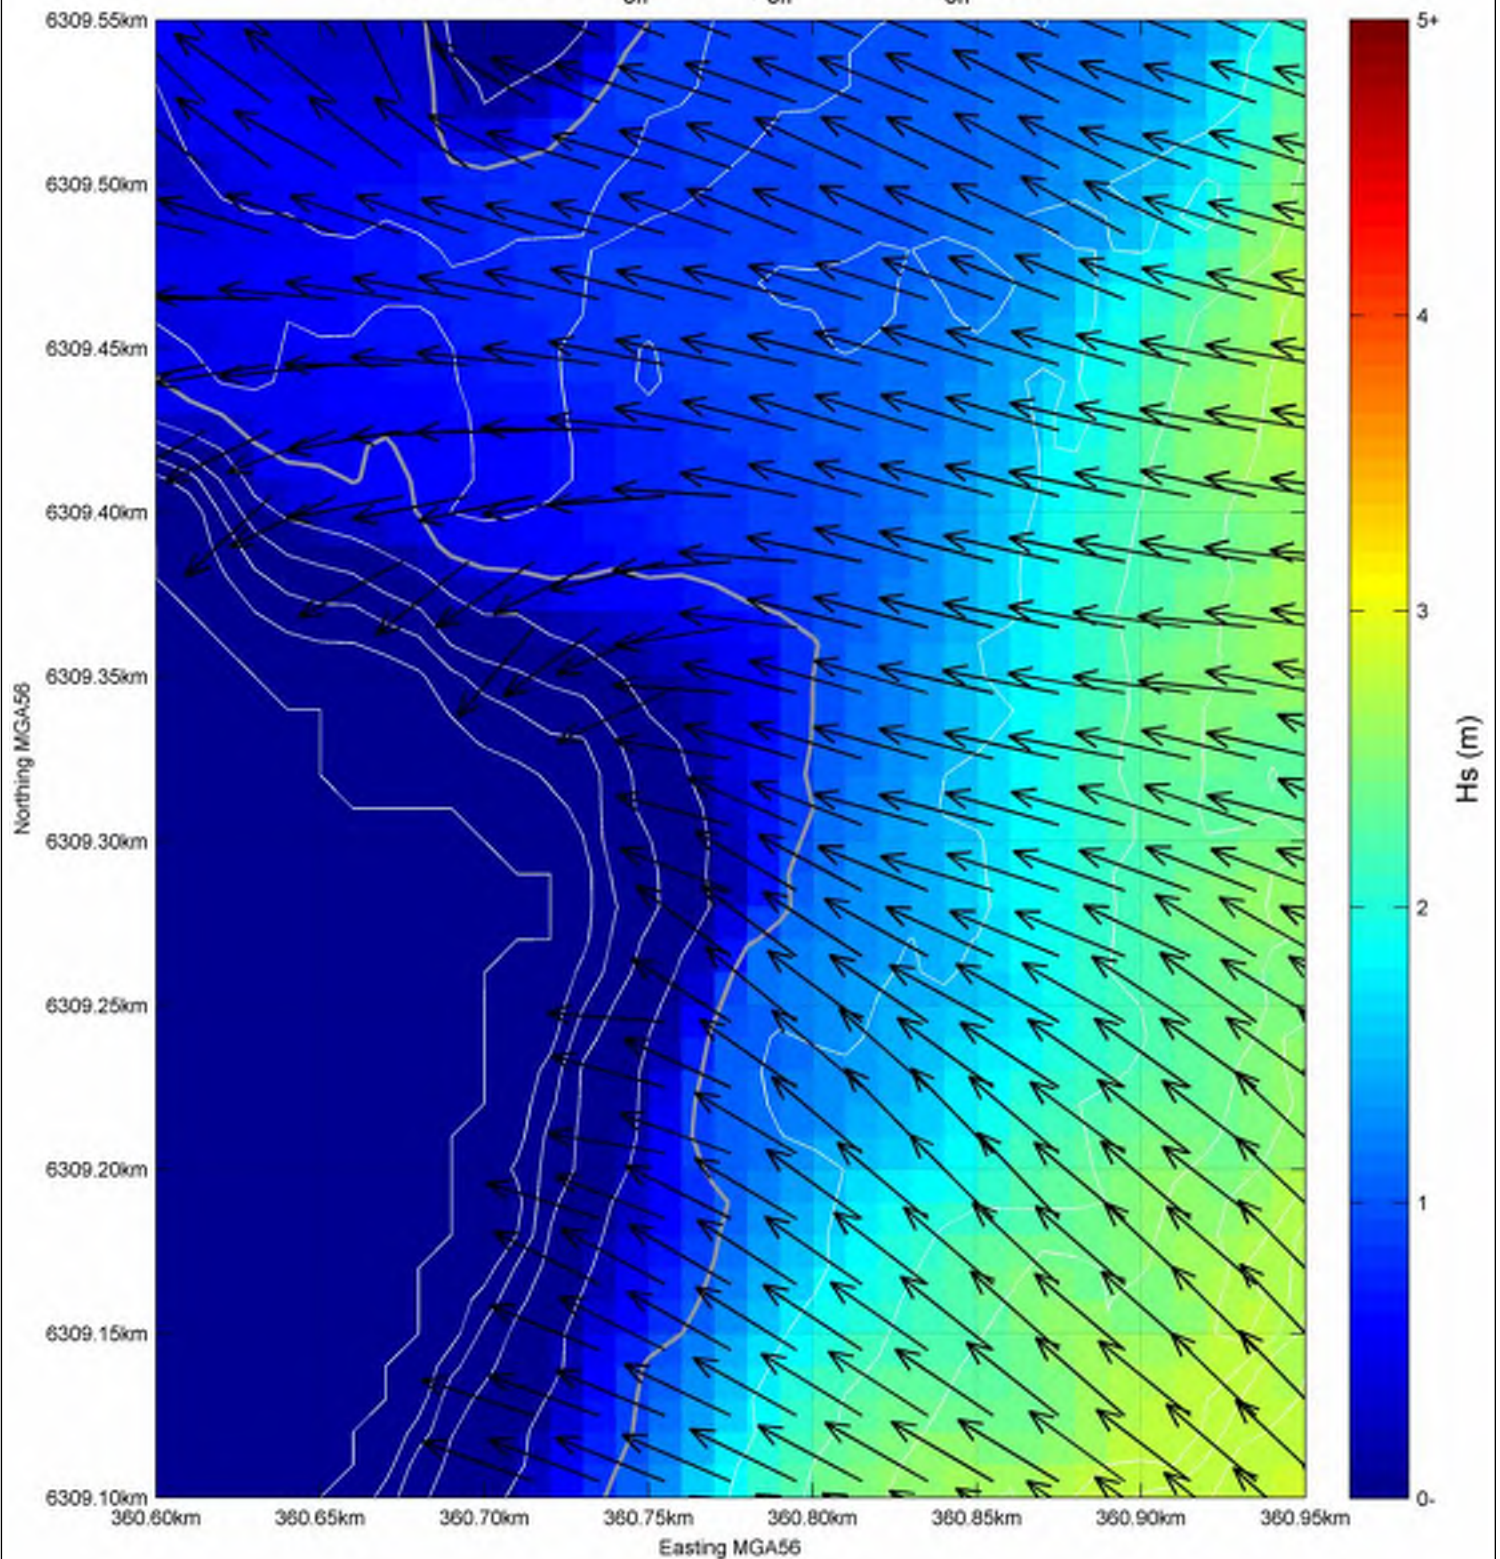
WL=0.9mAHD - $H_{s_{off}}=5m$ - $T_{p_{off}}=11.2s$ - $Dir_{off}=135^{\circ}TN$

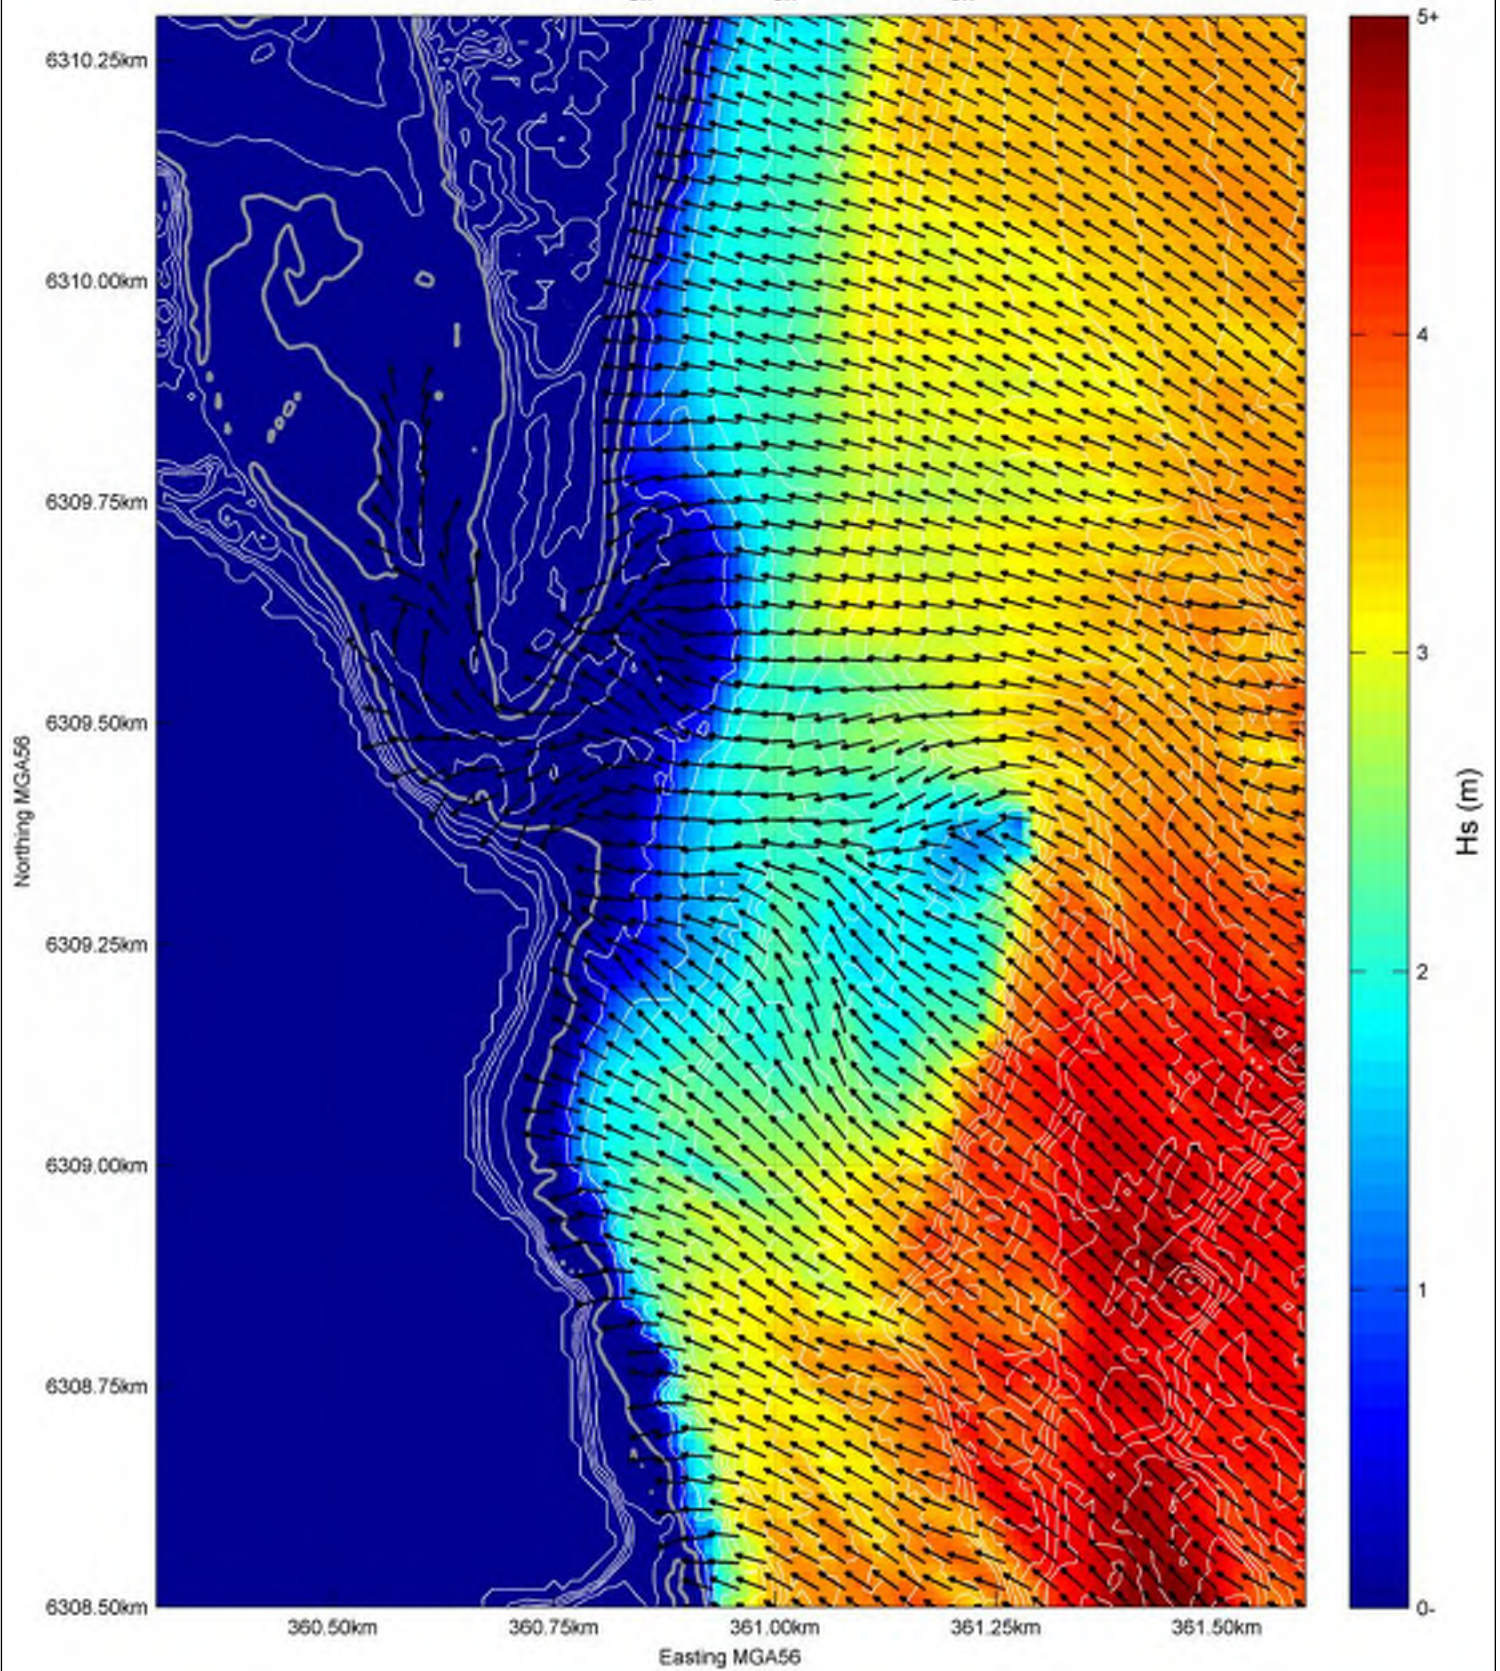
WL=-0.5mAHD - $H_{s\text{off}}=5\text{m}$ - $T_{p\text{off}}=11.2\text{s}$ - $\text{Dir}_{\text{off}}=135^\circ\text{TN}$

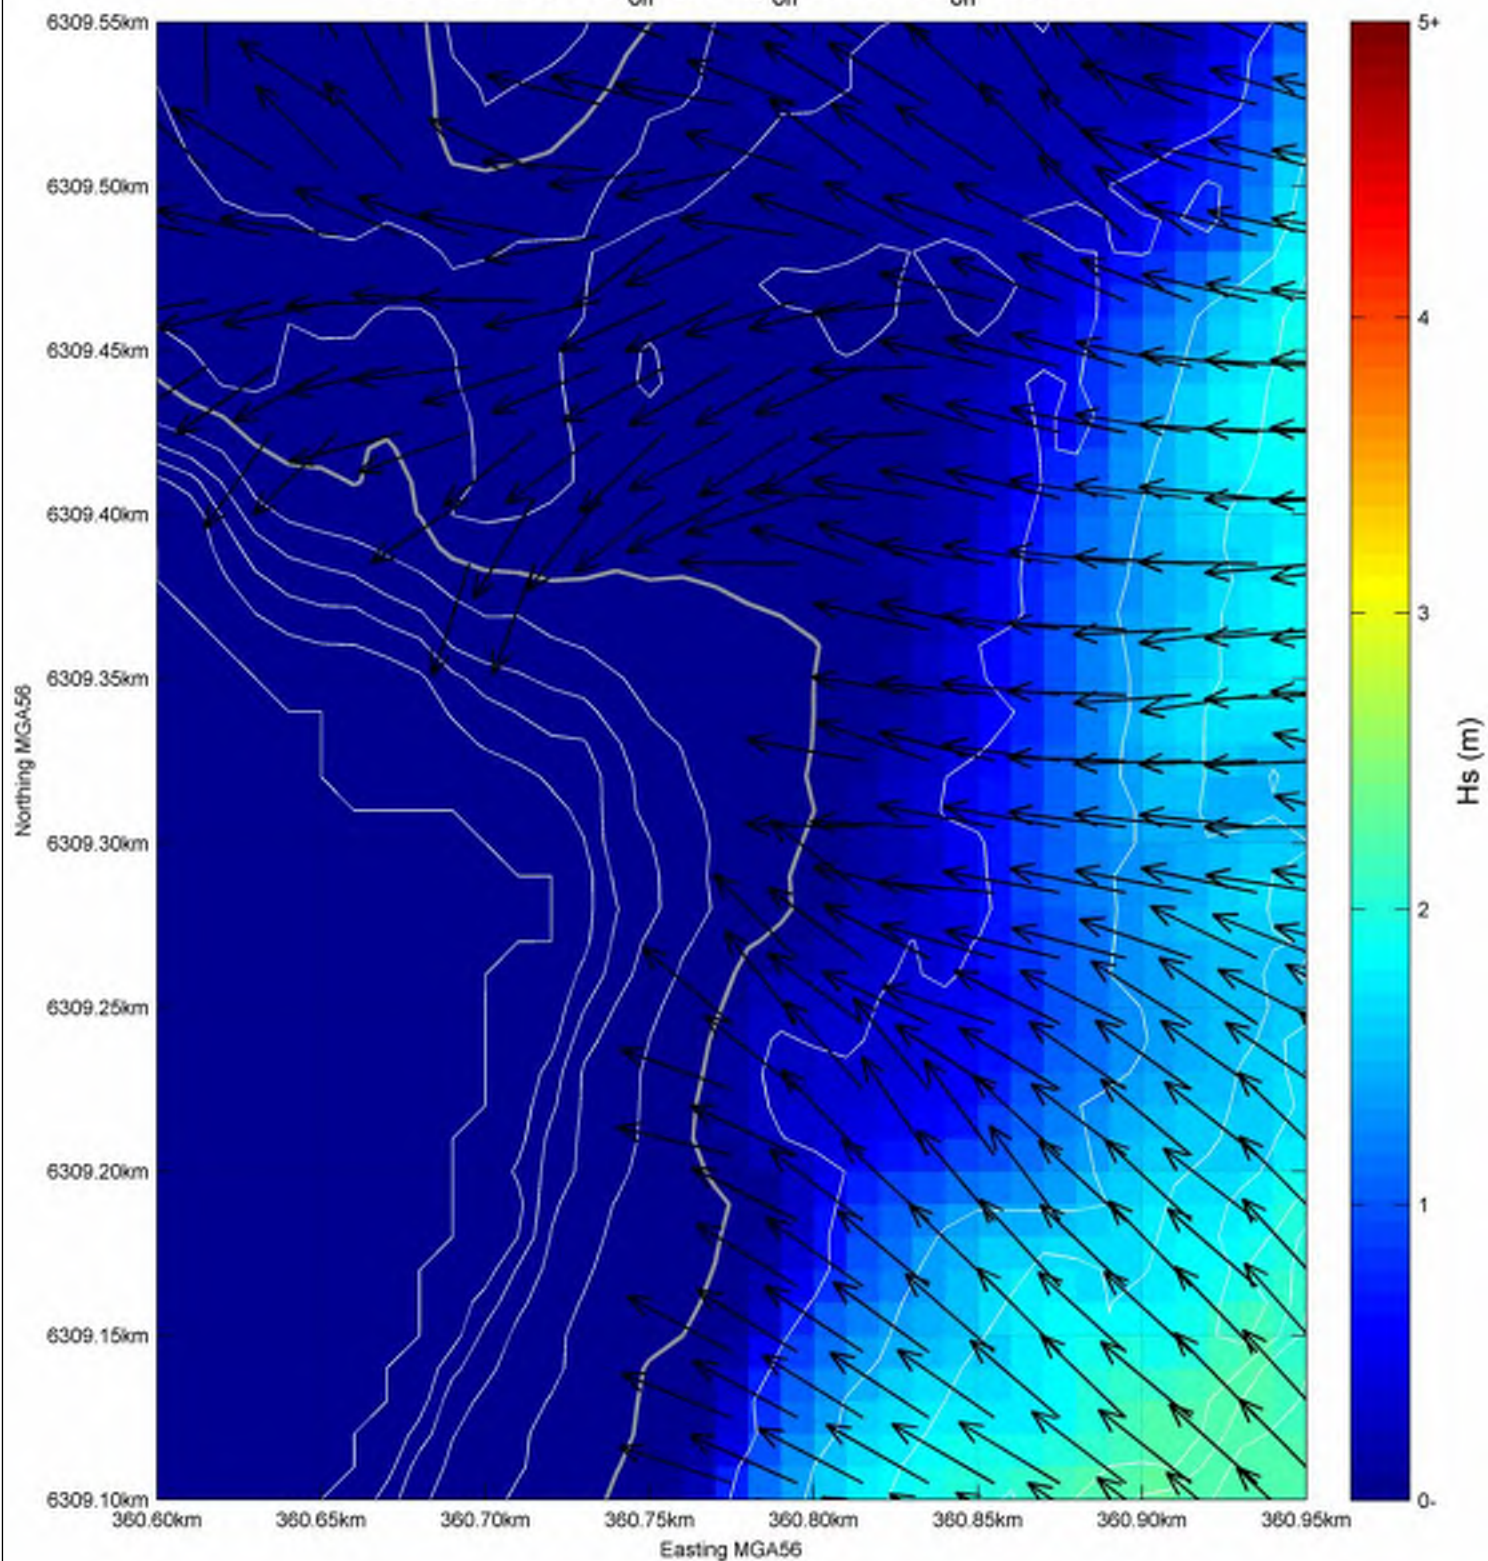
WL=-0.5mAHD - $H_{s_{off}}=5m$ - $T_{p_{off}}=11.2s$ - $Dir_{off}=135^{\circ}TN$
