Review of Environmental Factors

PROJECT: **The Entrance Rock Groyne**

SITE ADDRESS: **The Entrance, NSW**

DATE: **May 2016**

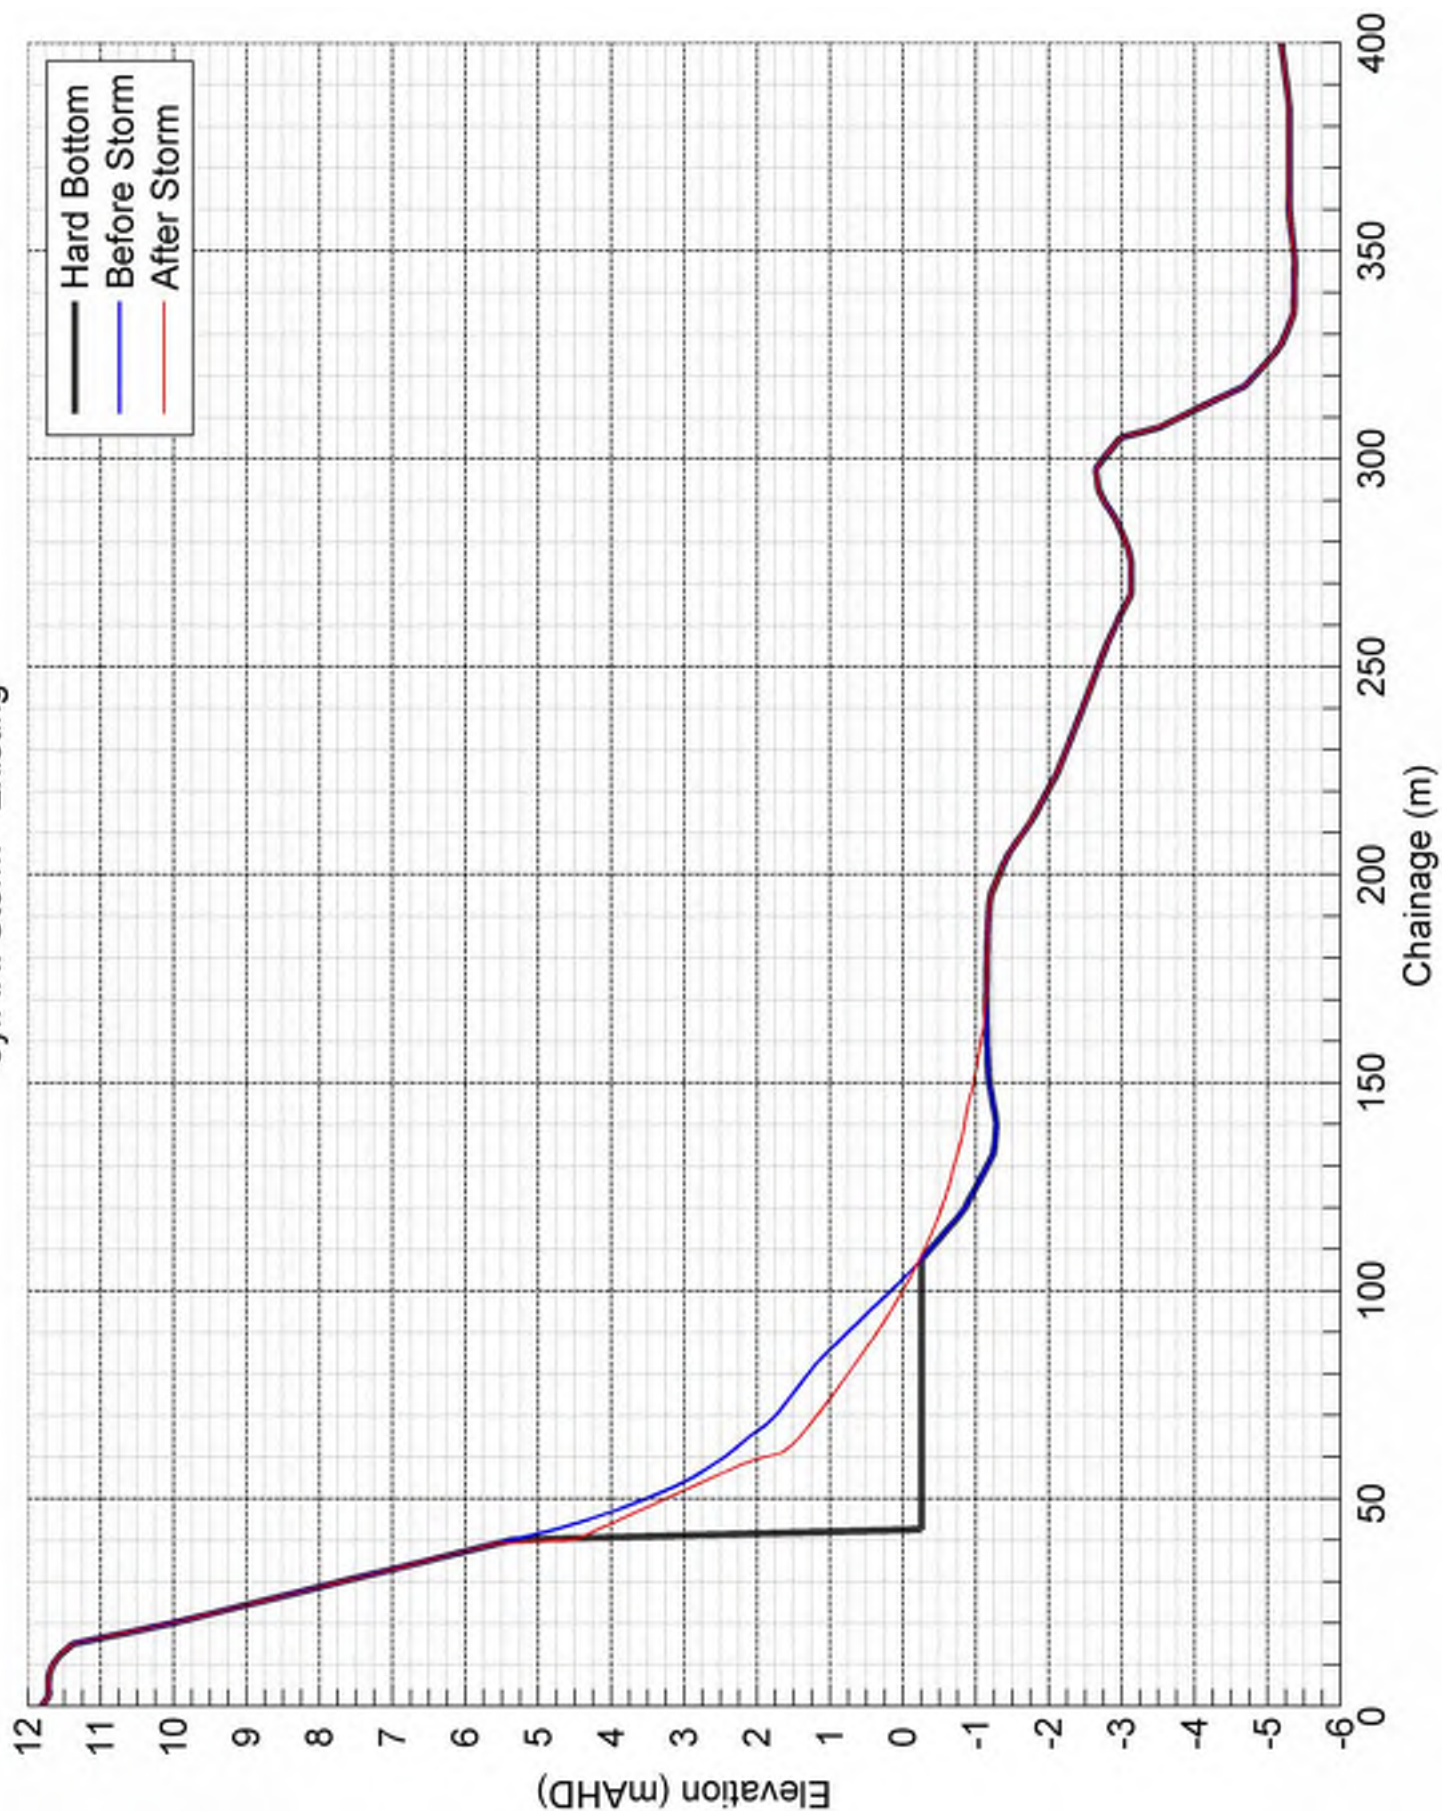
5yrARI Storm - Existing

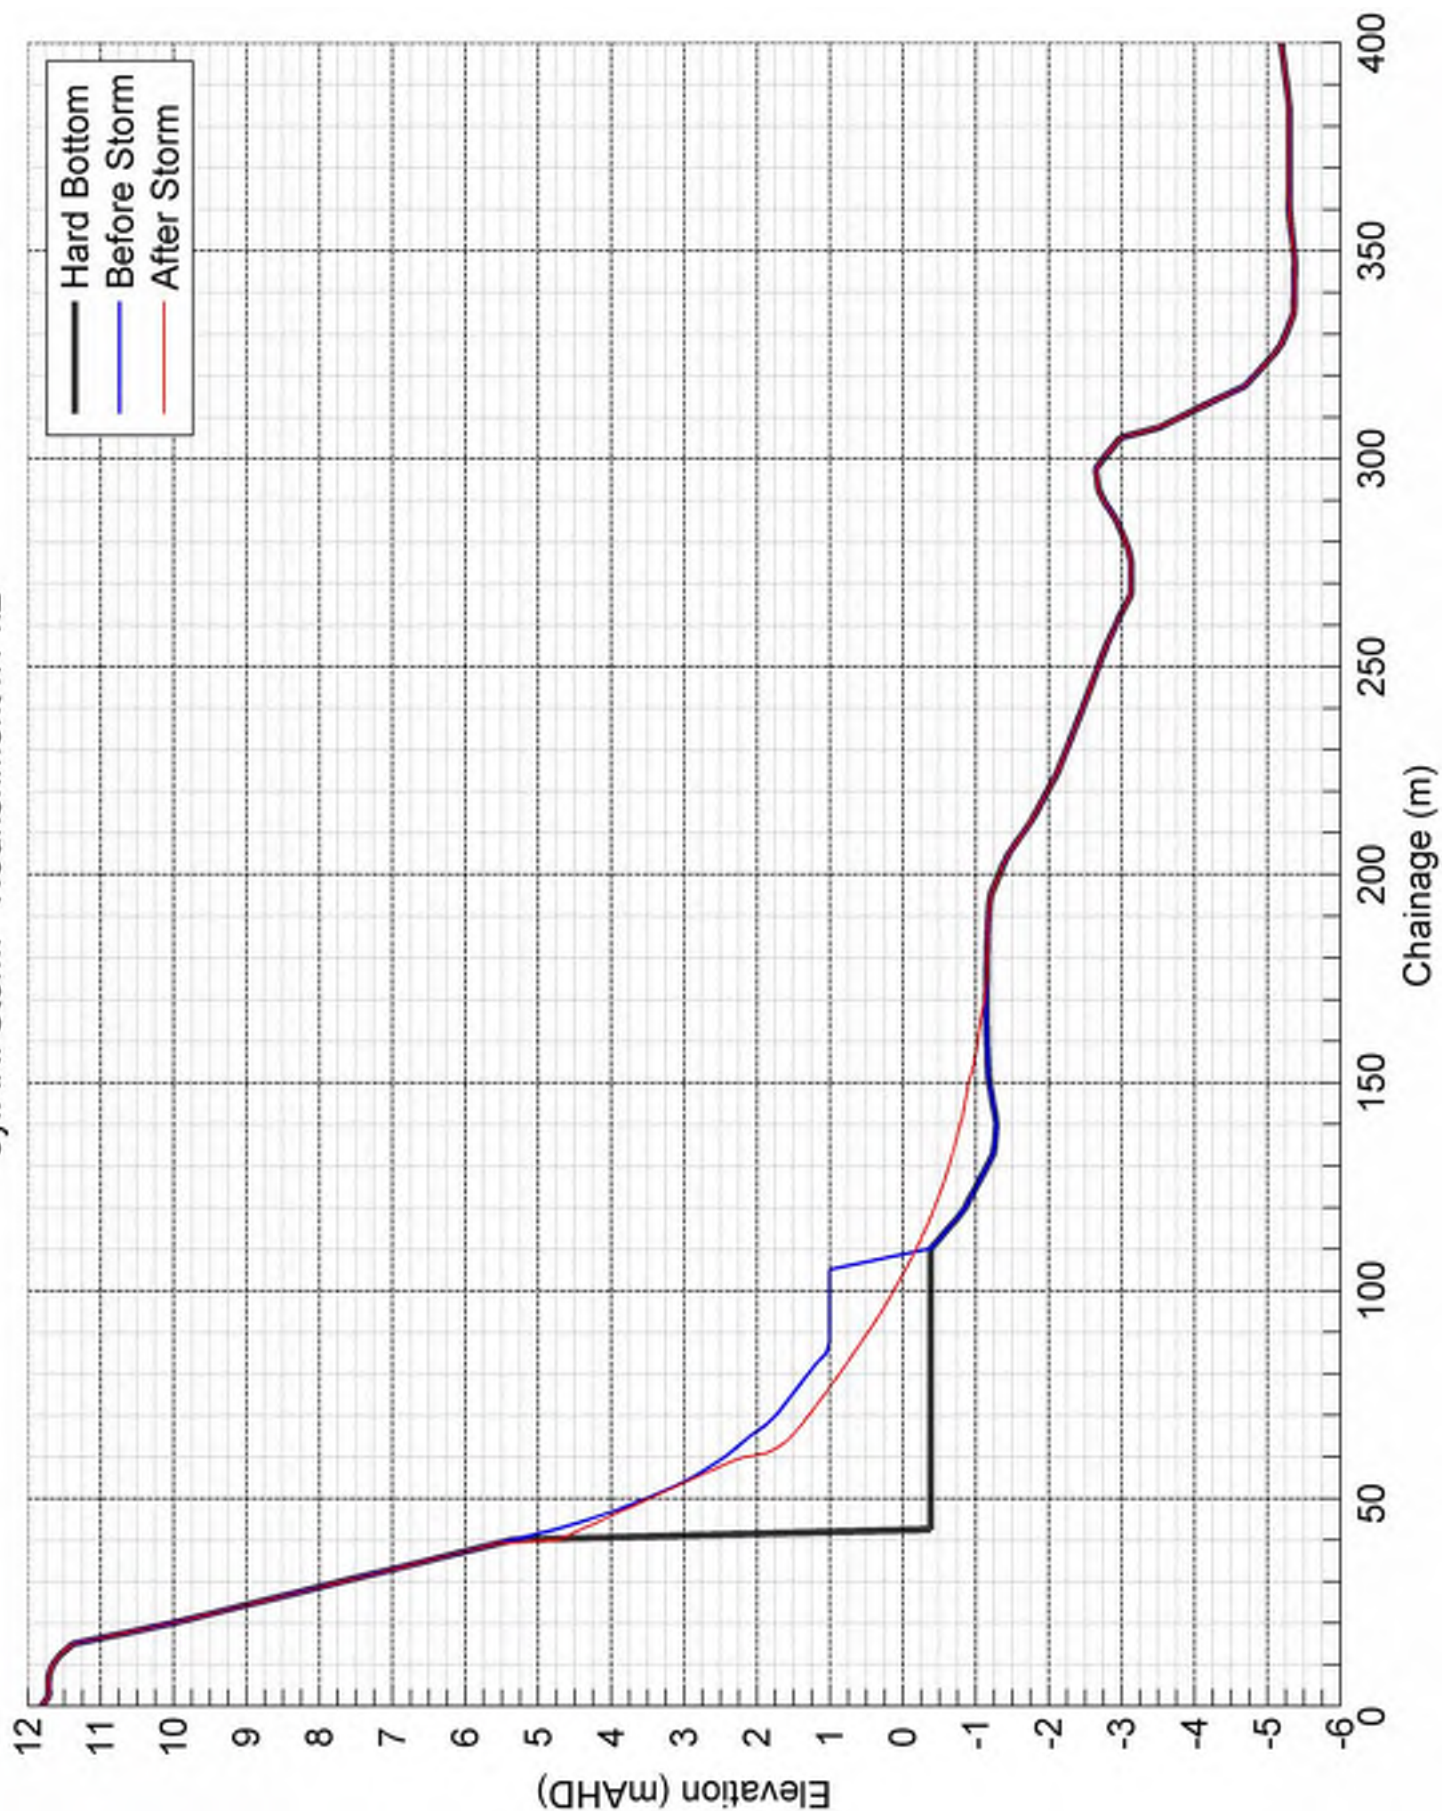
5yrARI Storm - Nourishment n1-n2

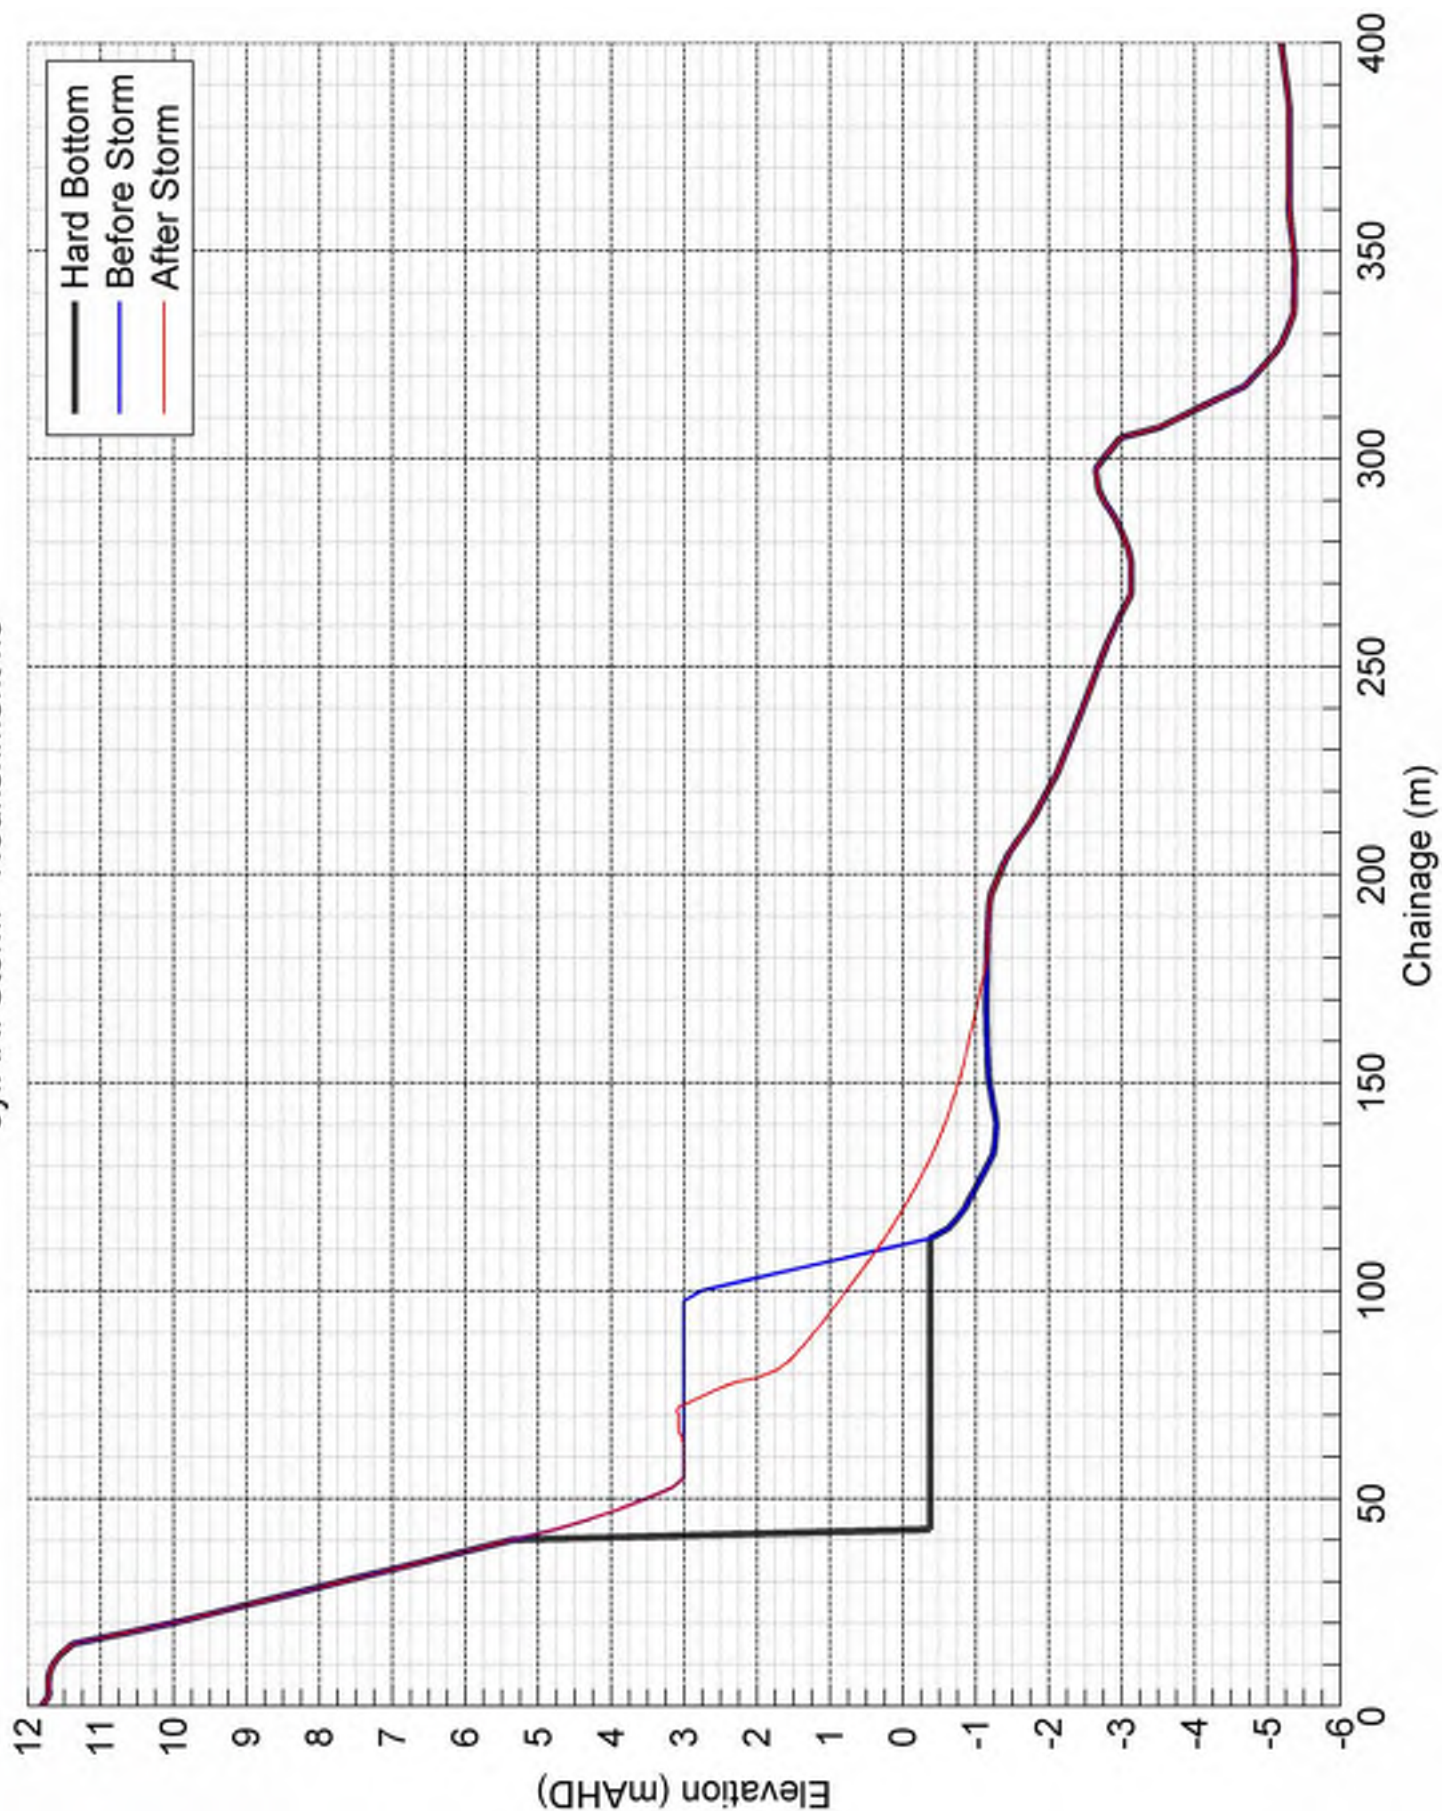
5yrARI Storm - Nourishment n3
